Beaver Valley Headwaters Preserve: SRWC Final Report

A Compendium of Natural Resource Information
Collected to Inform Management Decisions
Related to Riparian Habitat, Stream Channel
Restoration and Enhancement & Forest Health
Resiliency

*Prepared by Scott River Watershed Council
May 1, 2024*

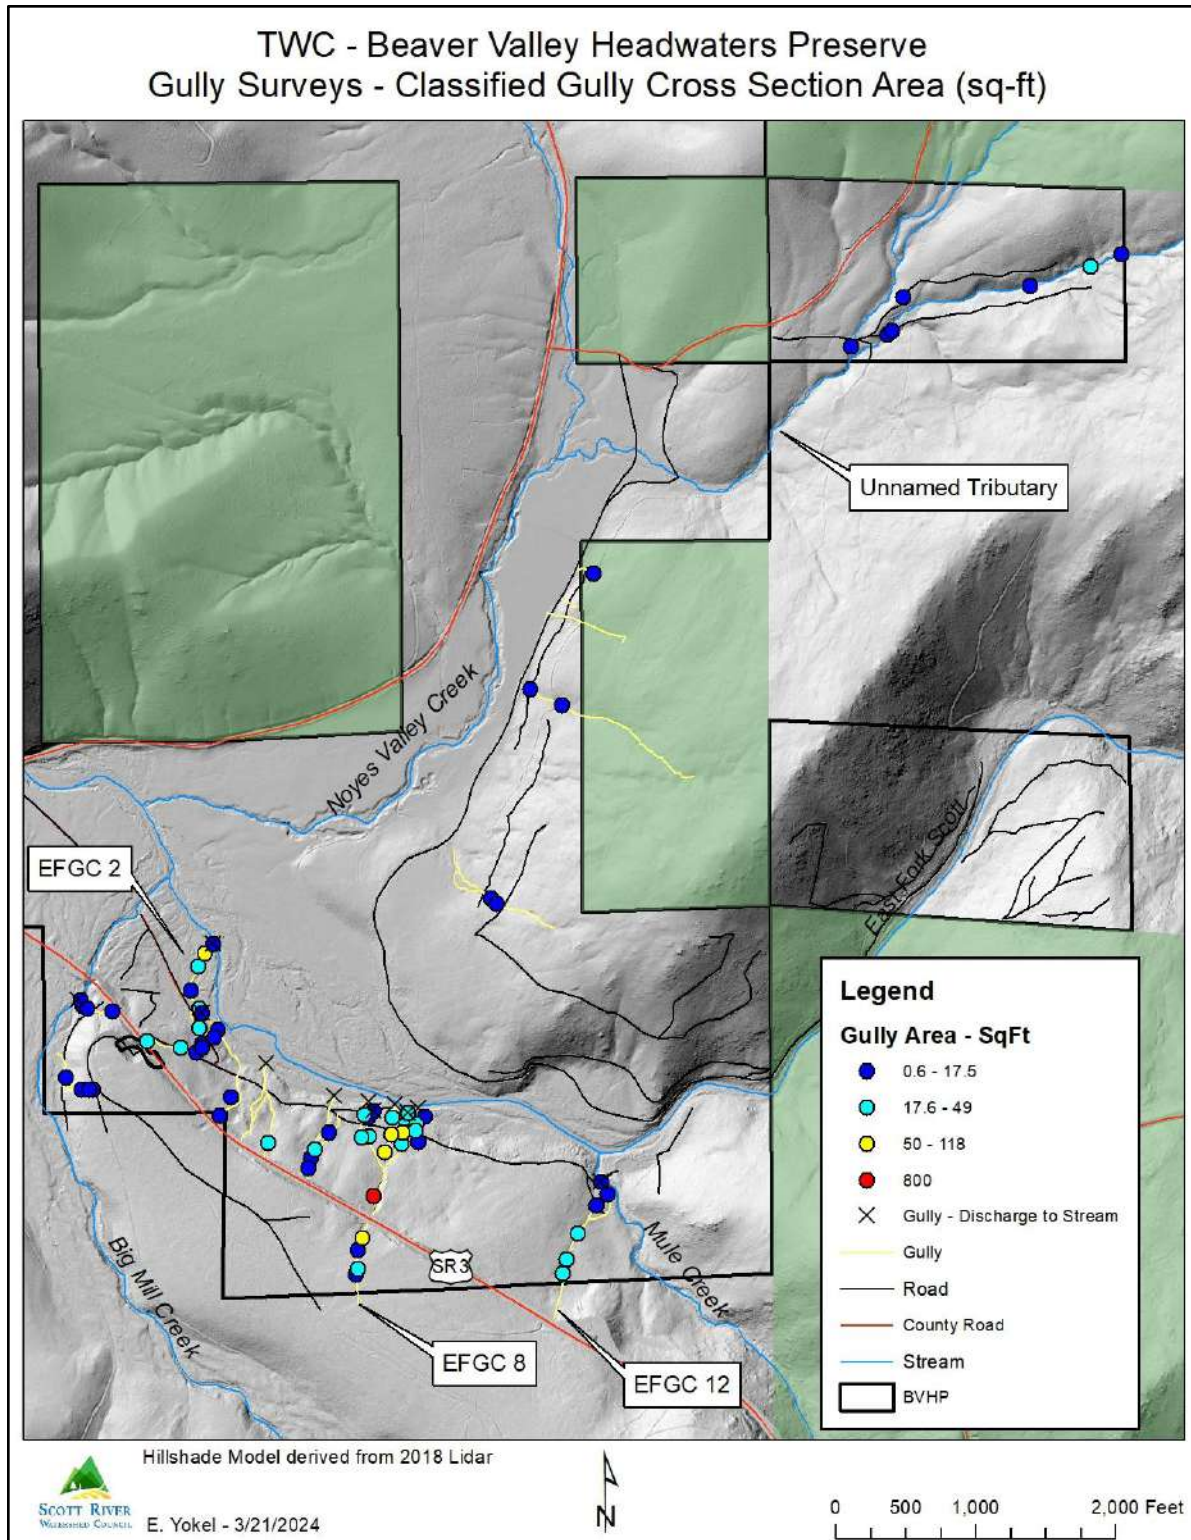
Initial mapping of the cross-section area of gully features, as shown in (Map 2.4) of the gully features made clear that some of the highest severity gully segments are part of the Gully 2 and Gully 8 Complexes. Scoring of individual segments (Table 2.3) and whole gully complexes (Table 2.4) concurred. Both scoring methods highlight East Fork Gully Complexes (EFGC) 2, 8, 12, and 5. A discussion of each of these high priority gully complexes follows, including representative photos. A more complete photographic representation of each gully can be found in Appendix A.

Map 2.4: Classified Gully Cross Section Area (square - ft) - East Fork Scott River.

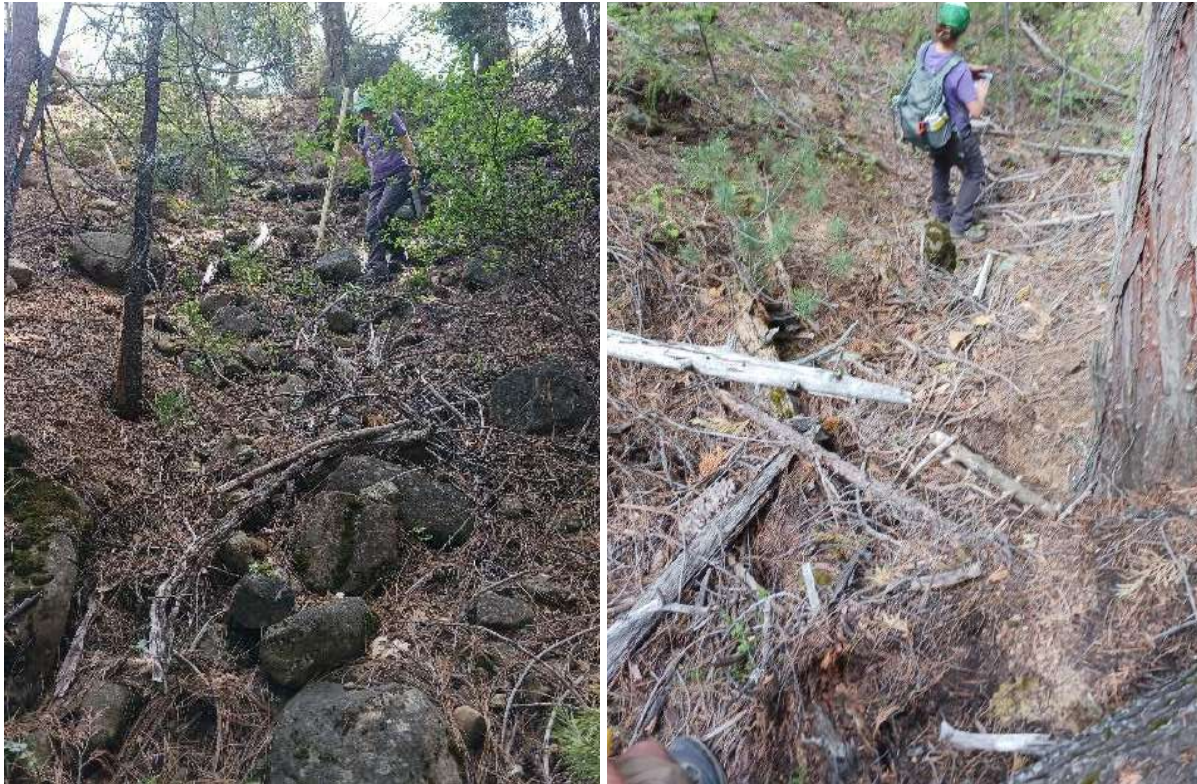
Gully Complex 6 (Table 2.10) begins slightly downslope of a berm on the downhill side of Highway 3 and bifurcates into two branches. Highway 3 does not appear to contribute to this gully system (Photo 2.21); there is no culvert or ditch. The thalweg of the gully is covered with a thick layer of duff (Photo 2.22), comparable to the forest floor around it, suggesting that it has not experienced recent erosion (Photo 2.23). It does not cause notable erosion when it crosses the dirt road. Perhaps this was a creek or swale that was cut off from its source by the construction of the highway.

Photos 2.21 and 2.22: Beginning of EFGC 6; no visible cause EFG6.1a (left photo). Significant layer of duff. EFG6g (right photo). May 29, 2023.

Water management related to Highway 3 causes, or exacerbates, erosion in almost all the high severity gullies and gully complexes. While it may not be feasible to improve water handling on Highway 3, methods to slow the flow--and hence decrease erosion--could reduce sediment delivery to the East Fork Scott River and protect the private roads from further damage.

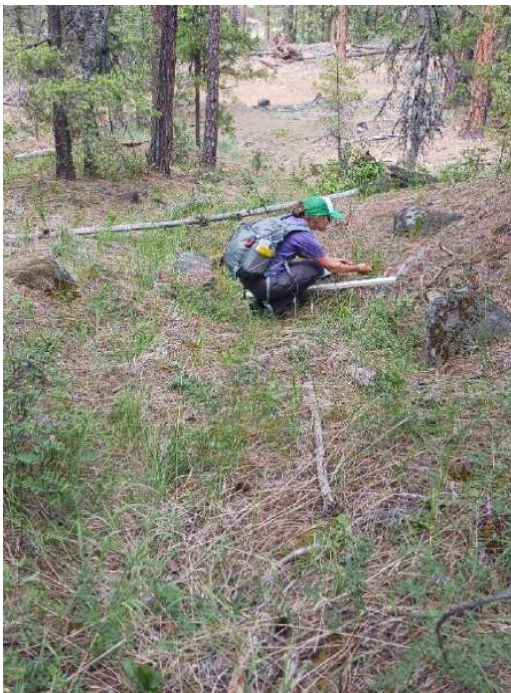
Photo 2.23: Duff and vegetation in gully. EFG6e; May 29, 2023.

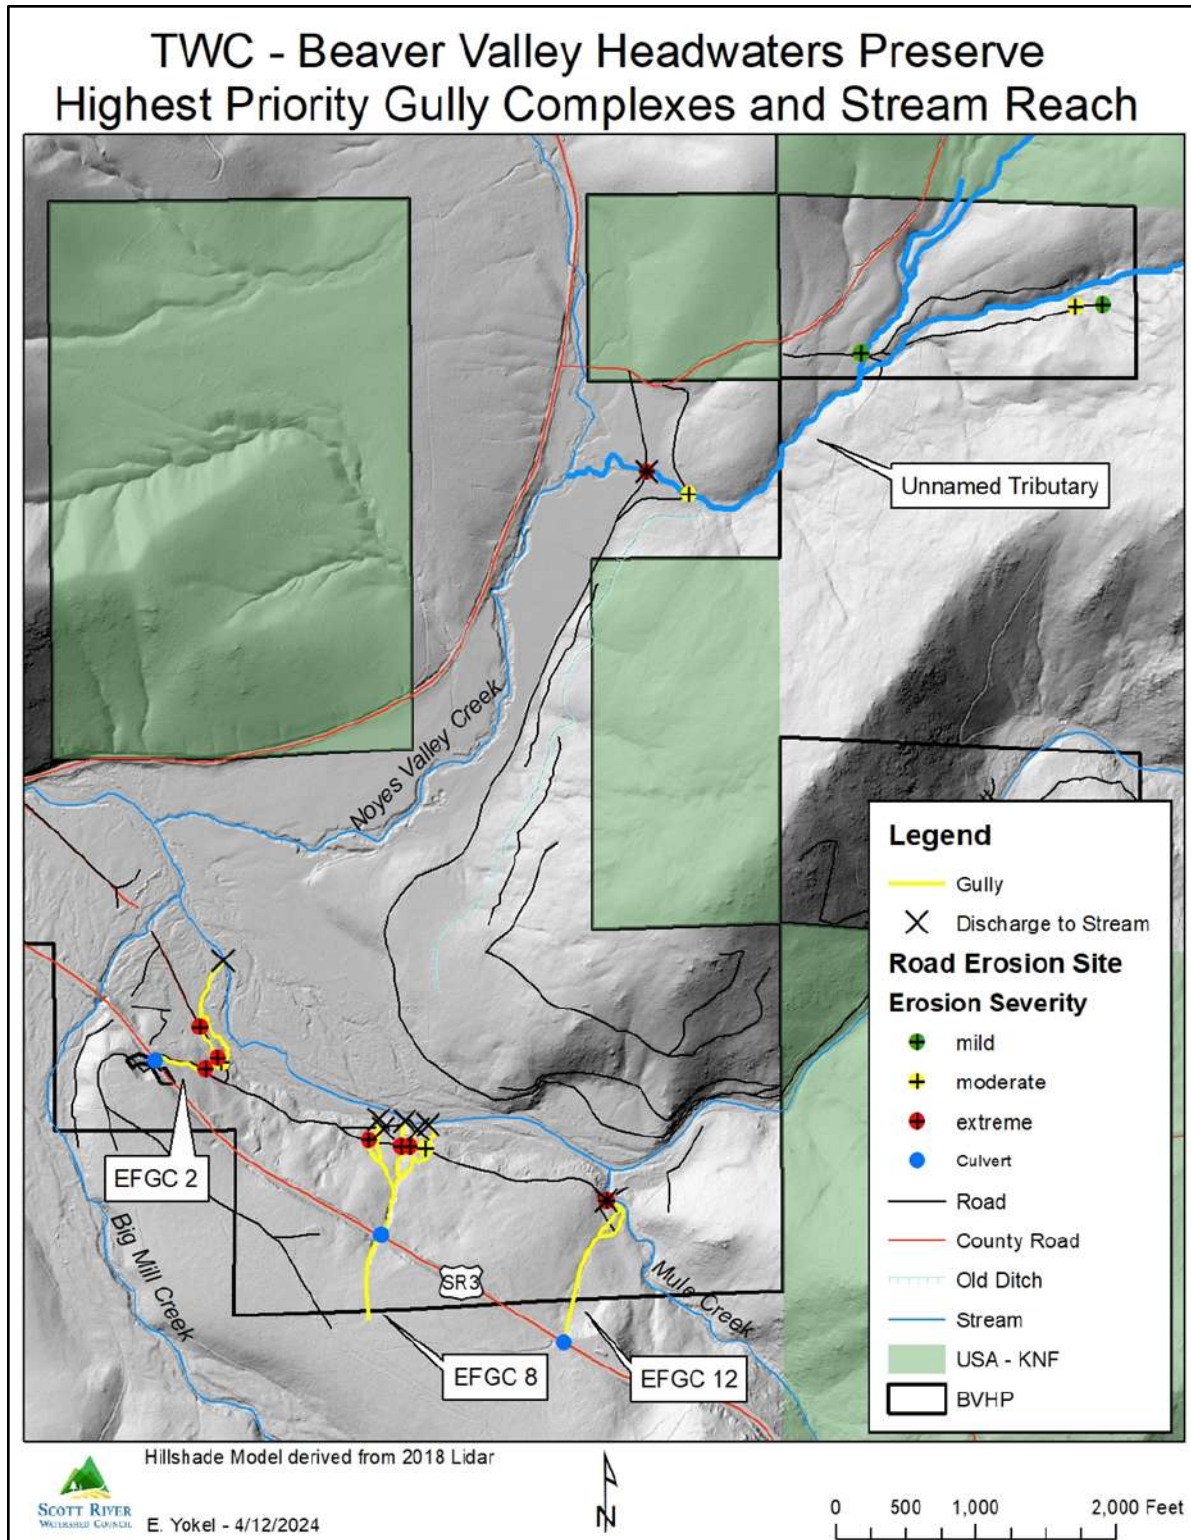
Map 2.9: Highest priority locations for treatment.

While some of the larger problems will require engineering design to address them, it may be possible to use low tech process-based approaches in the near term to reduce erosion until a more permanent solution can be implemented. Additionally, it would be useful to consider what locations lend themselves to simple, more inexpensive solutions. Even if they are not the major sediment sources, they may provide a decent return for the investment. A full copy of all the photos and photo points taken for this work can be found here: [BVHP East Fork Roads and Gully 240501](#).

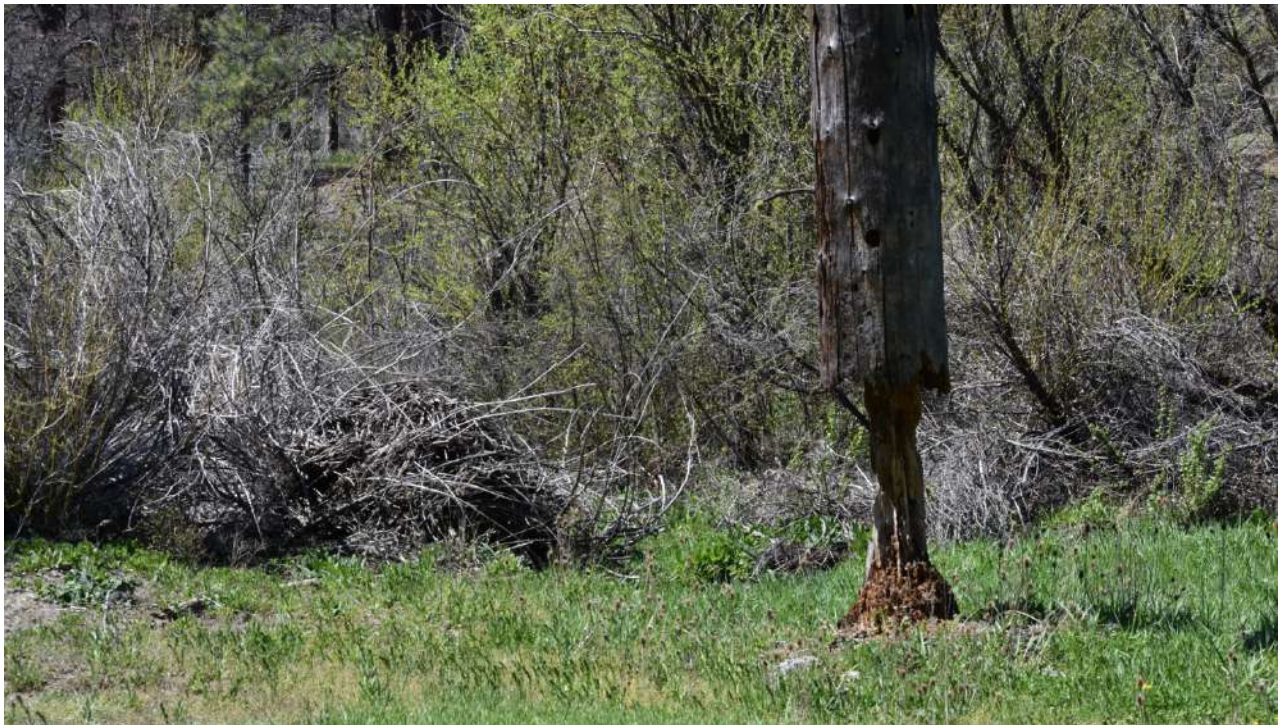
Photo 6.1: Footprint of a formal beaver pond. The dam has broken down over time, but evidence of its structure remains. Beaver chewed a conifer that once stood in ponded water behind the beaver dam (Gilmore 2024). April 28, 2024.

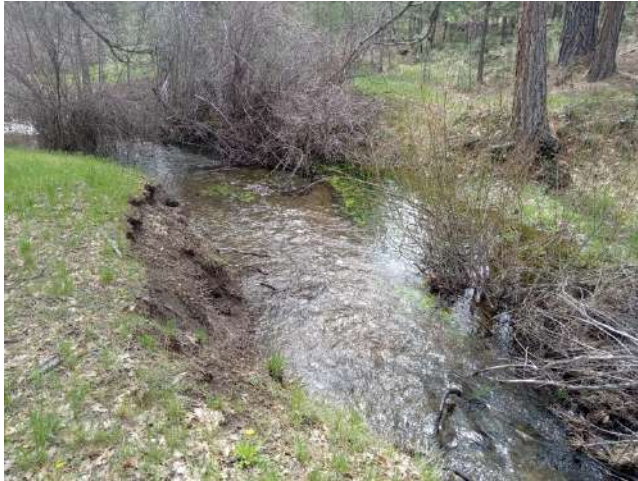
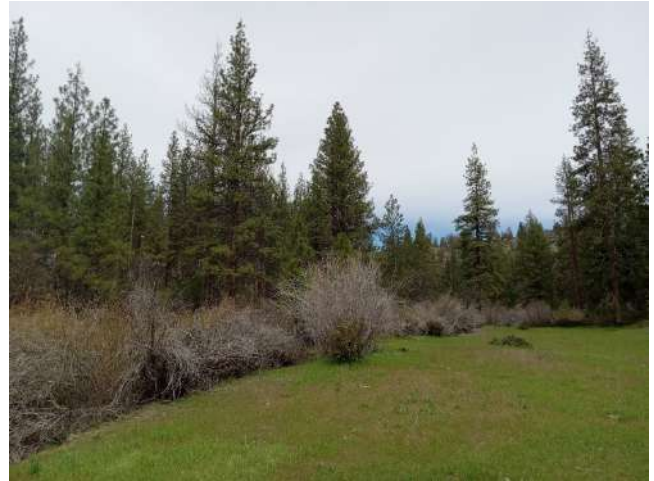
Photo 6.2 and 6.3: Eroding stream bank – Middle Noyes Valley Creek (left photo) and looking downstream (right photo). April 16, 2024.

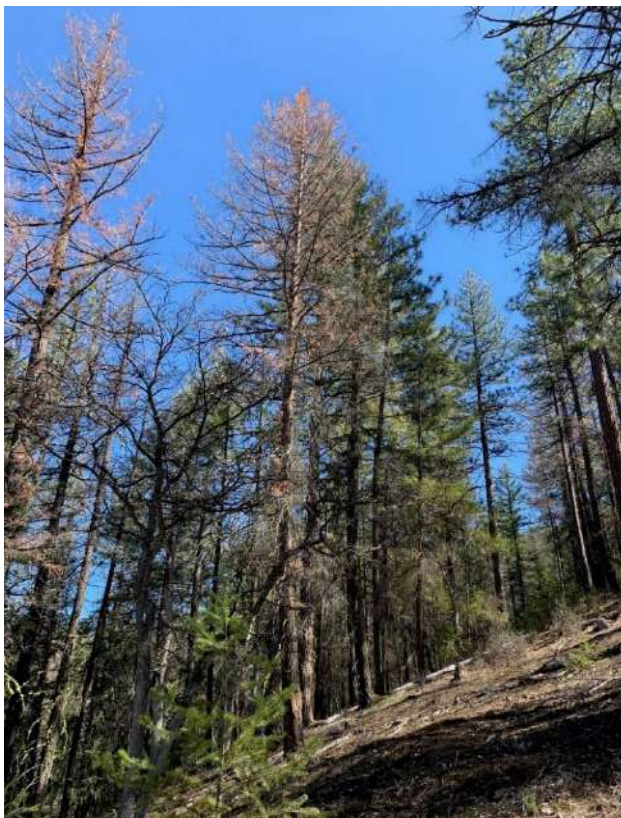
Photo 7.3: More drought tolerant oak and pine are thriving on sites where Douglas-fir is dying. Photo credit: Mark Lancaster, BBWA, March 18, 2024.

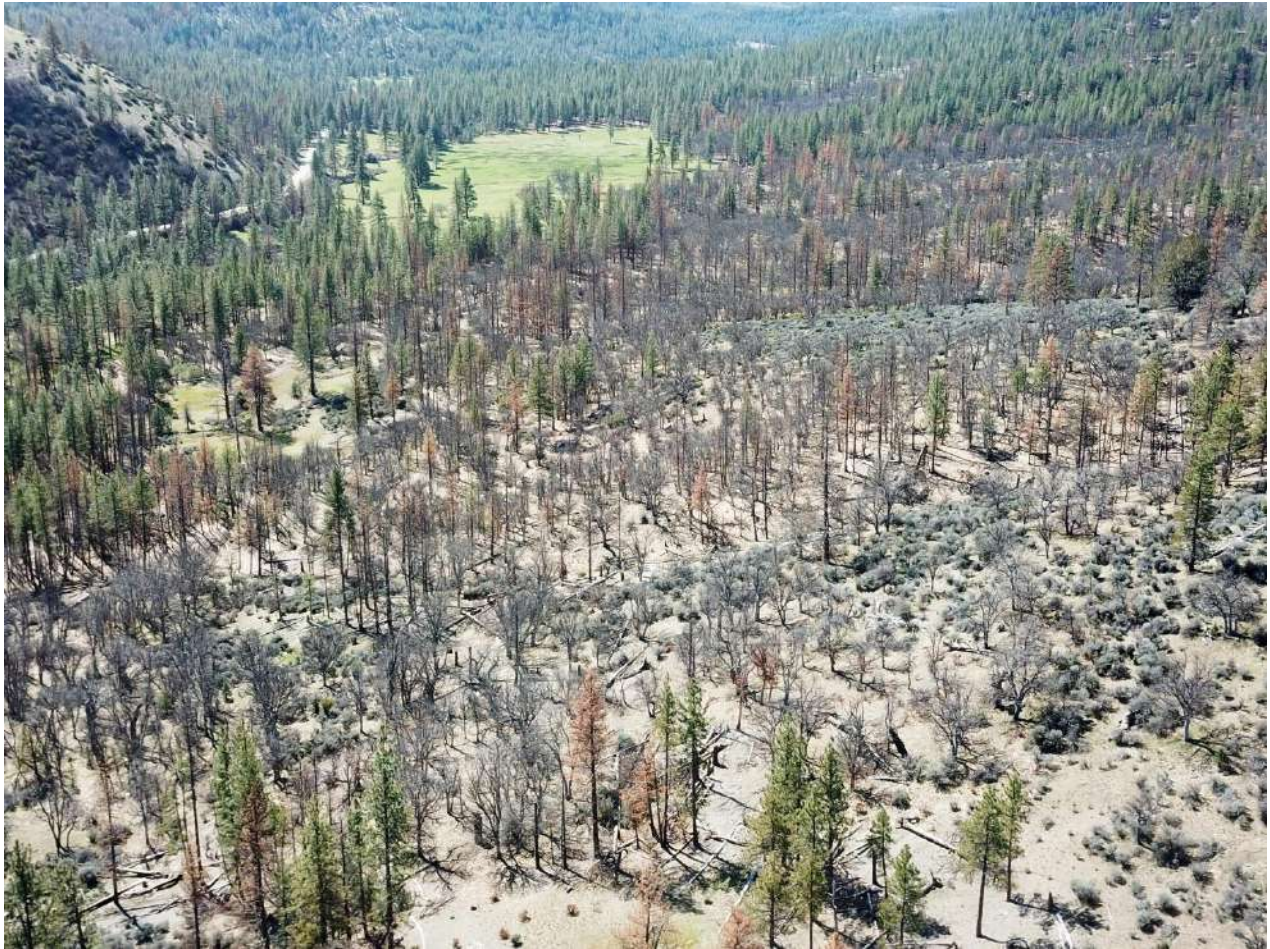
Figure 7.4: Aerial view of dying pines in Noyes Valley. March 25, 2024.

Immediate implementation of proposed drought mortality treatments is crucial to mitigate hazardous fuel accumulation and to capitalize on the economic feasibility of tree removal.

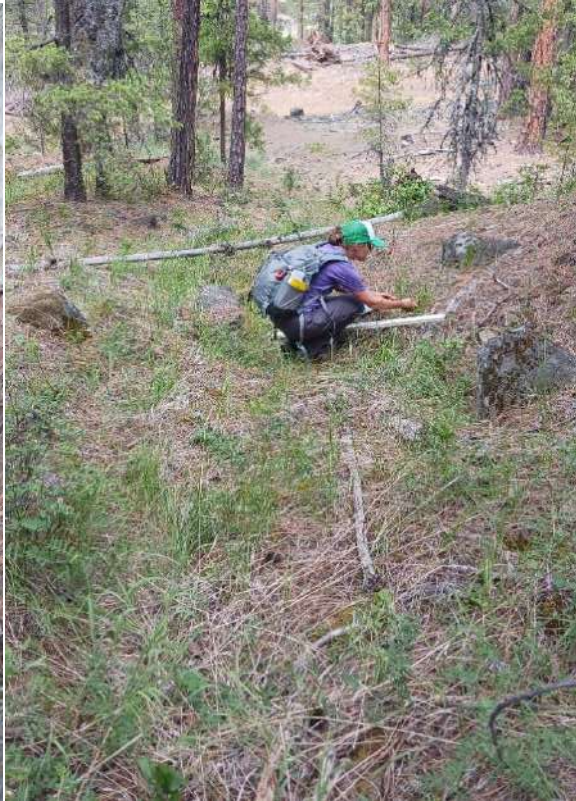
Photo 2.60: Duff and vegetation in gully. EFG6e. May 29, 2023.
