Evaluating the Effectiveness of Artificially-Introduced Instream Woody Debris for Restoring Coho Salmon (*Oncorhynchus kisutch*) Habitat in Patterson Creek

Emily Stavneak
Southern Oregon University
Environmental Science & Policy Program
In Partnership with the Scott River Watershed Council

March 2020

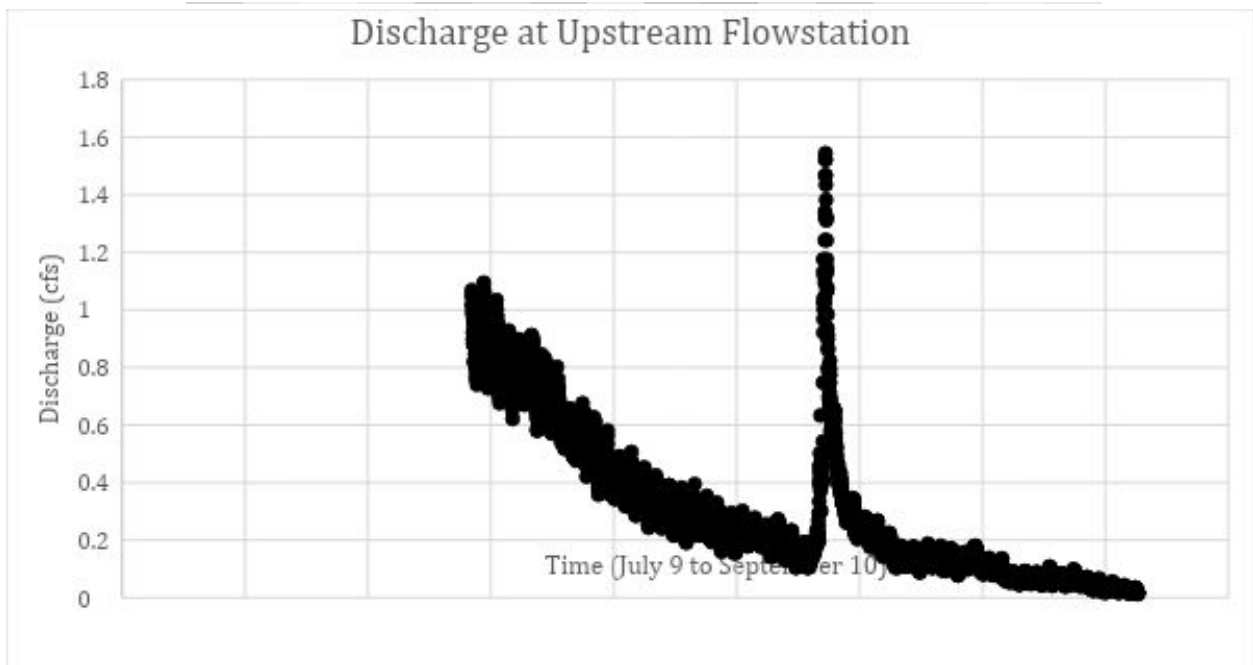
Figure 3: Stream discharge recorded at the upstream flow monitoring station on Patterson Creek from July 9 to September 10, 2019.

Temperature data was evaluated, and daily average temperatures were determined for each of the four temperature recording locations. Graphing this data confirmed that temperatures within Patterson Creek are typically within the desirable range for coho salmon viability (Figure 2). This is likely due to the adequate vegetative coverage throughout much of this study reach. However, this is contingent upon water levels maintaining an appropriate depth to buffer the effects of insolation on water temperatures. Discharge consistency in Patterson Creek is one of this tributary's limiting factors in supporting coho salmon populations. It becomes disconnected from the mainstem Scott River during summer months and may not reconnect until late winter. Stream discharge at the upstream end of the study reach was recorded and graphed (Figure 3). Discharge drops dramatically between July and September from an already low level of 1 cfs to 0.1 cfs. Notably, this low discharge may have been a result of the placement of the monitoring station. Further data collection is recommended to assess discharge in Patterson Creek.

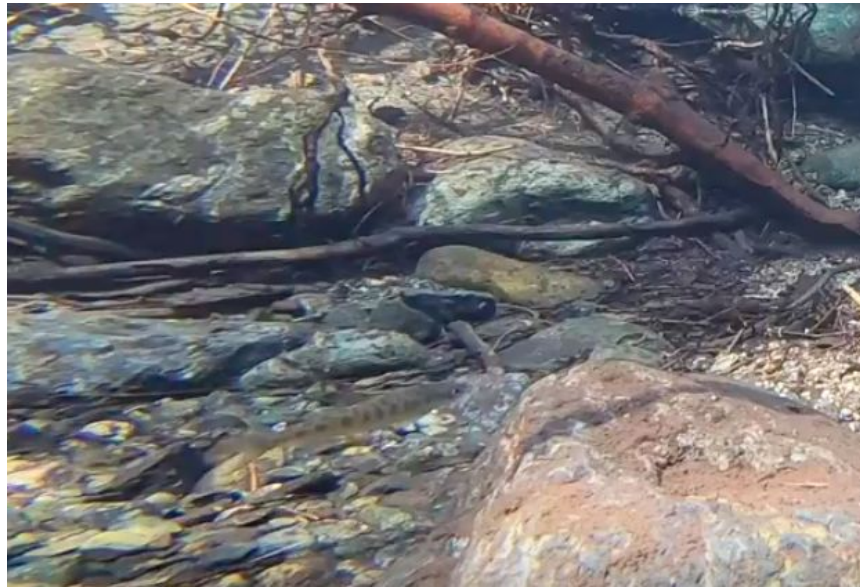
Figure 5: Juvenile coho salmon observed in log jam 1 complex.

While the majority of fish observed in snorkel dives and video footage were determined to be steelhead trout, one video confirmed positive identification of juvenile coho salmon in a pool habitat associated with the log jam #1 complex (Figure 5). Identification was based on the width of spaces between parr marks being wider than marks themselves, a strongly forked tail, and a lack of spots on dorsal fin and tail (Quigley 2004). Confirmation was approved by Erich Yokel, a member of the SRWC who mentored this research. Observing juvenile coho utilizing log jam associated habitats was an additional assurance that these structures are preferential rearing habitats in actuality rather than only in theory.

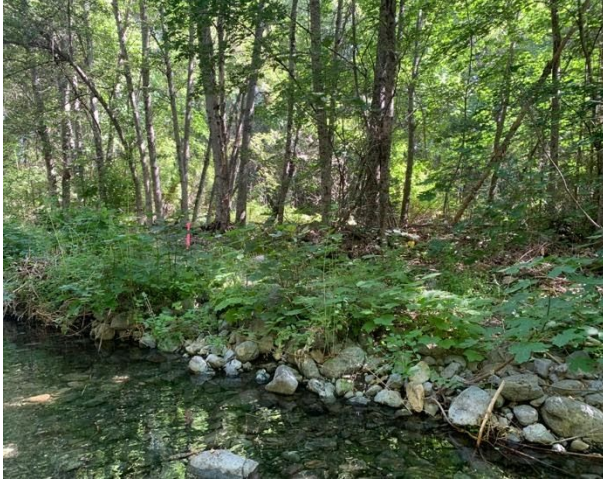
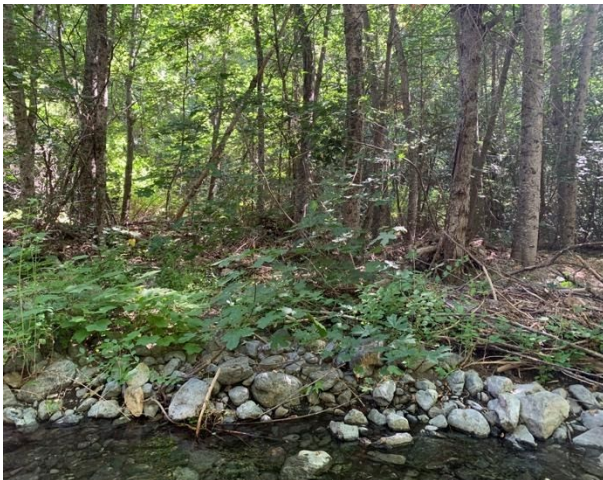
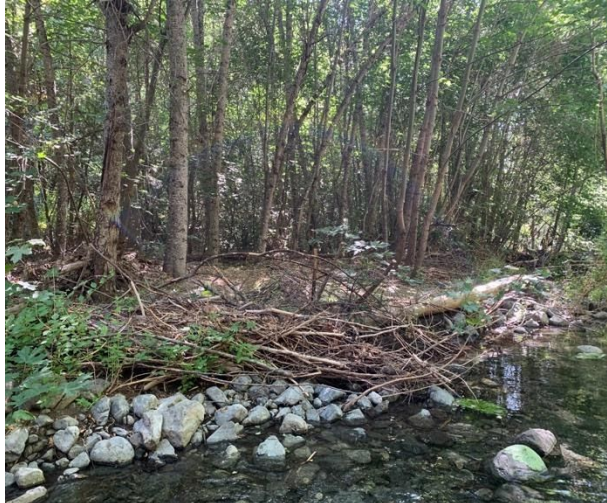
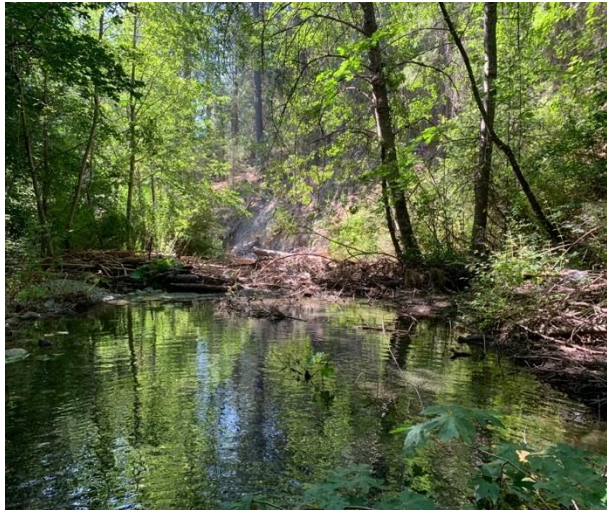
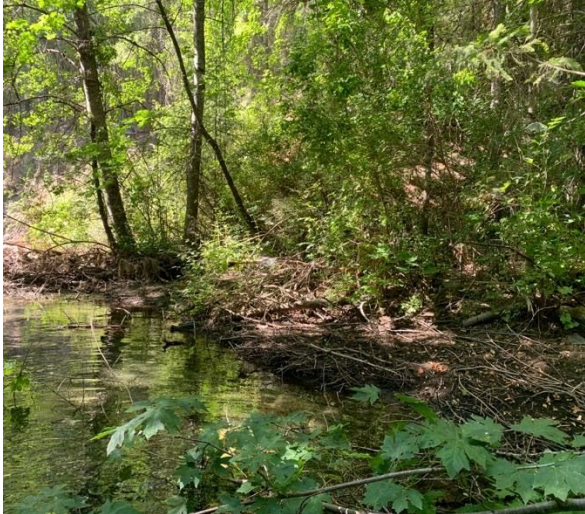
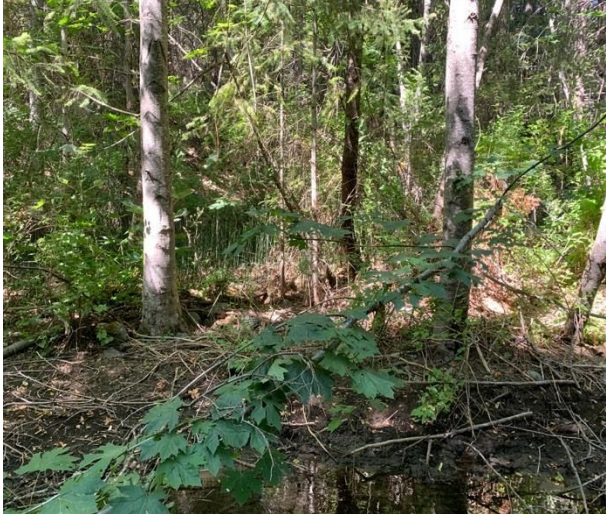
Appendix E

Photo point series near log jam 1, ordered as follows from left to right and down the page: north, northeast, east, southeast, south, southwest, west, northwest.

In order to supplement quantitative data collection with visual examples of Patterson Creek’s habitat conditions, a photo point procedure was developed. The replication of these photo points is ensured through thorough numerical delineation, GPS coordinate collection, and written description of each photo point location. Photo points were taken systematically in the middle of the main channel streambed at nose height facing north, northeast, east, southeast, south, southwest, west, and northwest. A total of twenty formal photo points were created throughout the entirety of the surveyed area. Additionally, previous photos of log jams taken shortly after the implementation of phase one were replicated to document changes in log jam structure or stream morphology. For examples of photo points, see Appendix E.

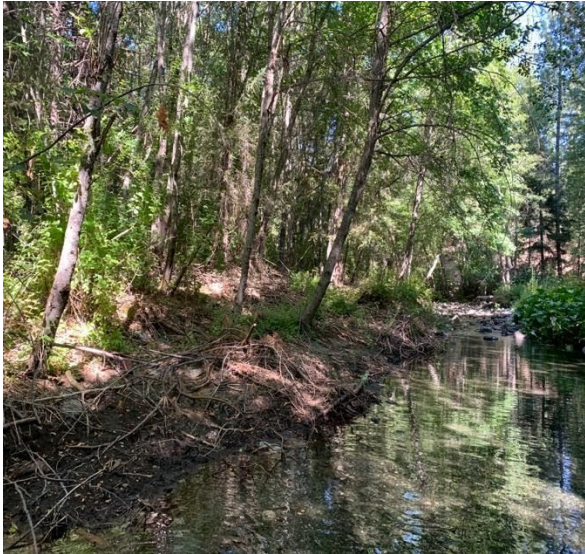
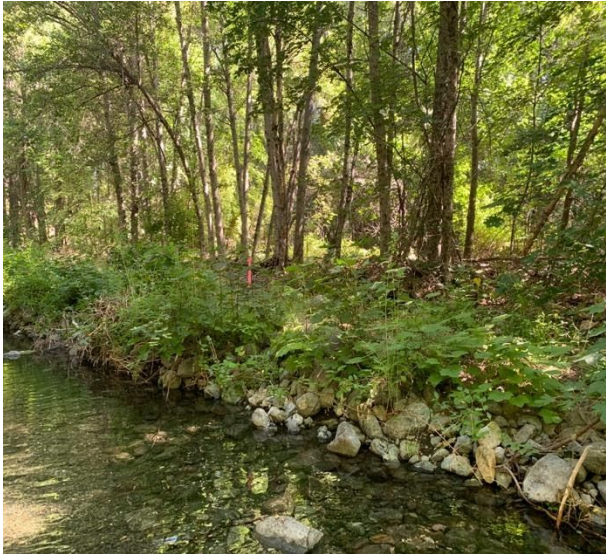
Appendix F

Rating curve for Patterson Creek based on collected discharge and temperature data from July 9 to September 10, 2019.

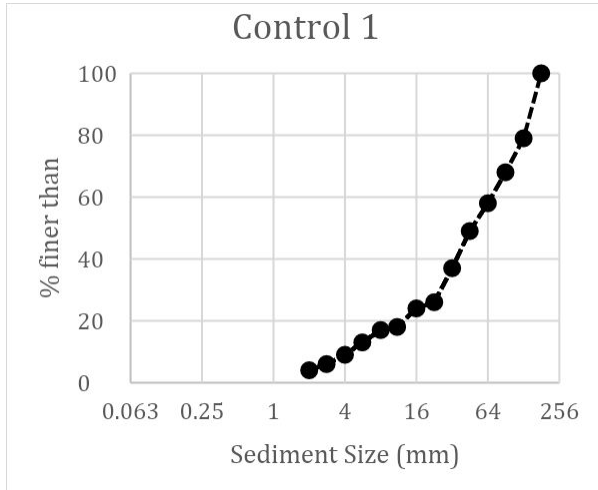
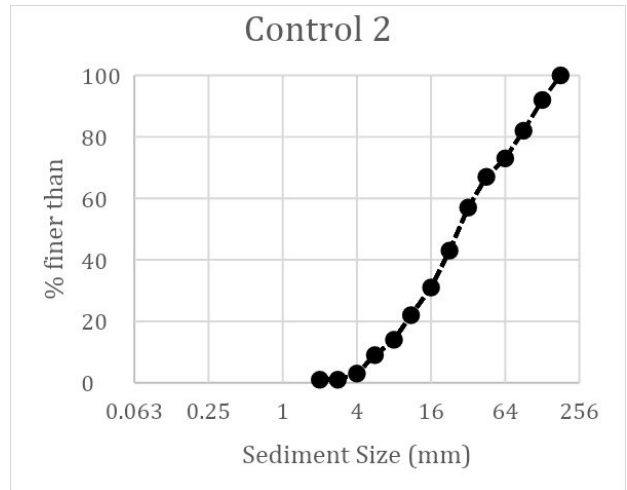
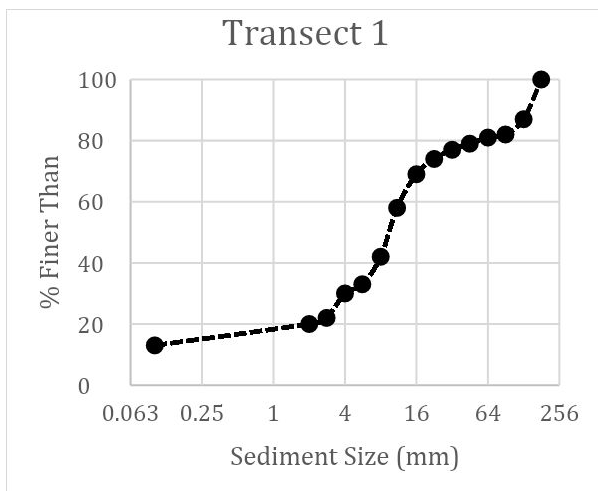
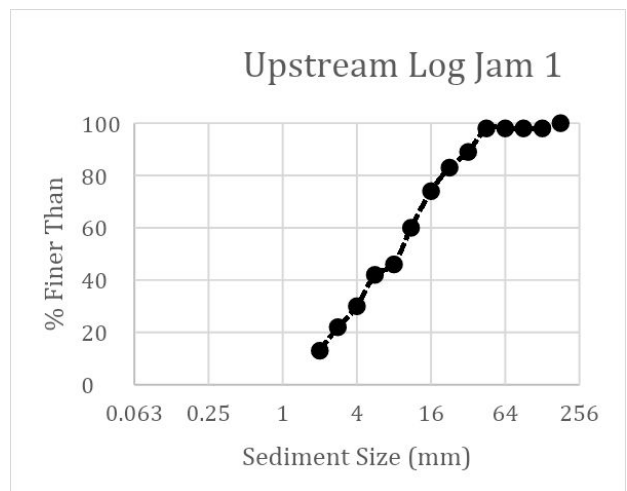
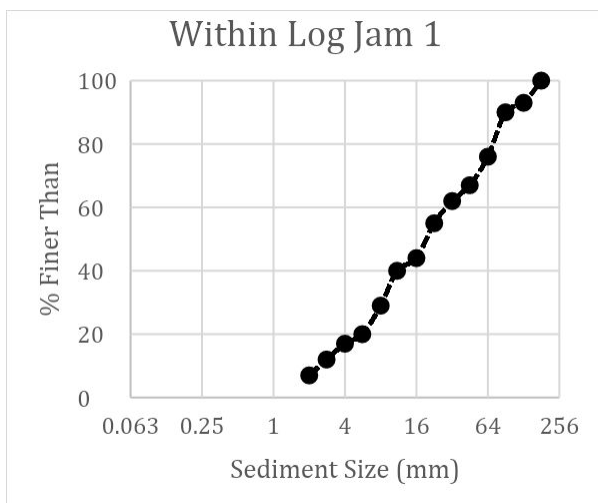
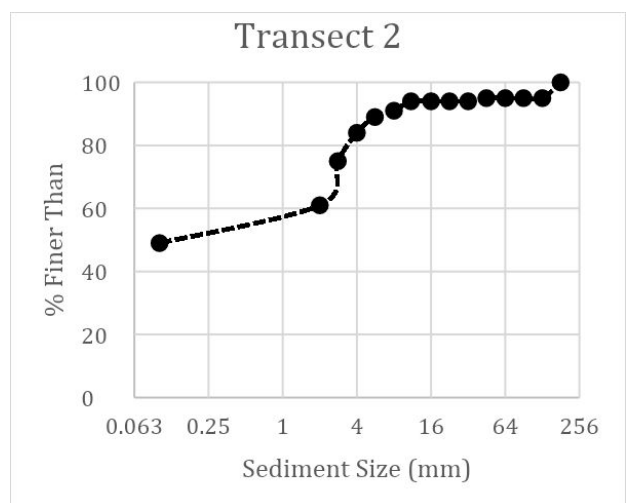
Appendix G

Cumulative frequency curves for each of the 15 Wolman Pebble Counts conducted throughout Patterson Creek, organized from upstream to downstream.

In assessing streambed substrate composition data, cumulative frequency curves were created for each data collection site (Appendix G). Additionally, calculations were made to
