Beaver Dam Analogues on Moffett Creek, Siskiyou County, California

Southern Oregon University
Environmental Science and Policy Program

June 5th, 2020

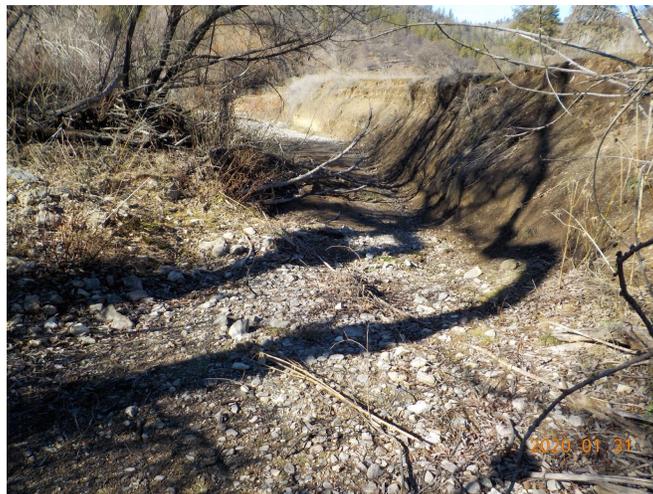
Figure 1. An example of channel incision on Moffett Creek, evident throughout much of the study area.

Due to elevated sediment levels and elevated water temperature, the Scott River water quality is listed as “impaired” under Section 303(d) of the Clean Water Act from the U.S. Environmental Protection Agency (National Marine Fisheries Service, 2014). In response, the North Coast Regional Water Quality Control Board (NCRWQCB) implemented the Scott River Watershed Sediment and Temperature Total Maximum Daily Loads (TMDL). The plan seeks to achieve the TMDLs, thereby improving water quality for the migration, spawning, and reproduction of salmonids (NCRWQCB, 2005). Although multiple tributaries contribute to elevated sediment levels, the Moffett Creek sub-watershed has been identified as one of the main sediment contributors to the Scott River (SHN Consulting Engineers & Geologists, 2003). The Moffett Creek Watershed accounts for 28% of the Scott River watershed and drains 227.9 square miles. Many sections of Moffett Creek consist of heavily incised streambanks that have resulted in disconnection from the adjacent floodplain, resulting in a decline in groundwater recharge and decrease in nutrient deposition, impacting the riparian vegetation (Figure 1).

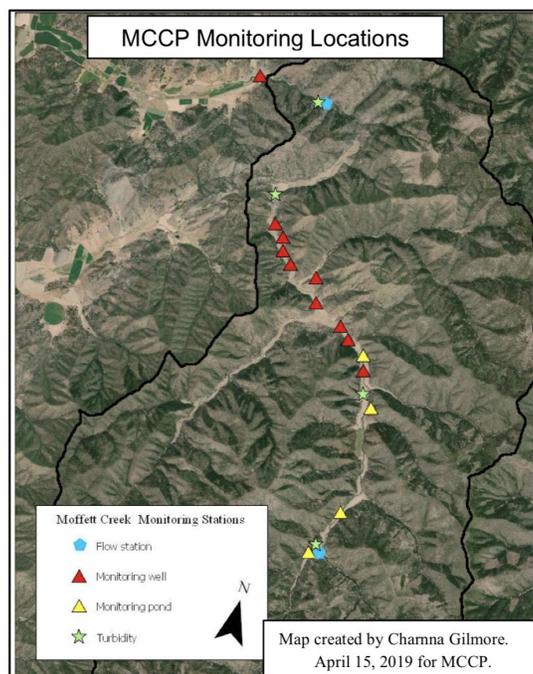
Figure 2. Monitoring locations for hydrologic data collection established by 2018/19 Moffett Creek Capstone Project.

Hydrologic data was collected utilizing the monitoring network established by the Southern Oregon University 2018/19 Moffett Creek Capstone project. Data was collected at two discharge stations, eight groundwater wells, and four surface ponds (Figure 2).

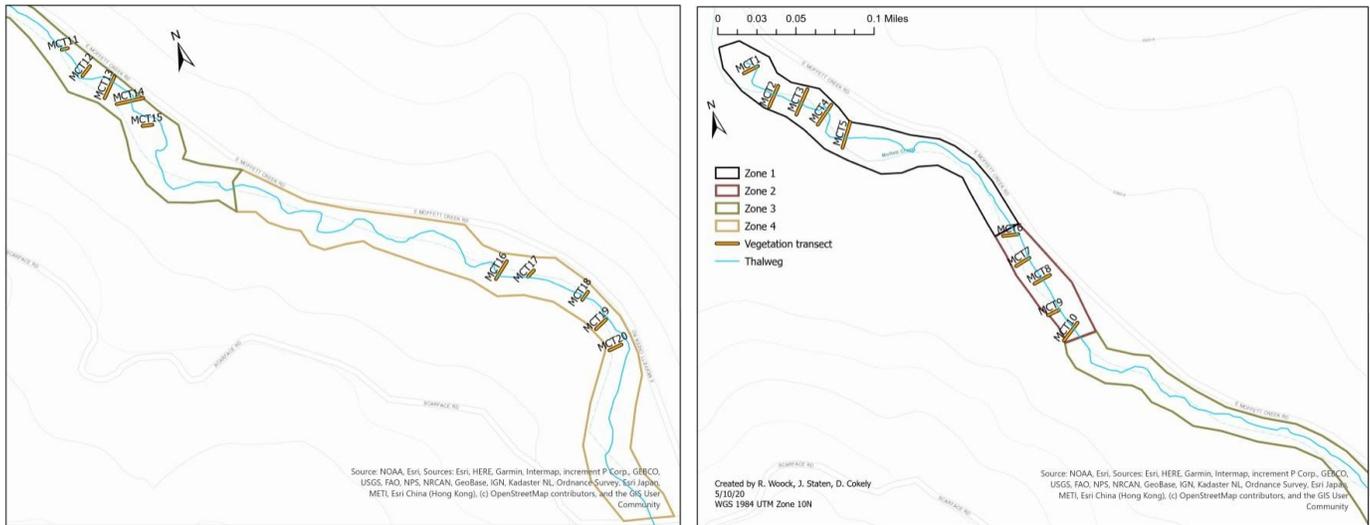
Figure 3: Vegetation sampling transect locations.

The study reach was divided into four zones based on similar riparian vegetation cover. Five belt transects per zone (20 total) were established (Figure 3). The five belt transects in each zone were placed approximately every 100 feet, moving upstream; the distance measured running parallel to the road located on river right. Each transect was 26 meters total; 13 meters from the center of the channel to river right and 13 meters from the center of the channel to river left. When necessary transect length was modified due to road proximity. The belt transect extended 3 feet upstream and 3 feet downstream, for a total width of 6 feet. A stem count of live, native woody vegetation rooted in the transect was collected and classified by size class (Appendix A).

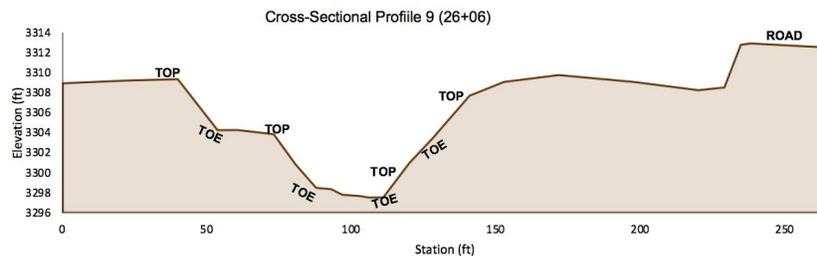
Figure 4. Example of cross sectional profile displaying terracing. Tops and toes used for stream channel morphology calculations are labelled.

To determine current stream conditions and assess historical conditions, 18 cross-sections were surveyed. In Microsoft Excel, each cross-section was graphed and analyzed to create a cross-sectional profile. For each cross-section, distance was calculated for: the historical (uppermost bank) top to top, toe to toe, river left top to toe, and river right top to toe. The same calculations were done for the first terrace, and, when present, the second terrace (Figure 4). Using the Excel engineering spreadsheet from the Wisconsin Natural Resources Conservation Service, the approximate area of each cross-sectional profile was calculated (NRCS Wisconsin Engineering, 2005).

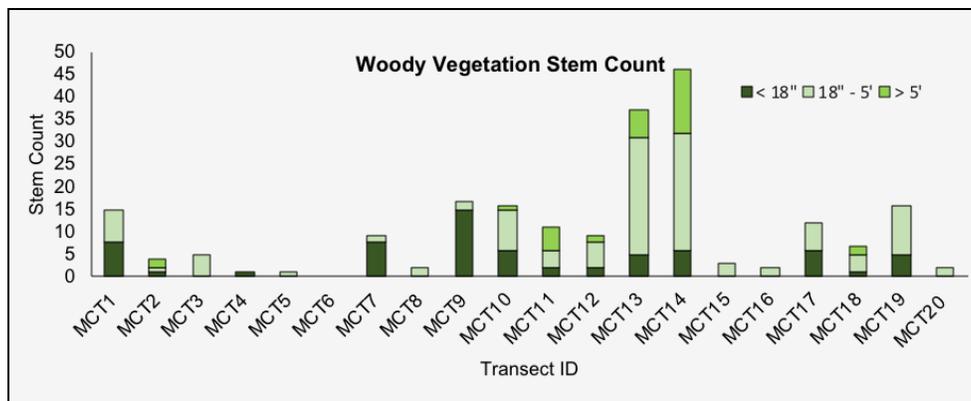
Figure 5. Stacked bar chart showing the proportion of woody vegetation by size class per transect.

The completion of the pre-restoration vegetation survey revealed an overall low density of riparian vegetation, and a low occurrence of mature vegetation (Figure 5). Willow (*Salix spp.*) appeared to be the dominant riparian woody species. Other observed woody species included cottonwood (*Populus fremontii*), alder (*Alnus rhombifolia*), willow (*Salix spp.*), arroyo willow (*Salix lasiolepis*), California box elder (*Acer negundo californicum*), buckbrush (*Ceanothus cuneatus*), and creek dogwood (*Cornus sericea*). The highest mean stem count was in size class II with a mean of approximately 6 stems, and size class III had the lowest mean, approximately 2 stems (Appendix B). The overall low stem count is expected given the condition of the riparian zone; the high stream velocity decreases groundwater recharge, resulting in a greater distance between the water table and the riparian root zone.

The relative density for size class I was about 31%, for size class II about 55%, and for size class III about 14%. The higher density in size class II was most likely because of the absence of cattle for much of the year. Typically, cattle in this area have access to the riparian area resulting in excessive browsing of young, vulnerable vegetation. However, absence of cattle allowed size class I vegetation to mature into size class II vegetation.

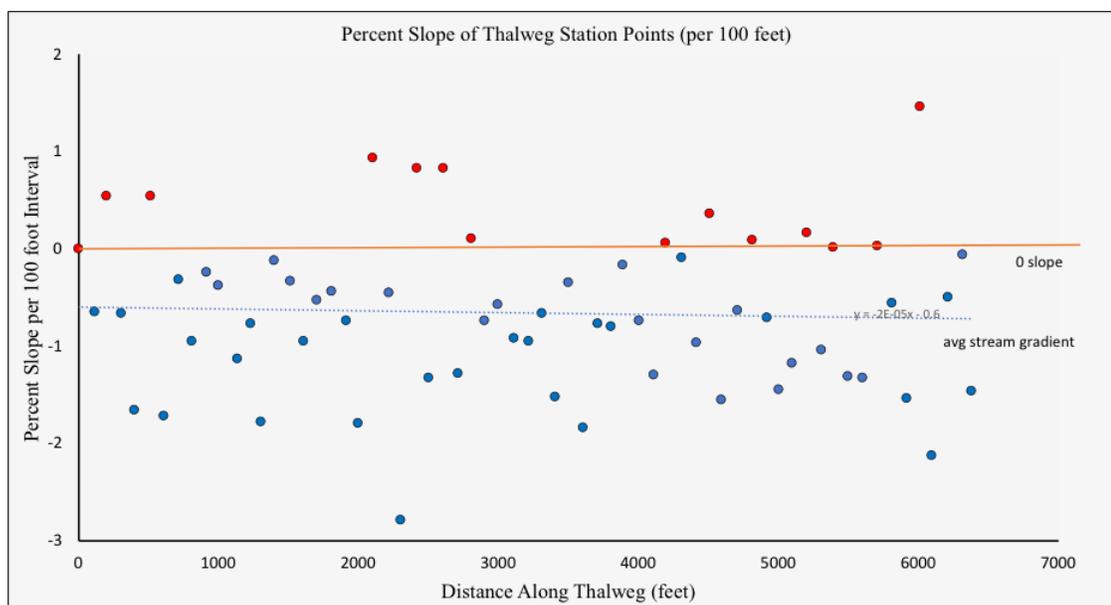
Figure 6. Scatter-plot representing 100-foot interval slope percentages. Red markers indicate a positive slope percentage while blue indicates a negative slope percentage.

The thalweg survey points were extracted from the survey data, and the distance between the points was calculated in Microsoft Excel. A longitudinal profile of the reach was then generated, showing elevation changes from the initial survey point to the lower reach of the study area. From the longitudinal profile, slope percentages were calculated at 100 foot intervals, allowing for areas of reverse grade to be determined. In total, 13 intervals exhibited positive slopes and were considered suitable for BDA placement. BDAs promote channel aggradation upstream of the structure. Construction of dams at the downstream end of the positive slope intervals supports continued aggradation. Intervals with a slope less than 2% also represent potential BDA placement (Figure 6).

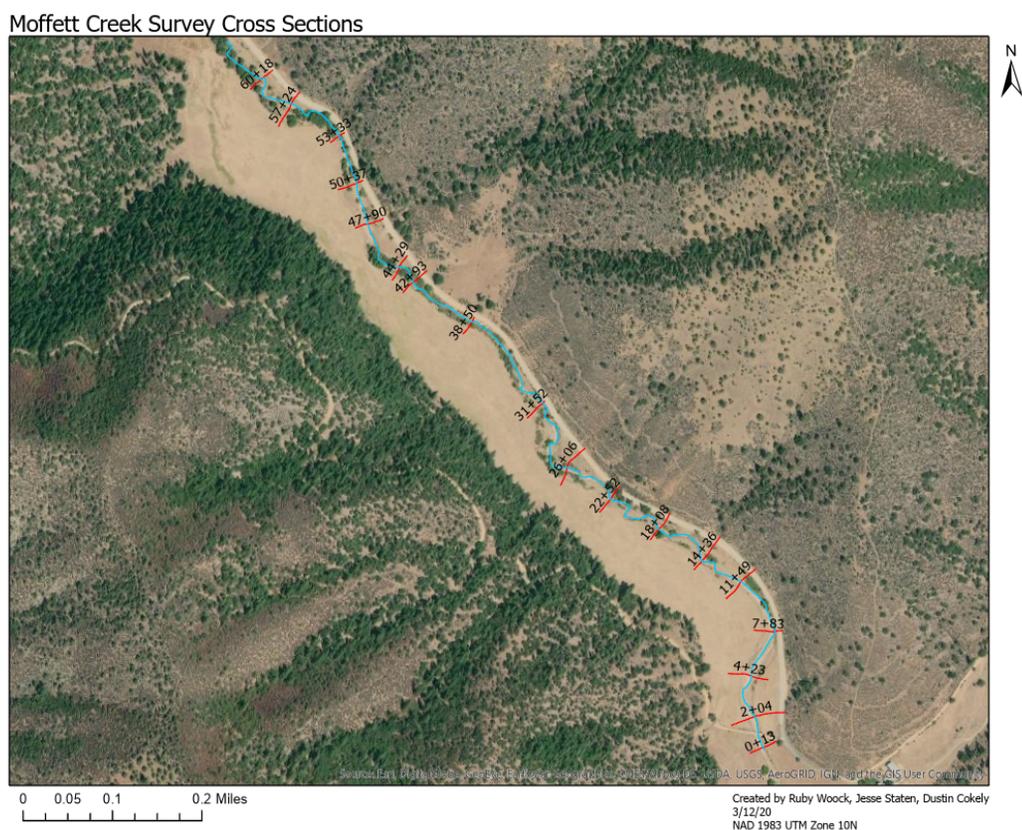
Figure 7. Topographical survey showing 18 representative cross-sections and assigned stations

The cross-section locations were mapped and assigned stationing. Stationing is used to indicate the horizontal distance along a survey line. The station number indicates the distance (feet) downstream from the initial survey point (0+00) along the thalweg (Figure 7).

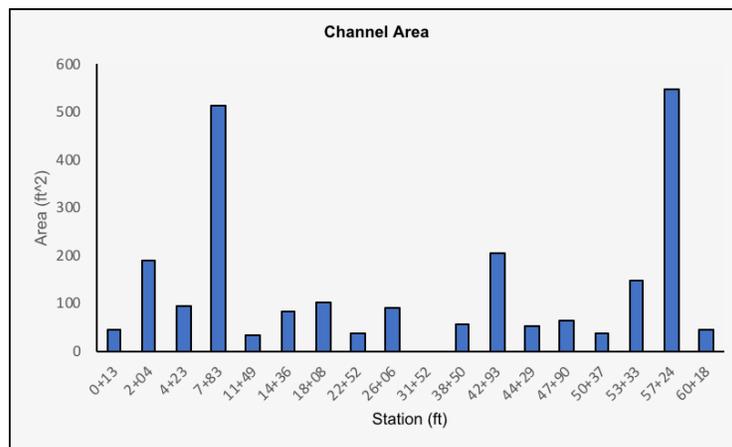
Figure 8. Comparison of cross-section areas calculated from the lowest top to top elevation. Station number indicates the location of the surveyed cross-section, distance (feet) downstream from the initial survey point along the thalweg.

Further analysis of the cross-sectional profiles revealed a high level of degradation in the reach, consistent with in-field observations. Distance calculations for each cross-section helped assess the stream channel morphology (Appendix C). Cross-sections 0+13, 11+49, 26+06, 38+50, 5+37, and 60+18 displayed multiple terracing, suggesting these sections of the stream are entrenched and disconnected from the historical floodplain. Cross-sections 22+52, 31+52, 38+50, 53+33, and 57+24 had a narrow channel width as demonstrated by a toe to toe distance under 15 feet. Additionally, the area of the lowest incised channel was calculated. By comparing the cross-sectional areas, the sections of highest channel confinement were determined. The middle of the study reach was found to be the most confined section (Figure 8).

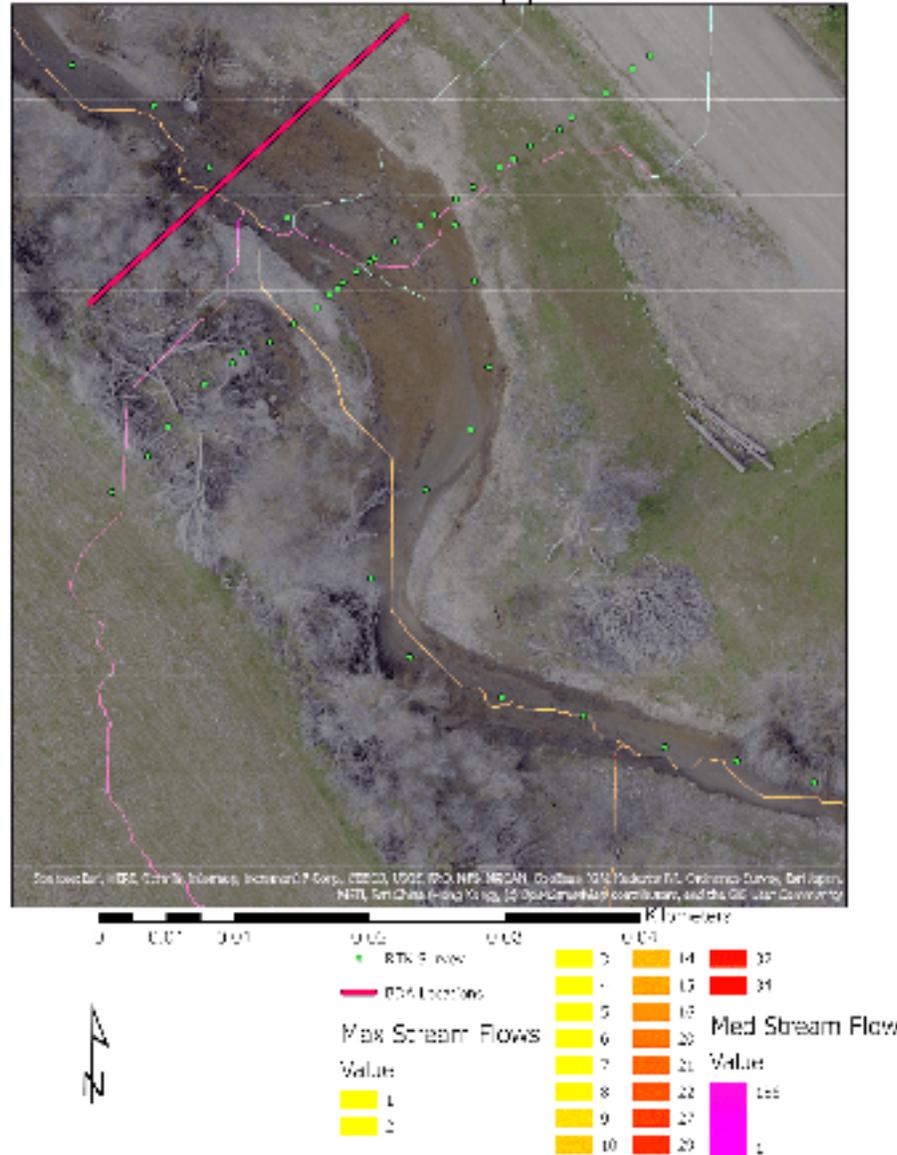
Flow Accumulation and Approximate Flows

Figure 9. Example of medium and high flows to the creek area and proposed BDA implementation location.

Using LIDAR data collected by the SRWC, an approximate flow accumulation map was created. The flow accumulation shows which areas accumulate the most water flows but also the most sediment from water transport, which can be used to verify areas in the field that are best suited for BDA implementation. A total of 40 BDAs can be placed at every creek accumulation point; according to the SRWC 20-30 BDAs would be ideal for the future implementation project. The 40 BDAs can be comfortably scaled down to meet the SRWC's goal if the proposed BDA locations are focused on medium and high accumulation areas (Figure 9). When aligned with longitudinal data taken from the RTK Trimble GPS unit, many of the cross-sections align with accumulation points within the creek (Appendix D). The alignment of the data will help facilitate review of proposed BDA locations when in the field. Key factors to assess in the field will be

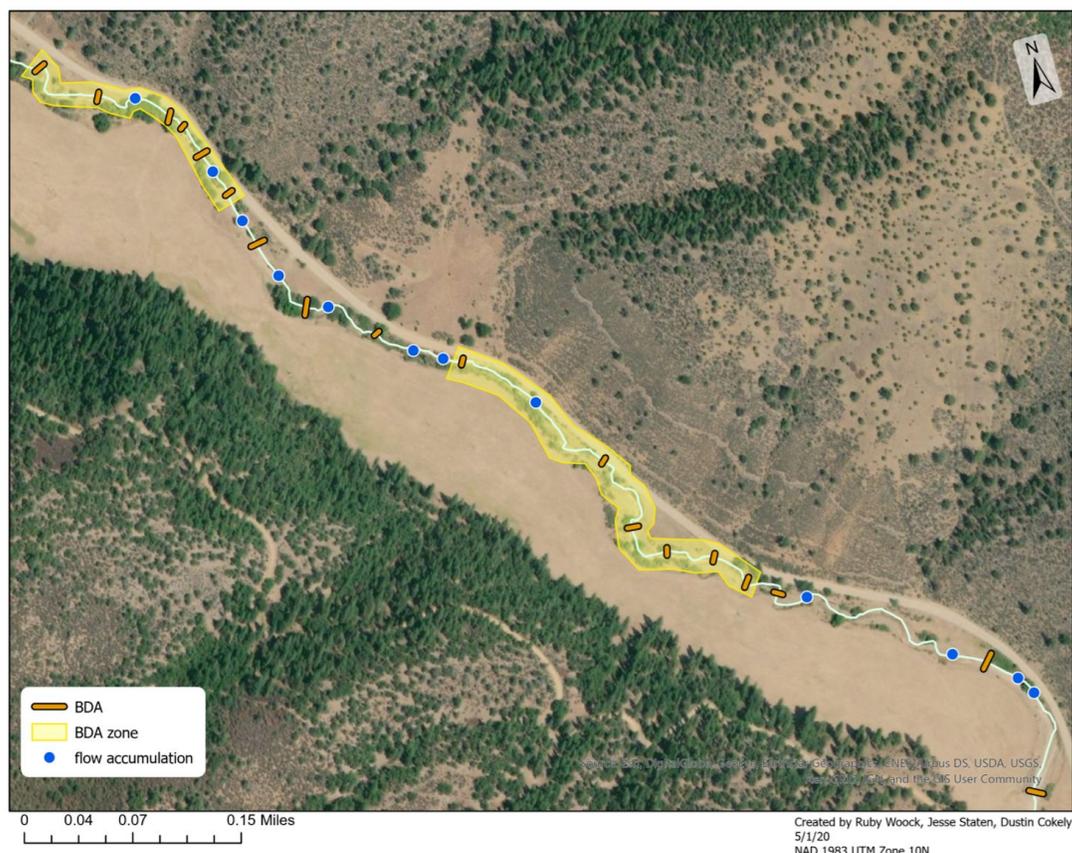
Proposed BDA Placement on Moffett Creek, Siskiyou County, CA

Figure 10. Proposed BDA locations for study reach. Yellow zones indicate ideal areas for BDAs, and dark blue represents high flow accumulation areas.

The longitudinal profile, cross-sectional profile calculations, and flow accumulation map guided the proposed BDA placements. We have identified potential BDA locations considering areas of positive slope where aggradation is already occurring, narrow channels where flow velocity can be slowed, and multiple terracing where the stream can be raised to a mid-level terrace. Areas of high flow accumulation are indicated in the map below, and also represent potential dam locations (Figure 10). The zones highlighted in yellow are particularly suitable for BDA placement. These areas displayed all the factors considered: positive slope, narrow

channels, terracing, and zones of high flow accumulation. After the initial BDA placement, additional BDAs would need to be placed upstream to provide redundancy. Constructing dams in a series reduces the risk of flooding downstream should a structure fail. Prior to construction, the SRWC will also need to consider road proximity and landowner approval.

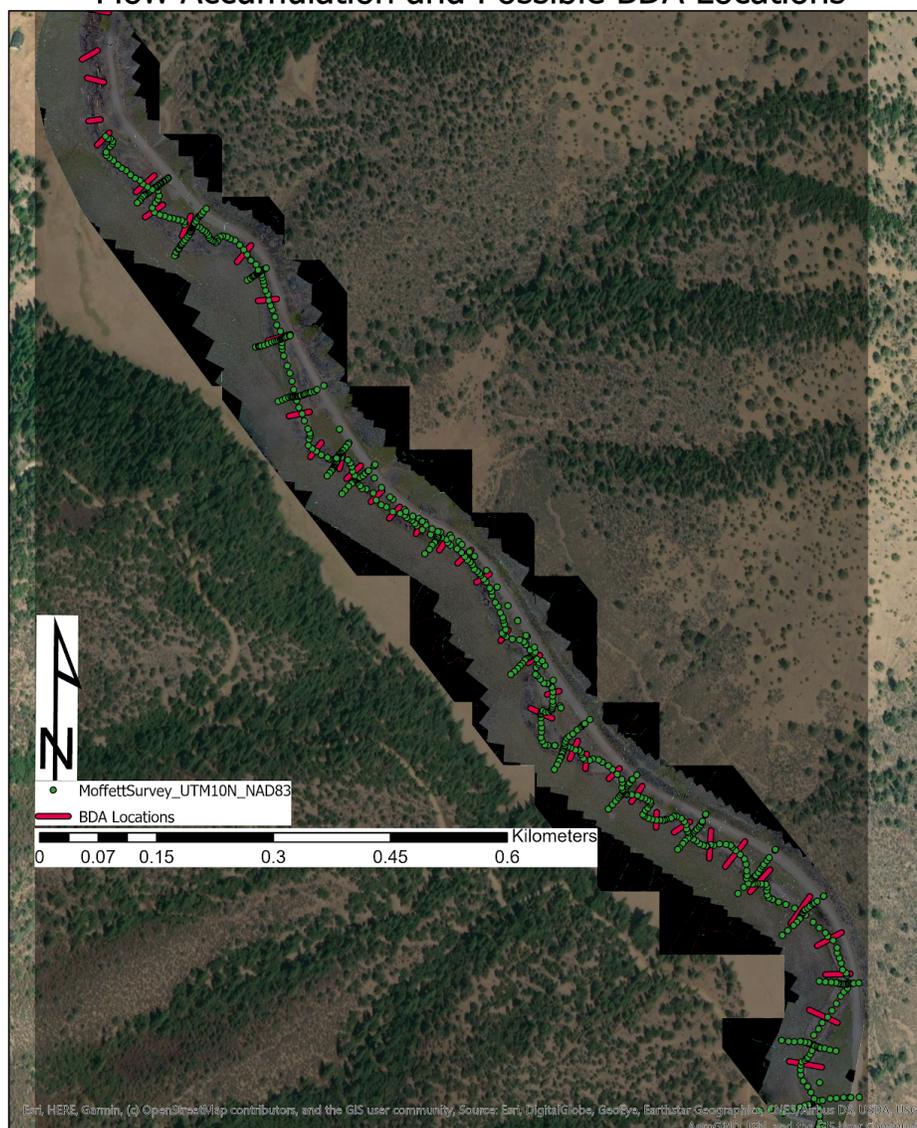
Flow Accumulation and Possible BDA Locations

Appendix D: BDA locations at high flow accumulation areas of the creek overlaid with longitudinal survey GPS data.
