French Creek Instream & Off Channel Enhancement Project

California Department of Fish & Wildlife
Fisheries Restoration Grant Program

Scott River Watershed Council
514 North Hwy. 3
Etna, CA 96027

February 28, 2021

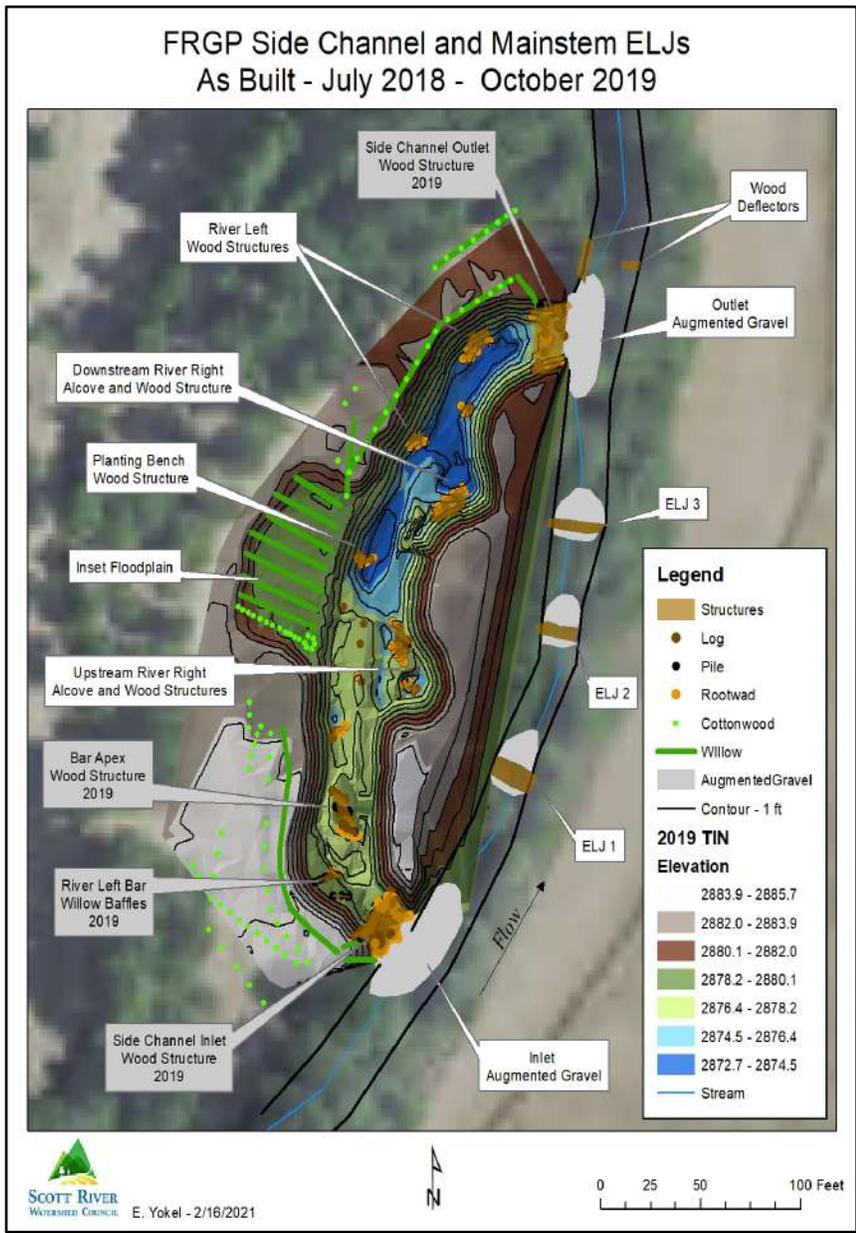
MAP 3. AS BUILT MAP OF FEATURES, STRUCTURES AND PLANTING INSTALLED FROM JULY 2018 TO OCTOBER 2019.

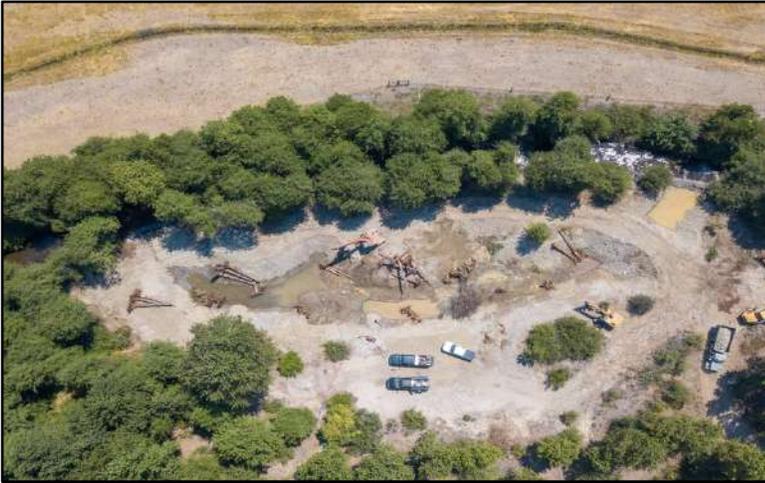
PHOTO 2. CONSTRUCTION OF SIDE CHANNEL – JULY 19, 2018.

On July 19, 2018, Project implementation began with the construction of a 310' distributary side channel (Photo 2). The "Side Channel" included several elements such as large wood (bank log structures), alcoves and a large inset floodplain, all intended to provide complexity under different flow regimes. Log structures were also installed at the margins of the inlet and outlet of the Side Channel to provide roughness, slowing the water to discourage the channel from capturing too much of the stream flow (Appendix C).

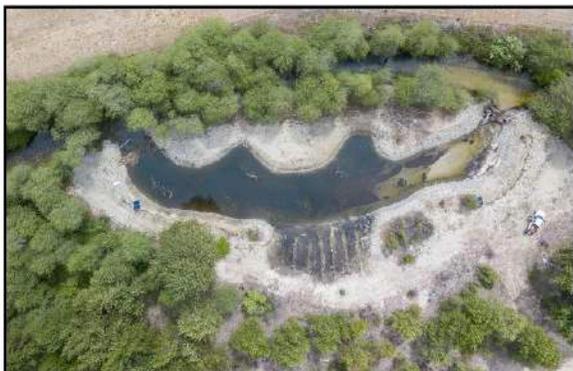
May 17, 2019 - Observed sediment deposition in the Side Channel.

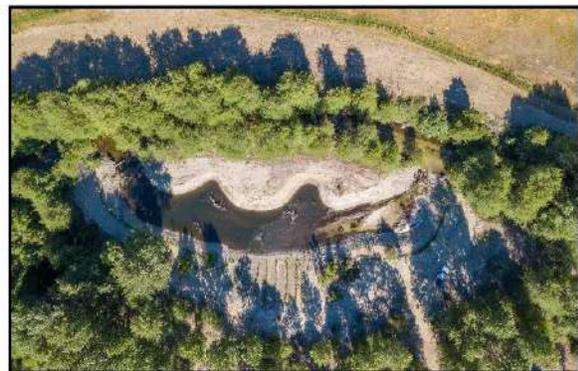
June 19, 2019 - The deposit appears stable as stream flows return to baseflow.

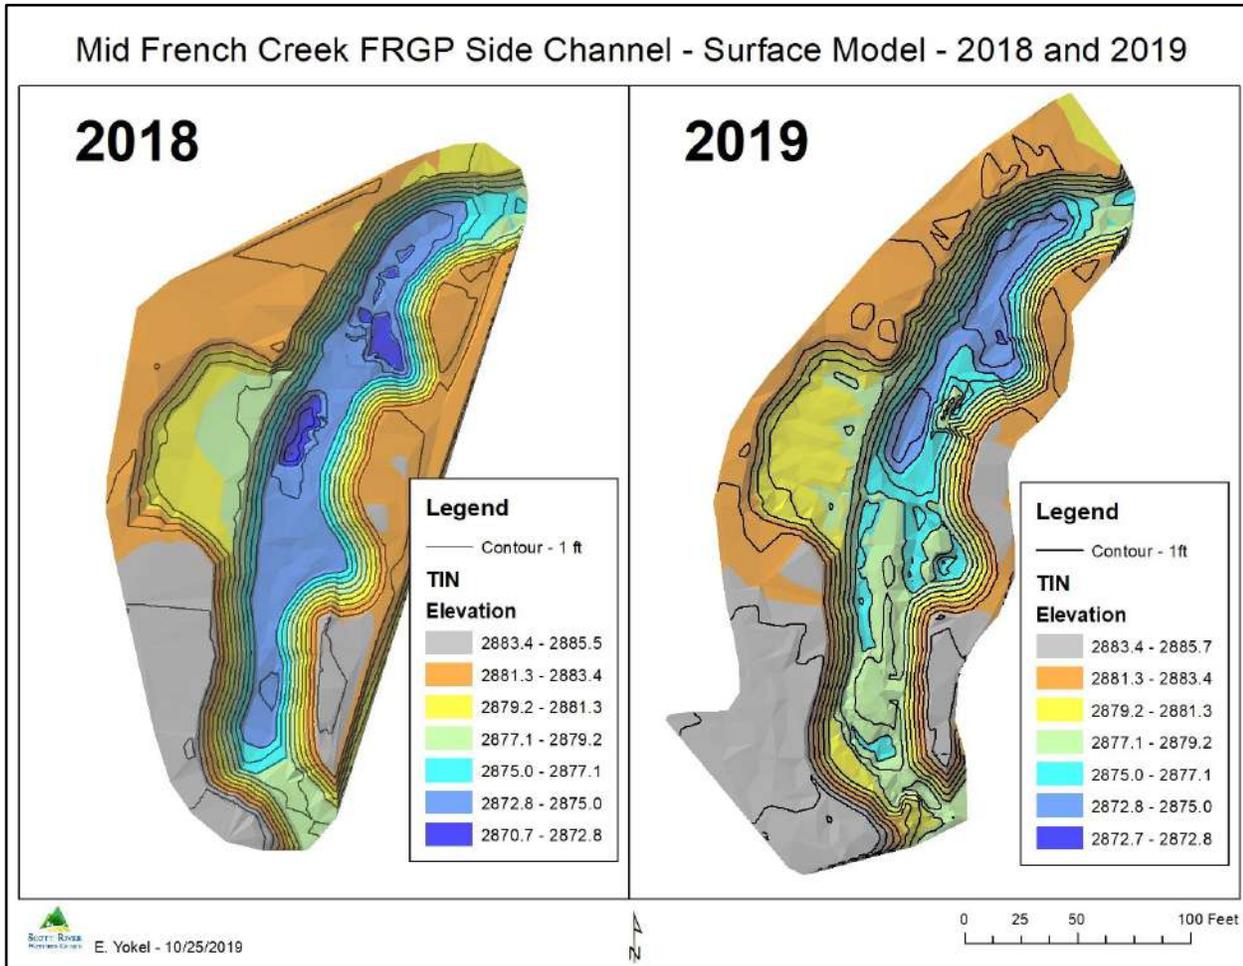
MAP 4. 2018 AS BUILT AND 2019 SURFACE MODELS OF SIDE CHANNEL.

Comparison of the surface model generated from the as-built topographic survey performed in 2018 to a surface model and a survey performed in 2019 documented the location and depth of the stored sediment (Map 4).

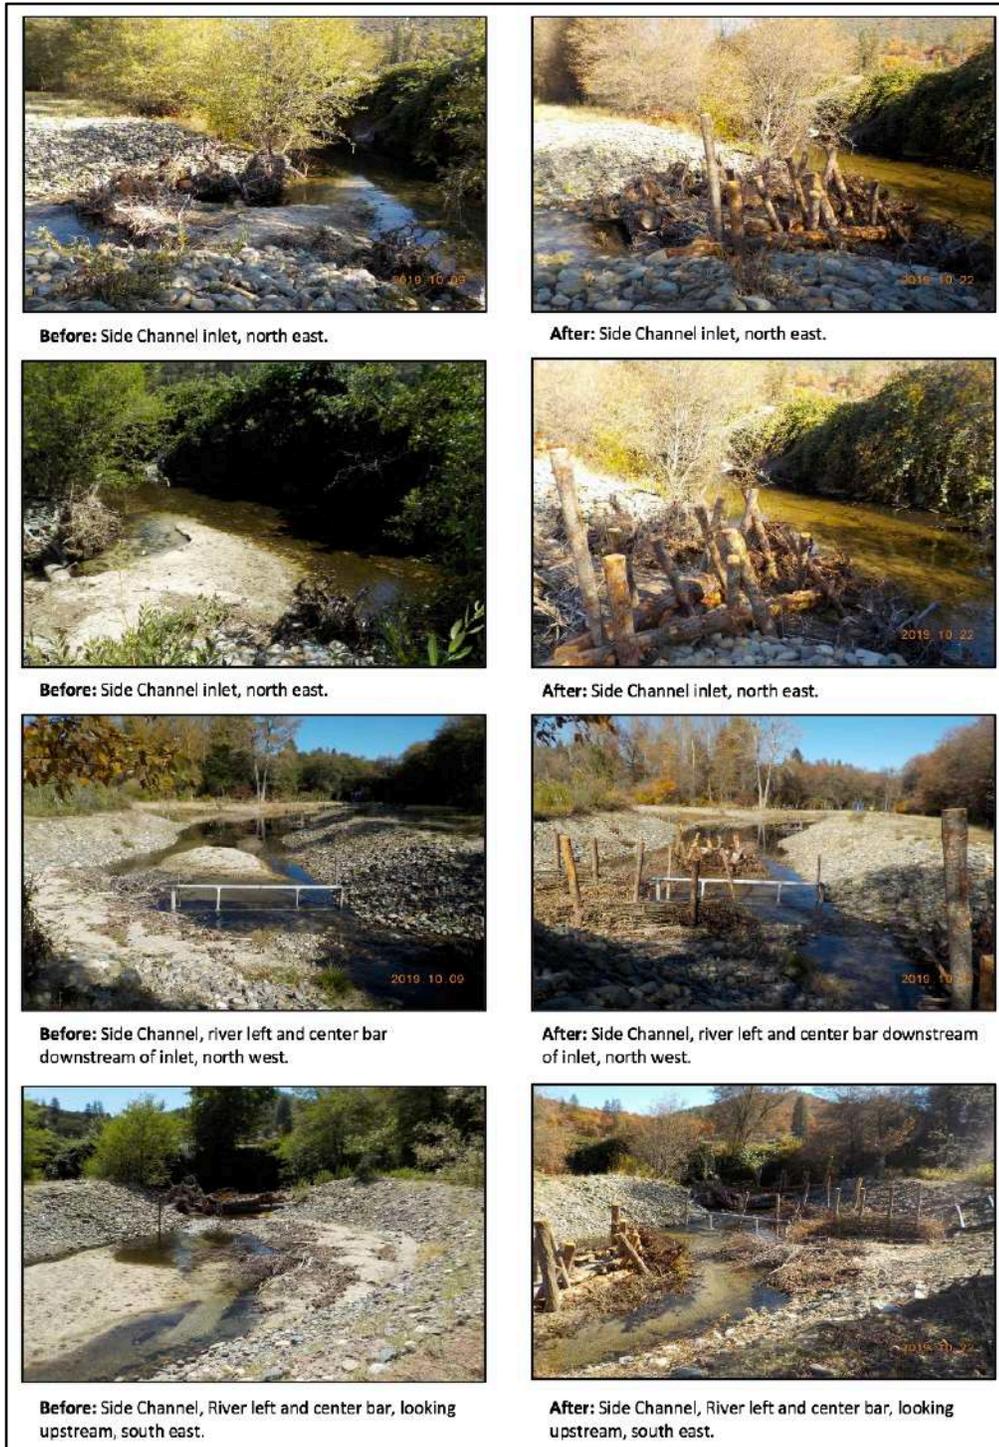
PHOTO 6. SERIES OF BEFORE AND AFTER PHOTOS OF SIDE CHANNEL INLET AND DEPOSITION OF SEDIMENT.

To help stabilize the deposited bar, willow cuttings were planted on the inlet, center and river left bars. The excavator bucket was utilized to “pull back” sediment to expose water and willows were placed in the cavity and the sediment was subsequently replaced. Planted willow cuttings were cut with approximately 10-12 inches above ground. Cuttings were placed by hand in the bars.

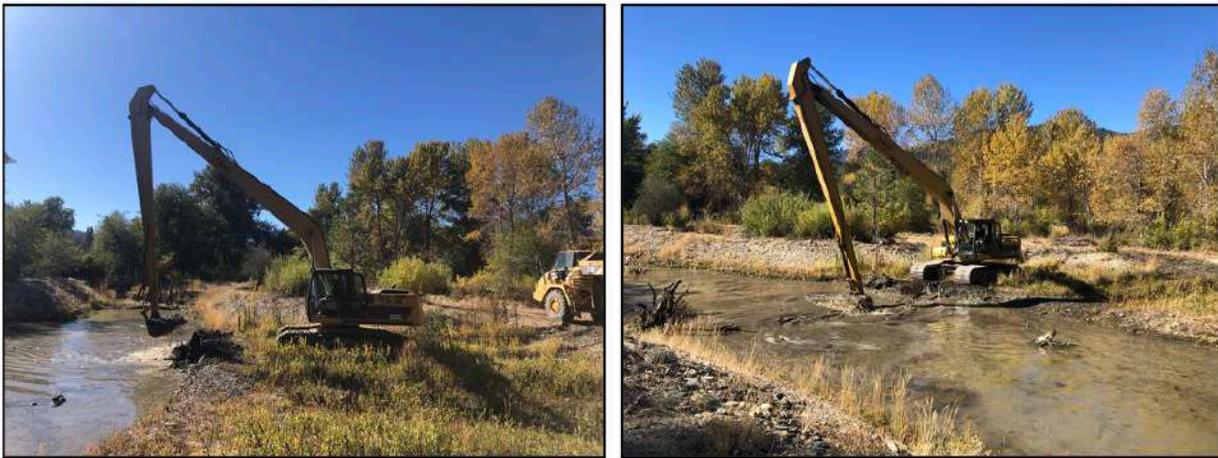
PHOTO 7. REMOVAL OF SEDIMENT IN THE SIDE CHANNEL, OCTOBER 15, 2020.

October 2020: To directly address the deposition of the sediment noted in 2019, approximately 225 cubic yards of excavated material was removed from the Side Channel and relocated to another location on landowner's property (Photo 7). The goal was to improve water quality, in particular summer water temperature by increasing the depth of water and allowing for increased stratification of the water column. At the end of the grant period (February 2021) there has been very little sediment deposition observed within the Side Channel.

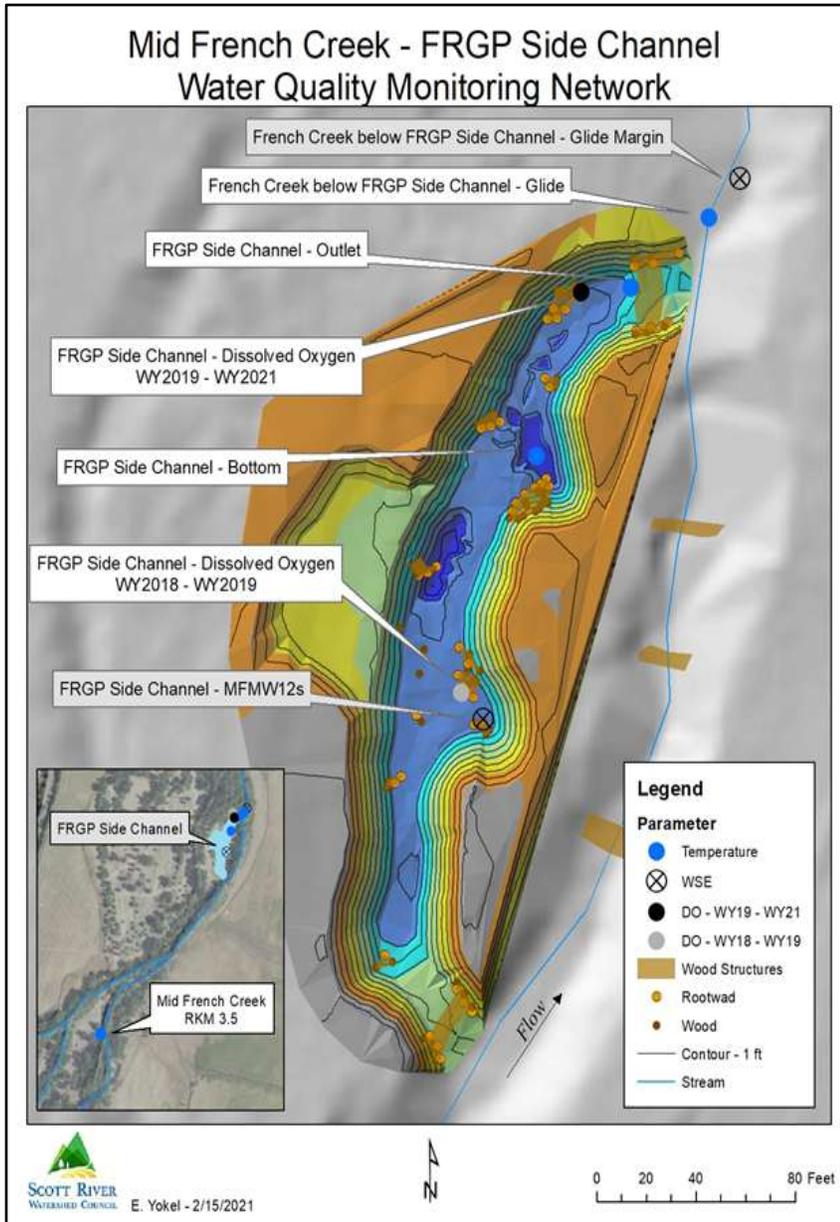
MAP 5. WATER QUALITY MONITORING NETWORK ESTABLISHED IN 2018 AT FRGP SIDE CHANNEL.

A network of water quality monitoring stations was installed in French Creek and the constructed Side Channel to document the water quality conditions before, during and after project implementation. Water temperature (Onset Computer Corporation Tidbit v2), water surface elevation (WSE) (Onset Hobo U20L pressure transducer) and dissolved oxygen (DO) (Onset Hobo U26 DO and temperature logger) loggers were installed in the mainstem French Creek and/or the Side Channel (Map 5). Loggers documented continuous (every 15 minute) data.

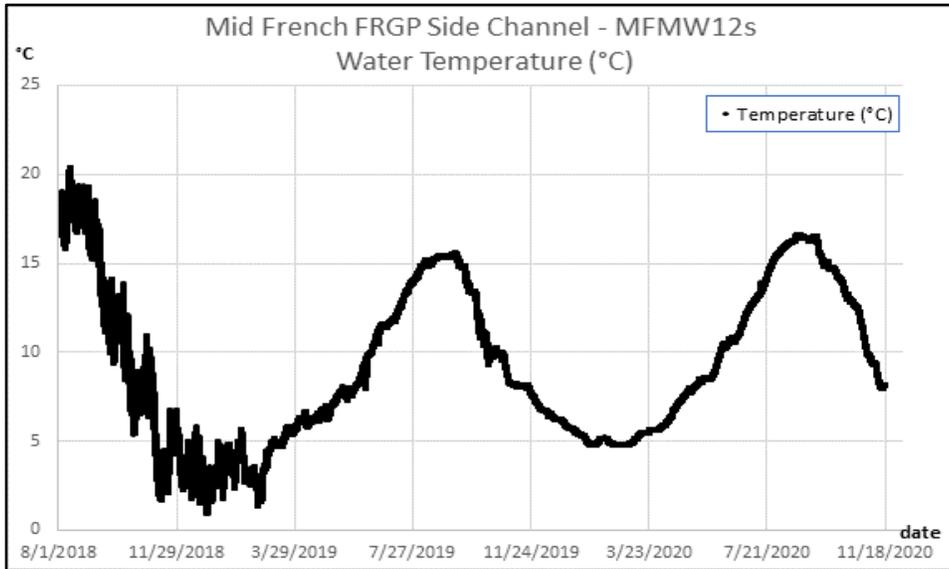
FIGURE 1. CONTINUOUS WATER TEMPERATURE (°C) WSE STATION MFMW12S.

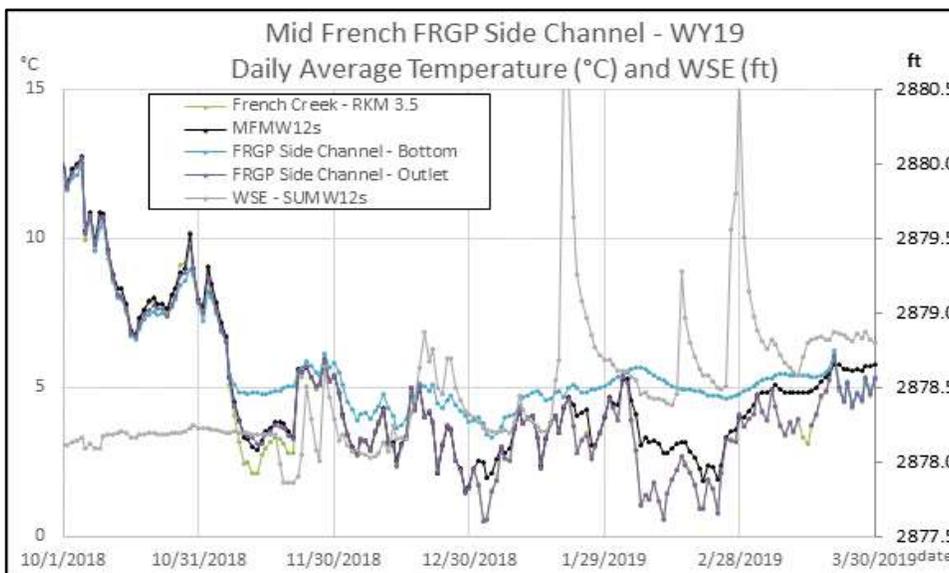
FIGURE 2. DAILY AVERAGE WATER TEMPERATURE AND WATER SURFACE ELEVATION (WSE).

Analysis of the continuous water temperature at the water surface elevation station (MFMW12s) installed in the upstream River Right Alcove illustrates the effects of the sediment deposition on temperature (Figure 1). The temperature exhibits a surface water signal with high diurnal variation before mid-February 2019 with subsequent data exhibiting a groundwater signal with low diurnal variation. Comparison of the daily average temperatures at temperature loggers in the Side Channel and the mainstem French Creek illustrates the divergence of averages associated with the sediment storage from the runoff events in WY2019 (Figure 2).

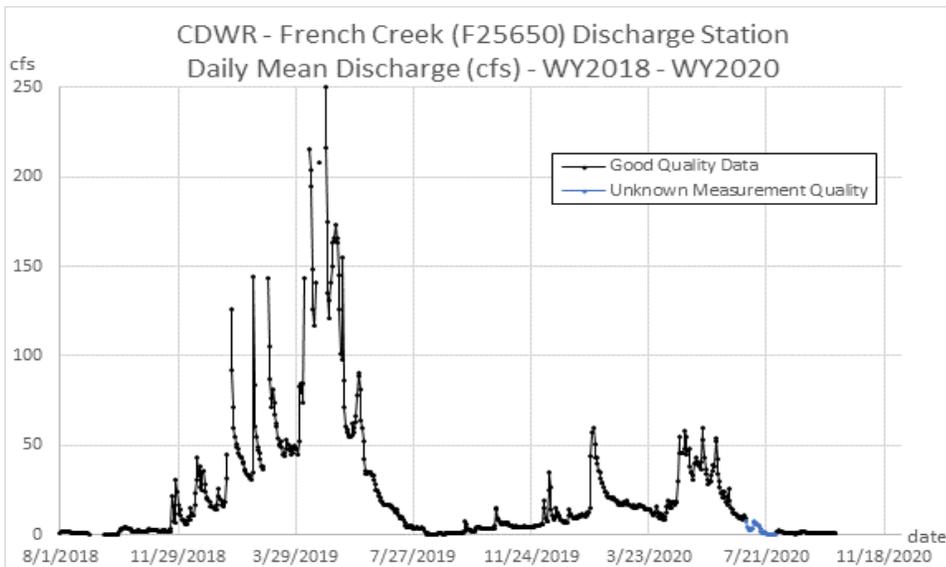
FIGURE 3. CDWR FRENCH CR (F25650) APPROVED DAILY MEAN DISCHARGE - FRENCH CREEK RKM 1.4.

The California Department of Water Resources (CDWR) operates a stream discharge station in French Creek at RKM 1.4 (F25650). The approved daily mean discharge data for WY18 - WY20 was retrieved from the CDWR Water Data Library (wdl.water.ca.gov). The French Creek discharge data illustrates the significantly higher flows during the winter and spring runoff period of WY19 as compared to the runoff period of WY20 (Figure 3). The base flow period of summer occurred later in the average WY19 (early August) then during the critically dry WY20 (mid-July). The different environmental conditions in WY19 and WY20 affected the observed water quality regimes during the base flow and runoff periods.

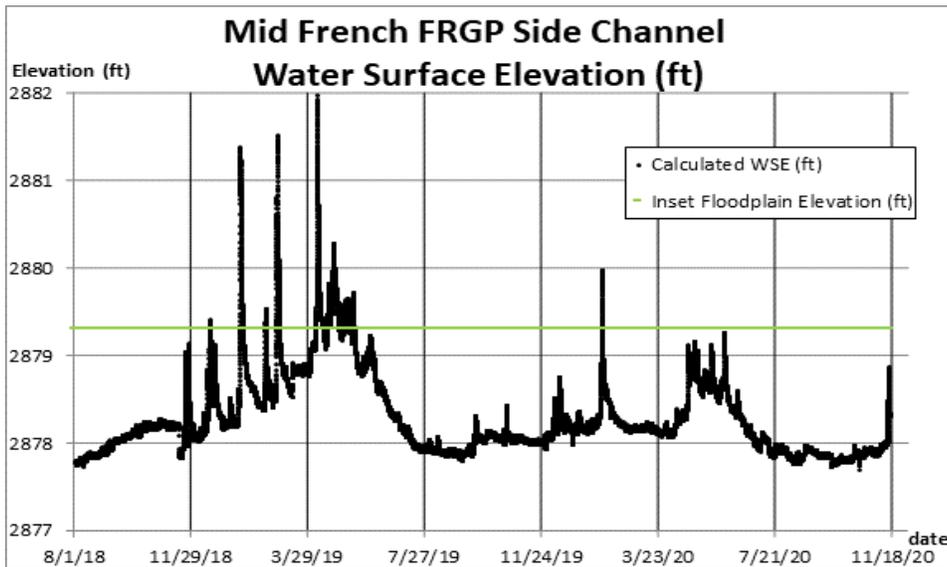
FIGURE 4. SIDE CHANNEL WATER SURFACE ELEVATION (WSE).

Figure 4 illustrates the elevation of the “inset floodplain” installed on the river left of the Side channel along with the Side Channel’s WSE. During the average WY19, the inset floodplain was inundated during the periods of precipitation driven runoff and snowmelt. The recurrence of inundation of the inset floodplain was reduced to a single runoff event in WY20.

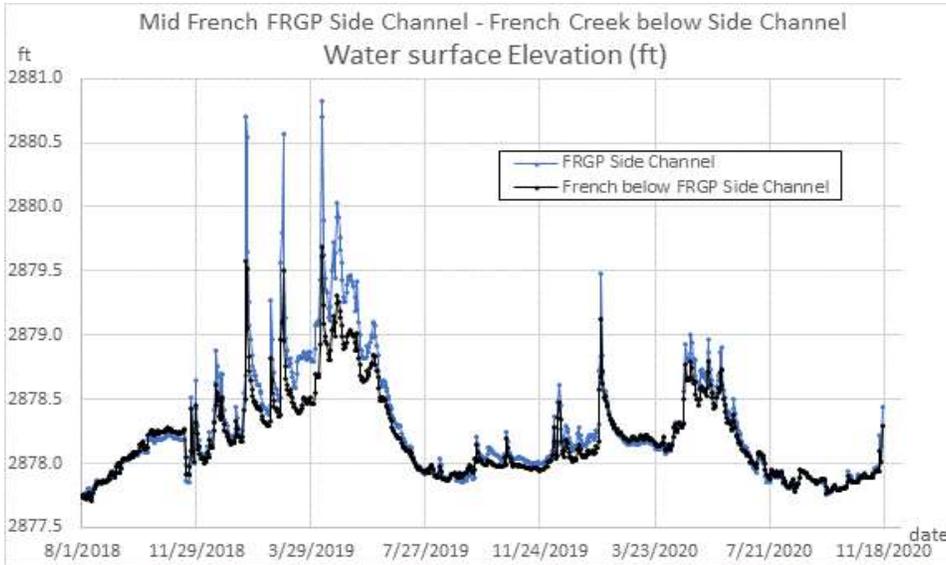
FIGURE 5. WATER SURFACE ELEVATION - SIDE CHANNEL AND FRENCH BELOW SIDE CHANNEL.

Comparison of the daily mean WSE in the Side Channel and in mainstem French Creek downstream of the Side Channel Outlet indicates that the WSE is the same during the periods of base flow and higher in the Side Channel during periods of runoff (Figure 5). The higher WSE in the Side Channel during runoff events is hypothesized to be due to the “backwater effect” created by the confluence of the flow in the Side Channel and mainstem French Creek along with the resistance from the outlet structure that was installed in March 2019. Throughout the base flow period of WY20 the WSE is identical at the two locations indicating a shared hydraulic control for both sites downstream of the mainstem WSE station.

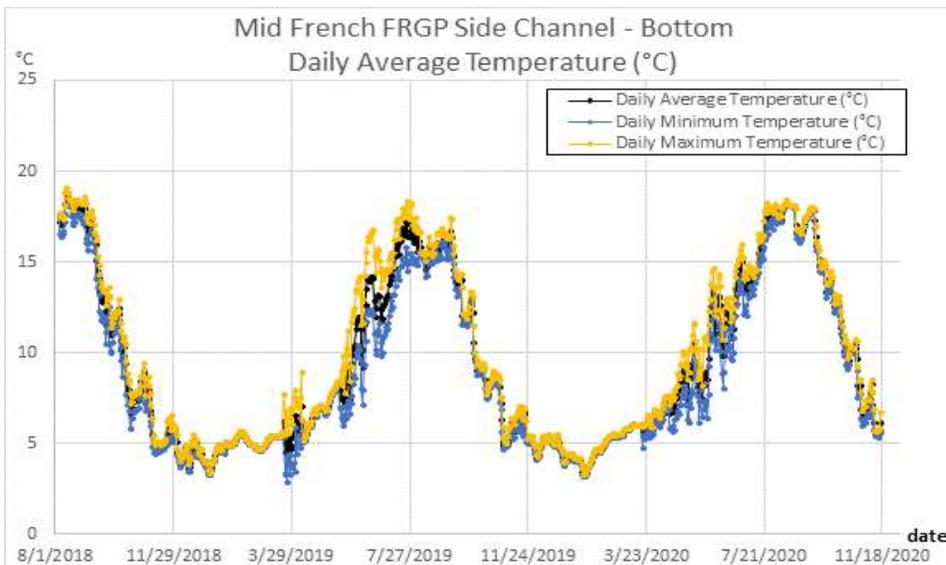
Figure 6. Average water temperature (°C) - Side Channel - Bottom - WY18 - WY21.

Water temperatures (°C) documented in the Side Channel indicate groundwater input and/or stratification in the deepest areas of the feature compared to shallower areas and the mainstem. Comparison of the daily average, minimum and maximum temperatures in the Side Channel - Bottom site (Figure 6) to the Outlet site (Figure 7) illustrates that the diurnal fluctuation during winter and summer is less at the Bottom site indicative of groundwater inputs. The maximum temperatures observed in the Bottom site are also lower than those at the Outlet site during the base flow period of summer indicative of groundwater inputs to and/or stratification of the deeper water.

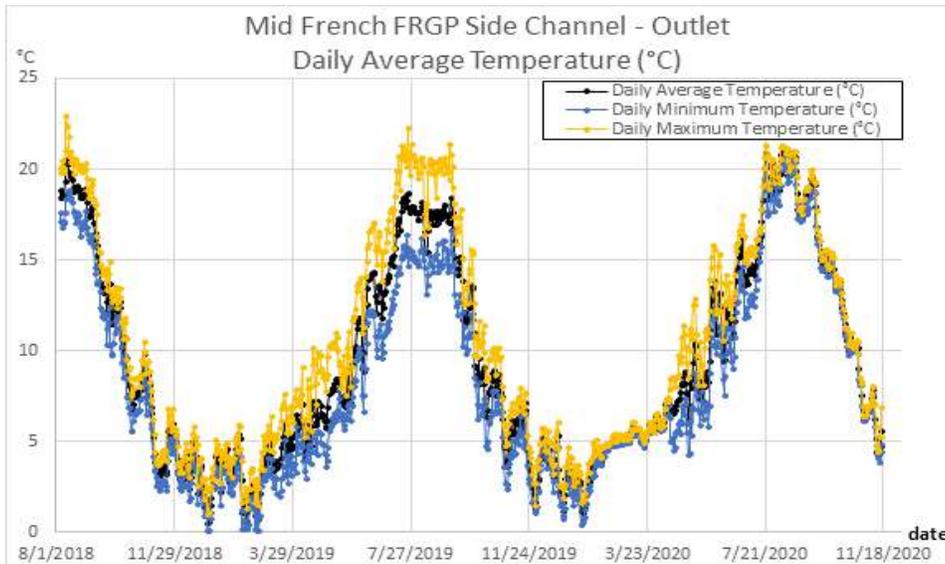
FIGURE 7. AVERAGE WATER TEMPERATURE (°C) - SIDE CHANNEL - OUTLET - WY18 - WY21.

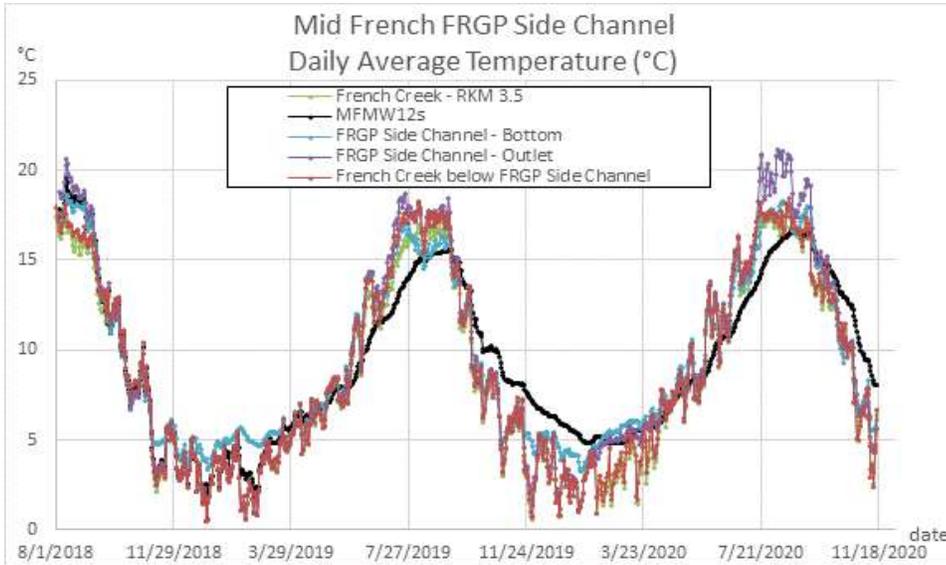
FIGURE 8. DAILY AVERAGE WATER TEMPERATURE (°C) - SIDE CHANNEL AND MID FRENCH CREEK - WY18 - WY21. DAILY AVERAGE WATER TEMPERATURE (°C) - SIDE CHANNEL AND MID FRENCH CREEK - WY18 - WY21.

Analysis of the daily average water temperatures (°C) at three locations in the Side Channel and two locations in the mainstem from WY18 - WY21 (Figure 8) corroborates the observation of a temperature difference in the Side Channel Bottom. It should be noted that the significant temperature difference observed in the upstream river right alcove at the MFMW12s WSE after the winter of WY19 is due to the stilling well becoming buried by sediment. The water temperatures at this site have a groundwater signal with a low diurnal fluctuation throughout the year.

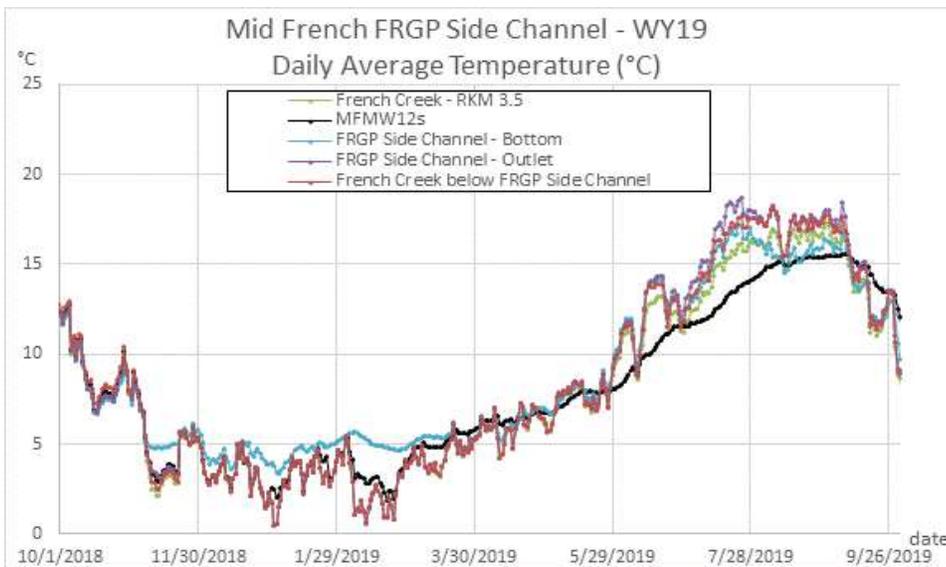
FIGURE 9. DAILY AVERAGE WATER TEMPERATURE (°C) - SIDE CHANNEL AND MID FRENCH CREEK - WY19.

Analysis of the daily average temperature (°C) during WY19 illustrates the warmer water temperatures during winter and cooler water temperatures in summer in the Side Channel Bottom in comparison to all sites with exception of MFMW12s (Figure 9).

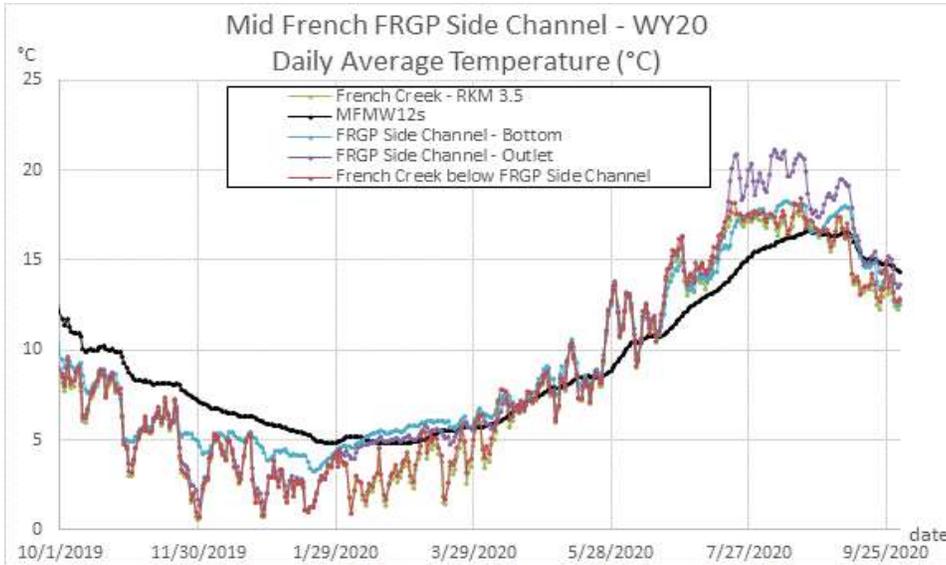
FIGURE 10. DAILY AVERAGE WATER TEMPERATURE (°C) - SIDE CHANNEL AND MID FRENCH CREEK - WY20.

The water temperatures in the critically dry WY20 are warmer at all sites during the base flow period due to the reduced stream discharge (Figure 10). The trends observed during WY19 persist during WY20 with the Side Channel Bottom being cooler during summer (maximum MWAT = 18.2°C) than the other surface water stations in the Side Channel and warmer during the winter (minimum MWAT = 3.4°C) than all stations (Table 7 and Table 8). Significant stratification is observed in the FRGP Side Channel during the summer of WY20 with the maximum MWAT at the DO Logger (21.4°C) warmer than at the Outlet and Bottom. The water temperatures in the Side Channel during the summer of 2020 are marginal to unsuitable for rearing juvenile Coho Salmon.

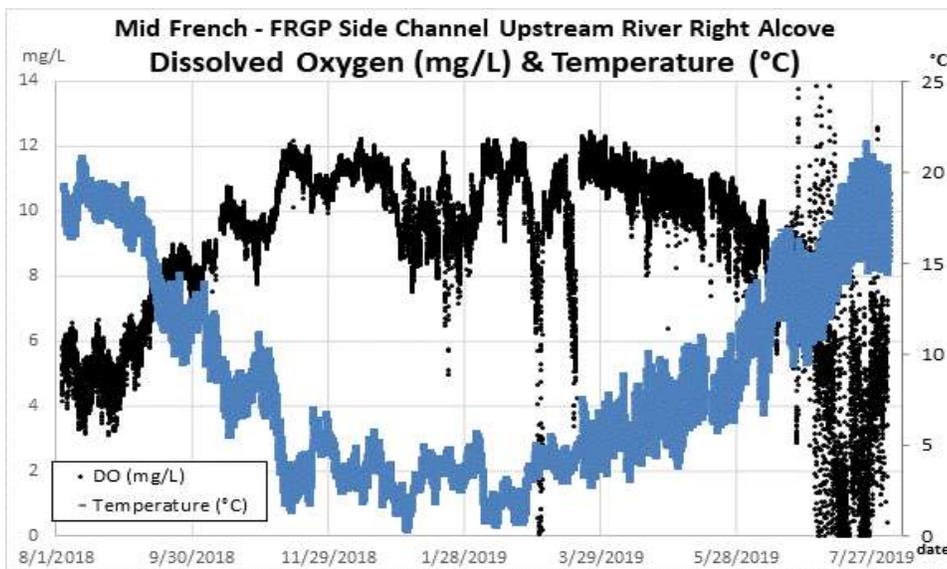
FIGURE 11. DISSOLVED OXYGEN (MG/L) AND TEMPERATURE (°C) - UPSTREAM LOCATION - WY18 - WY20.

oxygen (Figure 11). After the completion and connection of the Side Channel in August 2018 the DO was less than 6 mg/L for the majority of time with periods of DO less than 4 mg/L. DO increase in September as temperatures decreased with DO reaching saturation during the higher flows and colder temperatures of winter. Several large decreases in DO were observed during the runoff period. During the spring of 2019, large amounts of organic material was observed deposited in the Side Channel and it is hypothesized that the DO logger sensor was buried in organic material and fine sediment. As the stream flow decreased to base flow in early July 2019 the dissolved oxygen fluctuated rapidly. On August 2, 2019, the location of the DO logger was found to be significantly altered by deposition of sediment and organic material and the logger was moved downstream to deeper water with observed utilization by juvenile Coho Salmon.

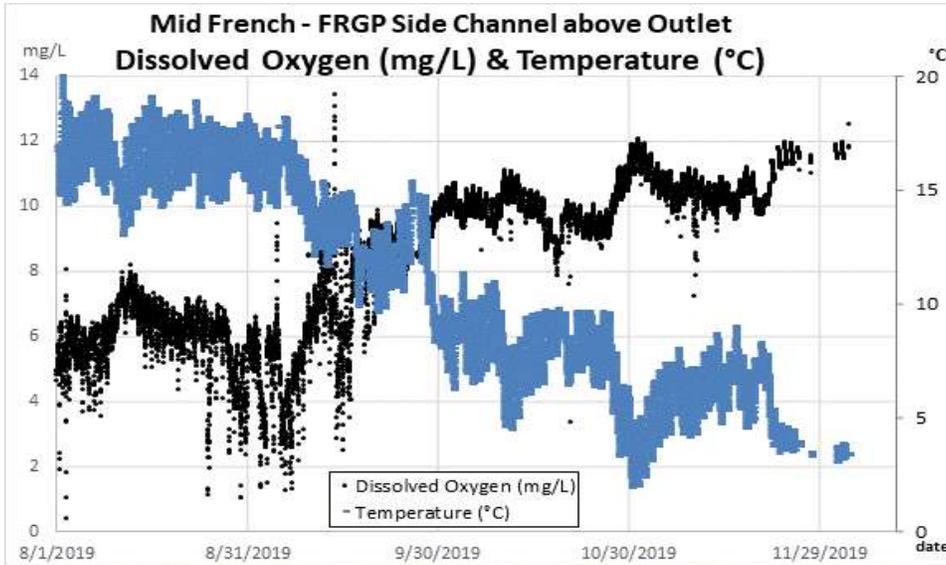
FIGURE 12. DISSOLVED OXYGEN (MG/L) AND TEMPERATURE (°C) - DOWNSTREAM LOCATION - WY19-WY20.

The DO at the downstream site had significantly less diurnal fluctuation than that observed at the upstream site (Figure 12). DO was less than 6 mg/L for a majority of the base flow period of August to mid-September with instances of DO less than 4 mg/L observed in late August and September. DO increased and water temperatures decreased in late September and DO was saturated from October through the period of record. The DO logger battery failed in Late November and the logger was replaced.

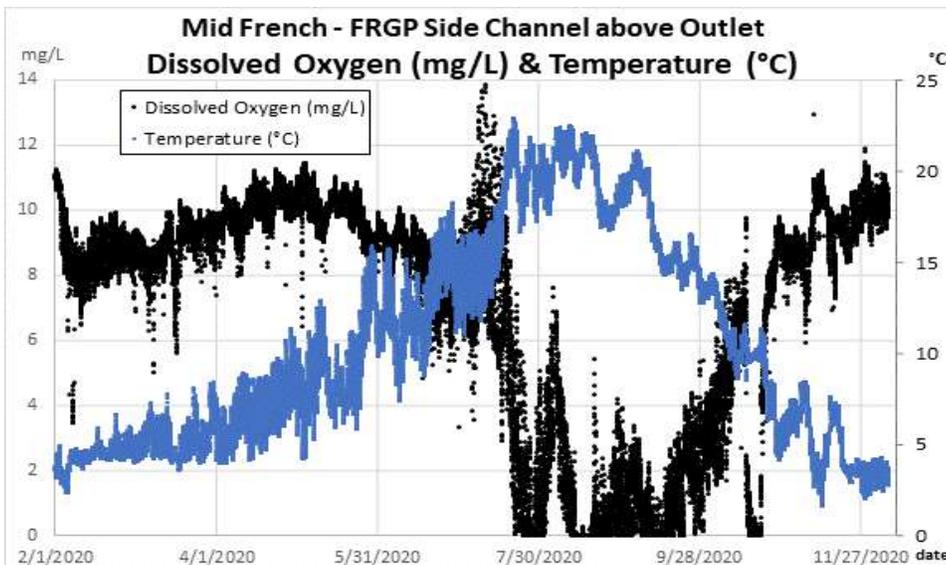
FIGURE 13. DISSOLVED OXYGEN (MG/L) AND TEMPERATURE (°C) - DOWNSTREAM LOCATION - WY20-WY21.

The inlet to the Side Channel had become obstructed with sediment during the winter of 2019 and a decision was made to allow the inlet to remain obstructed over the summer in order to keep cold water in the main French Creek channel.

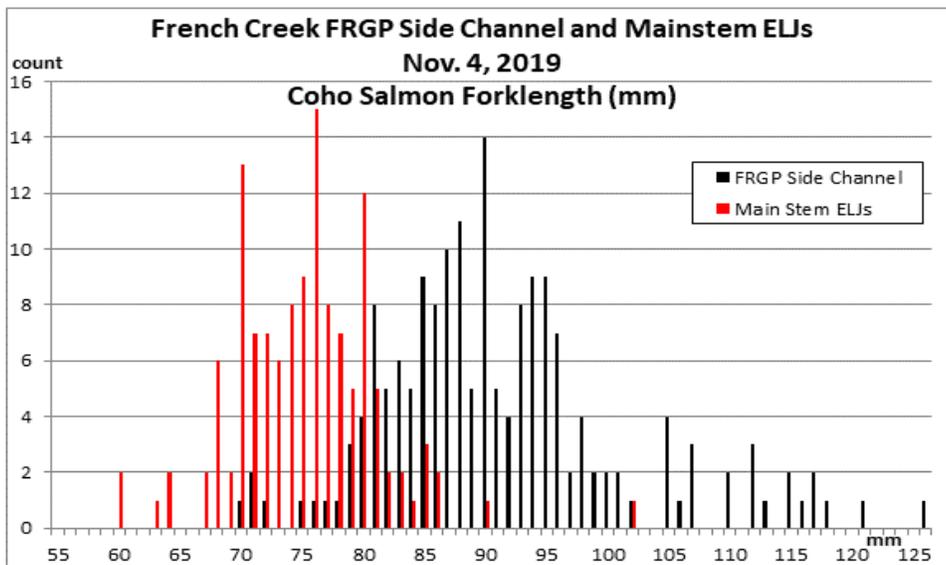
FIGURE 14. FORKLENGTH (MM) HISTOGRAM - COHO SALMON CAPTURED IN THE SIDE CHANNEL AND MAINSTEM ELJS - NOV. 4, 2019.

Analysis of the forklength (mm) histograms of the Coho Salmon captured in the Side Channel (n = 173) and ELJ Reach (n = 129) illustrates the larger sized fish captured in the Side Channel (Figure 14). The average forklength of Coho captured in the Side Channel (91 mm) is greater than those captured in the ELJ Reach (75 mm) and the French Control Pools (76 mm) during the week of October 28th - November 4, 2019 (Table 14). It is hypothesized that the Coho captured in the Side Channel in early November had been rearing in the Side Channel for some time and their superior condition is indicative of preferred habitat and increased feeding opportunities. The condition of the fish captured in the ELJ Reach is equivalent to those captured in the upstream Control Pools (Map 9).

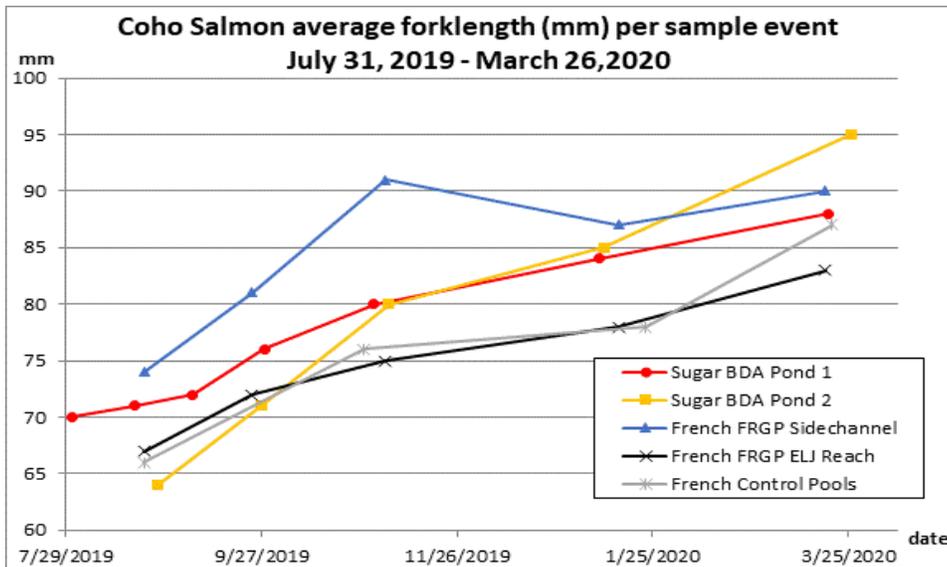
FIGURE 15. COHO SALMON AVERAGE FORKLNGTH (MM) PER SAMPLE EVENT.

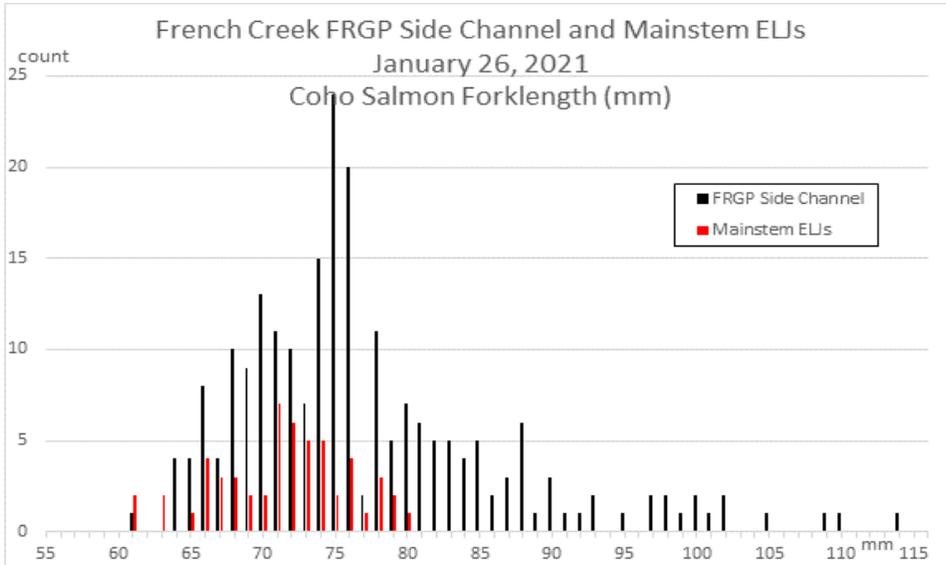
FIGURE 16. FORKLENGTH (MM) HISTOGRAM - COHO SALMON CAPTURED IN FRGP SIDE CHANNEL AND MAINSTEM ELJS - JANUARY 26, 2021.

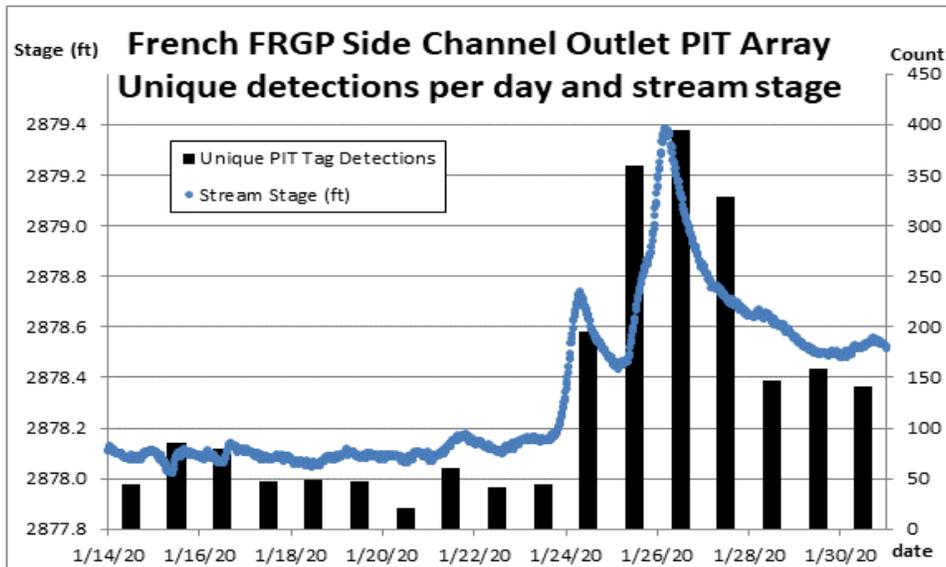
FIGURE 17. SIDE CHANNEL OUTLET PIT ARRAY STATION – UNIQUE PIT TAG DETECTIONS PER DAY AND FRENCH CREEK STREAM STAGE - JANUARY 2020.

detection of movement direction at the Side Channel outlet. Diurnal movement from an Off Channel Pond in Sugar Creek to the mainstem Sugar BDA Pond has been observed during the late winter and early spring, triggering an interest to see if this pattern of habitat utilization could be detected at this location. The paired arrays at the outlet created the ability to detect direction of movement to document if fish are moving between the Side Channel and mainstem habitats.

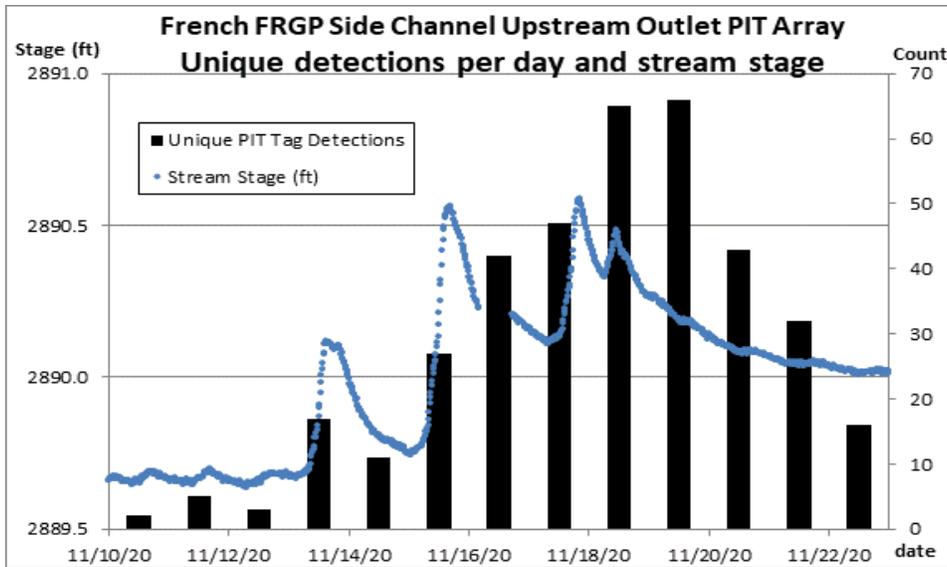
FIGURE 18. SIDE CHANNEL UPSTREAM OUTLET PIT ARRAY STATION – UNIQUE PIT TAG DETECTIONS PER DAY AND FRENCH CREEK STREAM STAGE - NOVEMBER 2020.

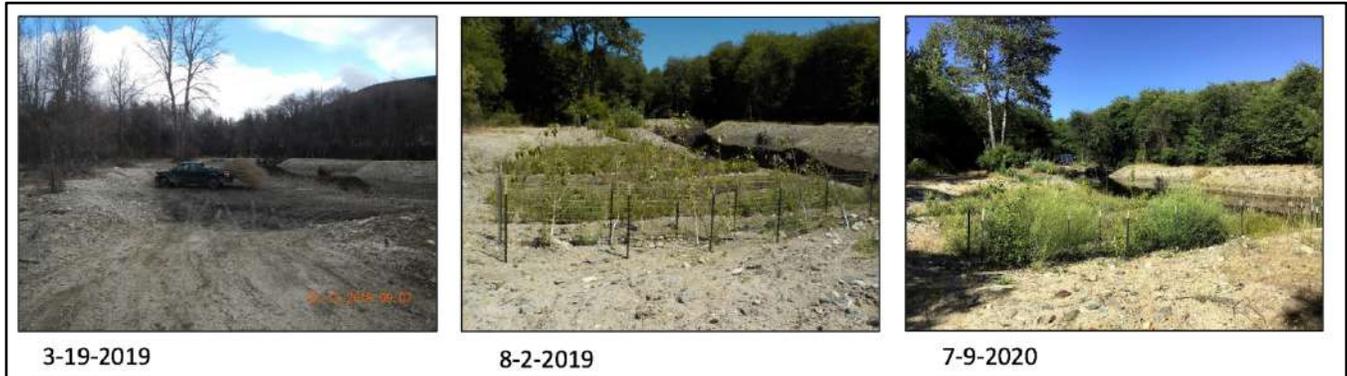
PHOTO 15. CONSTRUCTED FLOODPLAIN

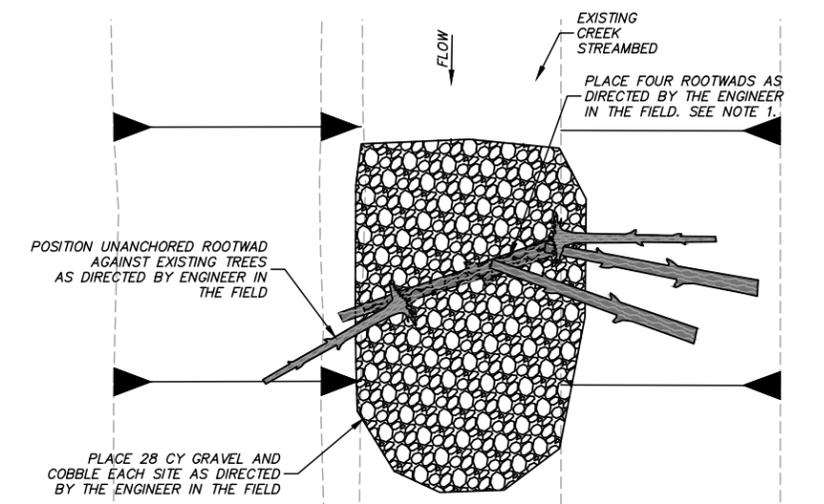
GRAVEL AUGMENTATION AND ROOTWAD PLACEMENT LAYOUT
NOT TO SCALE

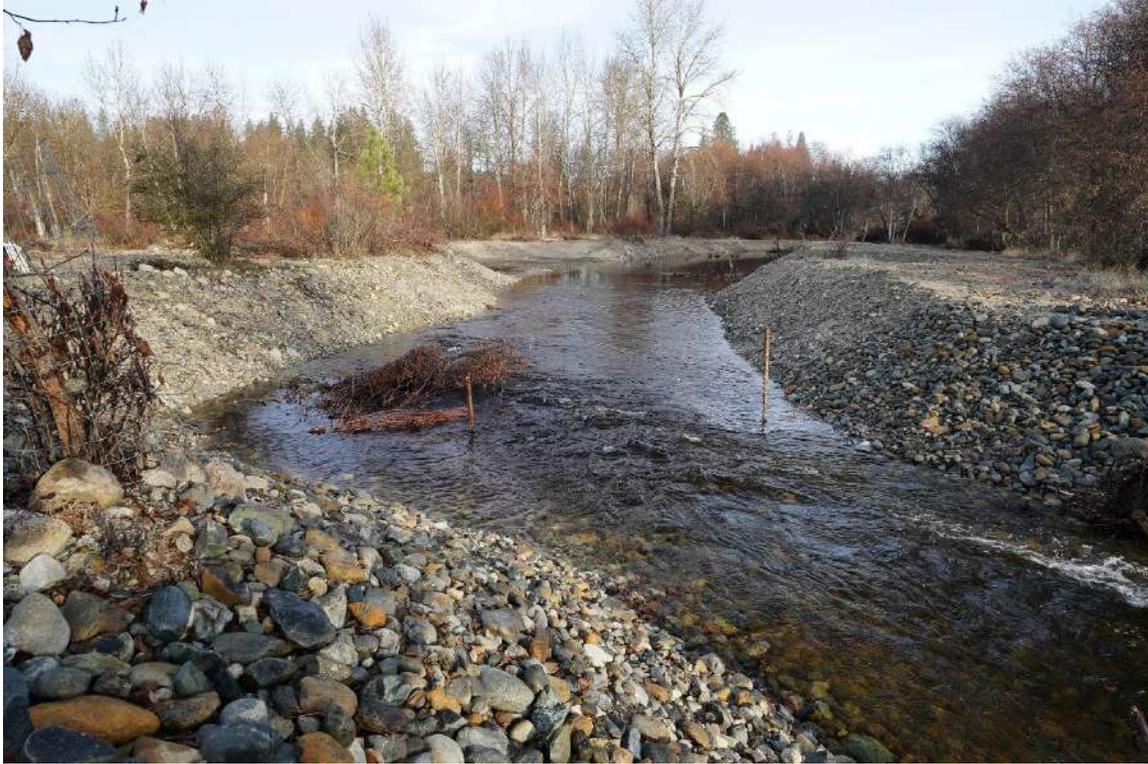
Photograph 3. Side Channel Inlet

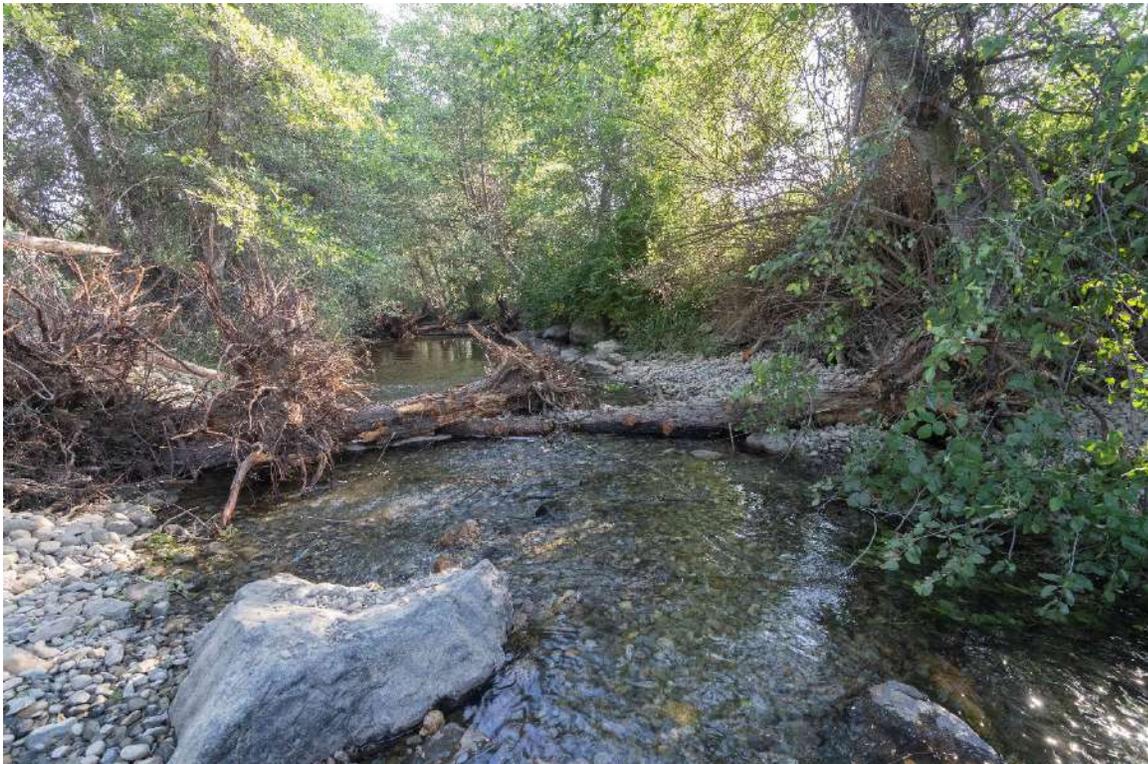
Photograph 6. Channel spanning wood jam at summer low flow

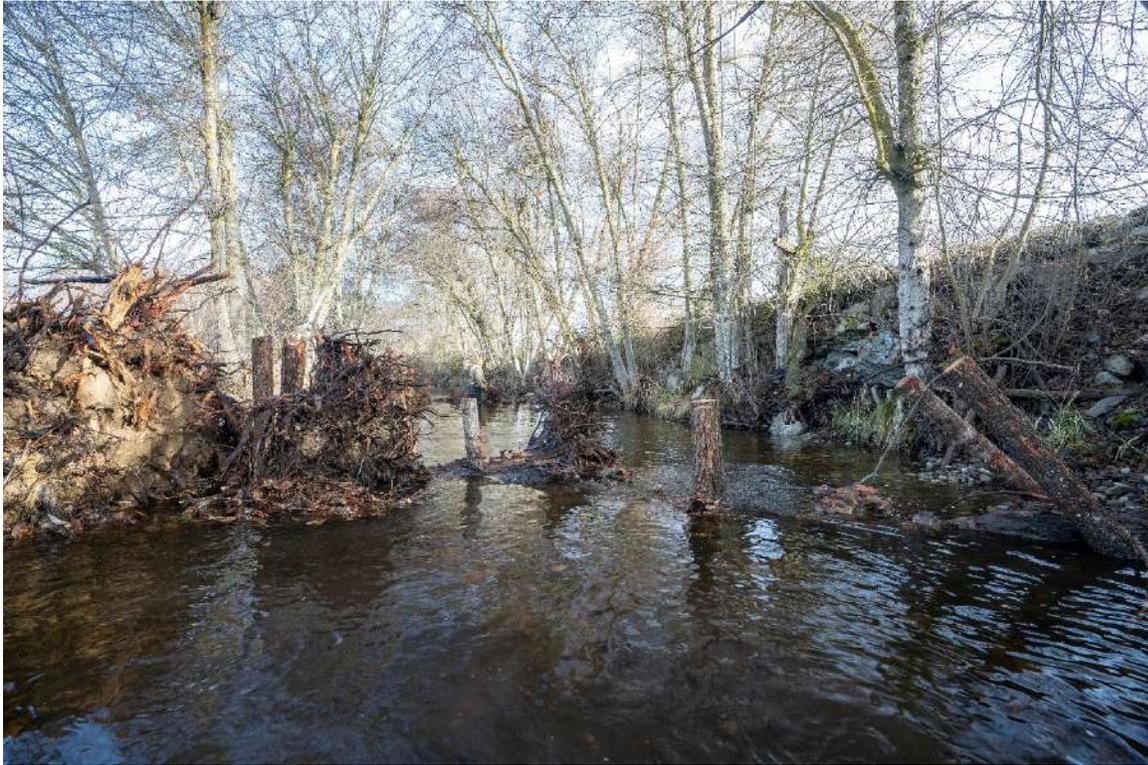
Photograph 7. Channel spanning wood jam during winter flow
