French Creek Instream & Off Channel Enhancement Project

California Department of Fish & Wildlife
Fisheries Restoration Grant Program

Scott River Watershed Council
514 North Hwy. 3
Etna, CA 96027

February 28, 2021

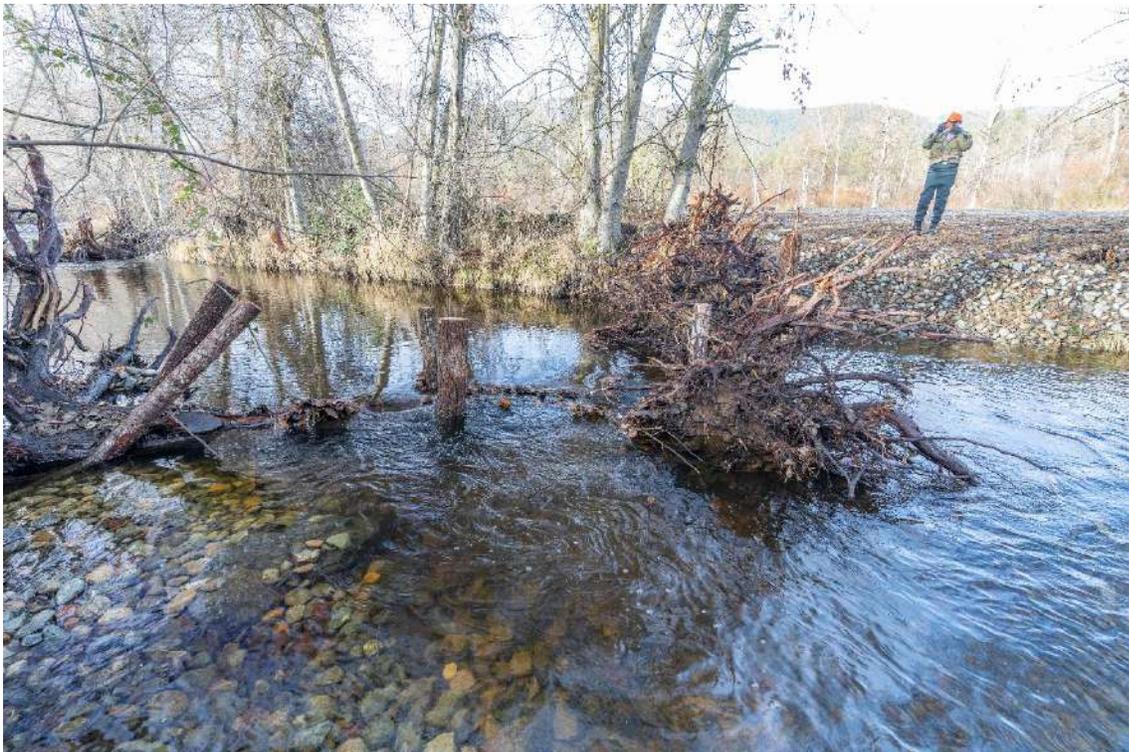
Photograph 8. Channel Spanning Wood Structure

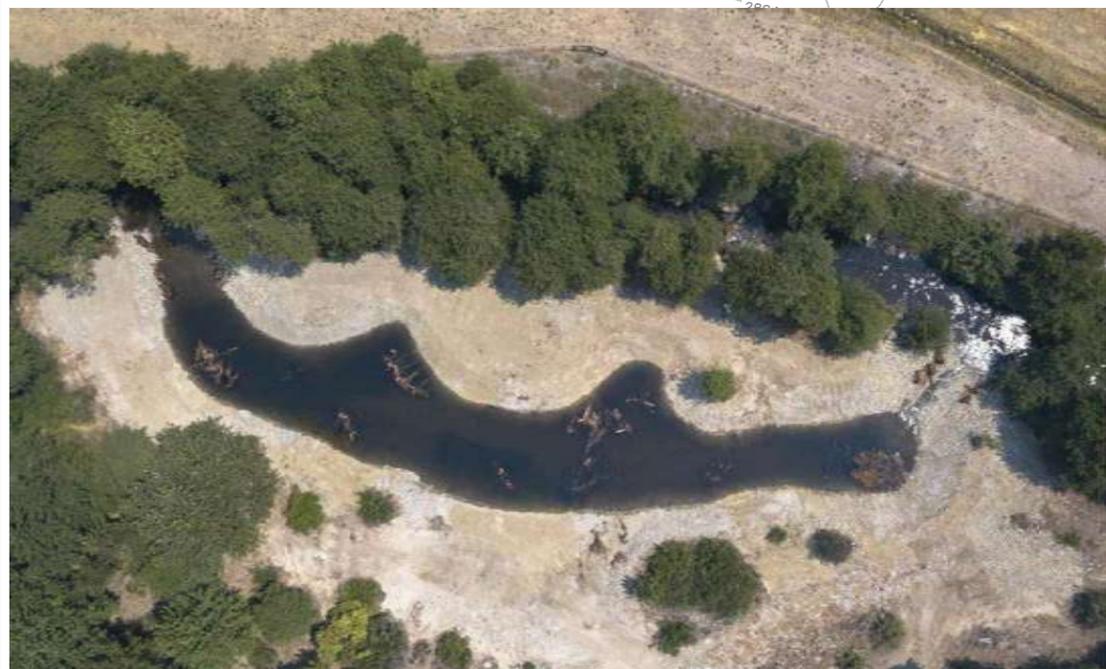
SIDE CHANNEL WITH WOOD STRUCTURES
