Moffett Creek Capstone Project

Final Report 2018/2019

Scott Ford, Charnna Gilmore, Spenser Mangold
Southern Oregon University
Environmental Science and Policy Program
ES 494C - Dr. Jamie Trammell
June 7, 2019

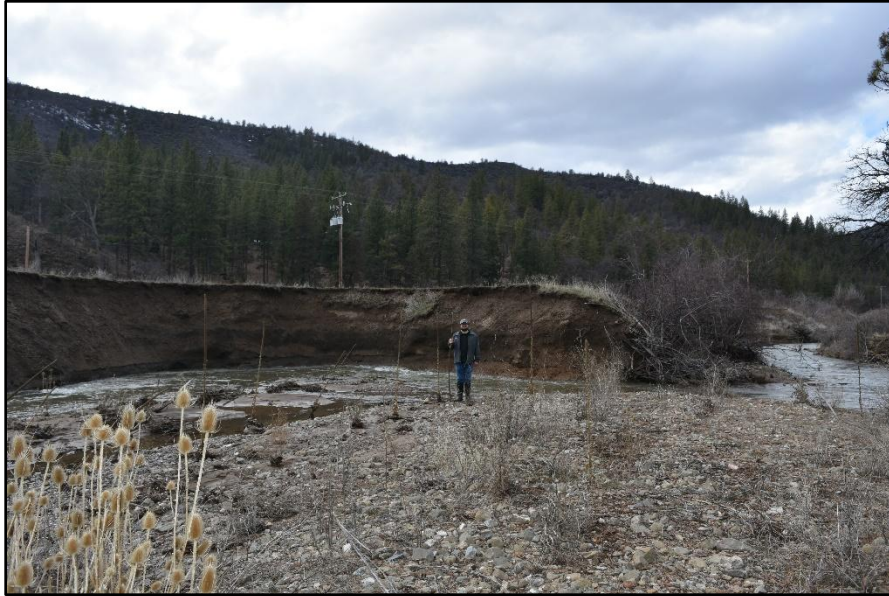
Figure 6: Large cut bank on Moffett Creek.

One area of interest within Moffett Creek lies along the valley floor and consists of deep, well drained soils that were formed by in residuum derived from metamorphic rock (United States Department of Agricultural 1978). In much of the area, significant incision has occurred due to anthropogenic impacts that may have be exacerbated by channel simplification (Figure 6).

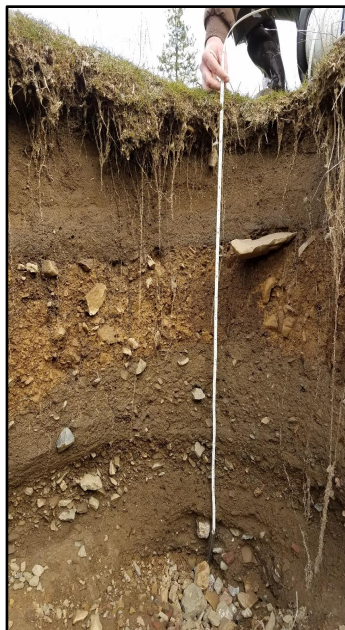
Figure 7: Distinct soil horizons exist within the soil sample on valley floor in Moffett Creek watershed.

This particular soil is classified as a Bonnett gravelly loam, 2 to 5 percent slopes. These soils consist of very deep, well drained soils from alluvial fan deposits and formed in mixed alluvium (Figure 7) (Appendix D).

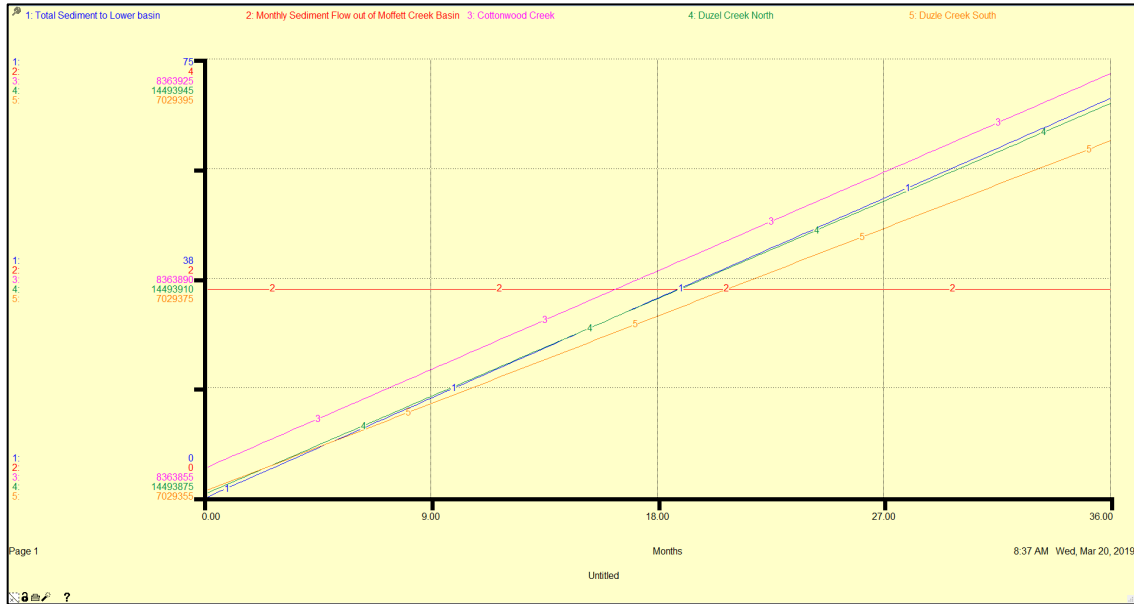
Figure 8: Stella model results. Line 2 is sediment delivered out of watershed. Lines 1, 3, 4, 5 are sediment amounts for each modelled sub-basin.

Soil Model: The Stella Model resulted in a combined sediment delivery of 1.9 tons/month from the five simulated sub-basins. While the amount of sediment delivered fluctuated with increased and reduced anthropogenic effects the effect was fairly small. The major finding of the model was that the amount of loose sediment being created in the upper areas of the sub-basins was much higher than the amount of

sediment being delivered through Moffett Creek (Figure 8). This sediment creation means that while large amounts of loose sediment is being created from the soils there is not enough water in the watershed to remove it under normal conditions. During large precipitation events however, this loose sediment is carried out of the sub-basins with surges of water. While surprising, these results match what was observed in stream turbidity after large precipitation events.

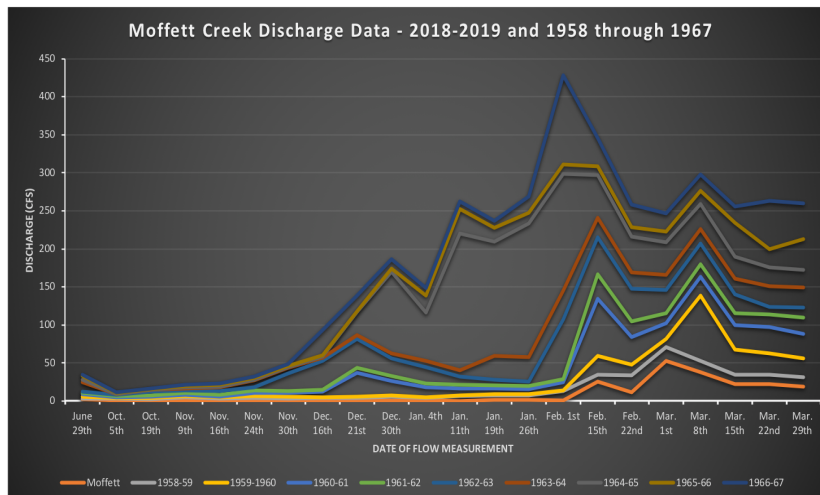
Figure 9: Moffett Creek discharge data from study period in 2018-2019 and historic data set from 1958-1967.

Discharge: The flow data that was collected for this project was analysis with a historic data set from 1958 to 1967, along with looking at the hydrography as it compared to the Scott River flow data for same period of time (USGS 1958-67). Similar trends were observed in the different years, however there was a noticeable in the difference cubic feet per second (cfs) between the historic data set and the 2018/2019 data set (Figure 9).

Peak flows measured on March 8, 2019 at 40.16 cfs as compared to flows recorded in February 1, 1967 at 423 cfs. Decadal precipitation data was also evaluated the data suggests a possible trend towards a drying regime (Figure 10) (California Department of Water Resource 2019).

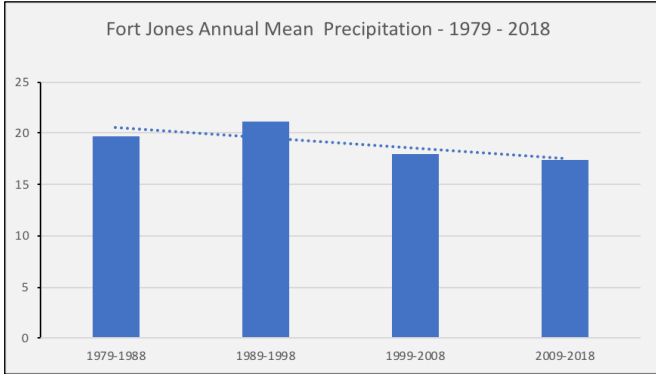
Figure 10: Fort Jones precipitation data from 1975-2018

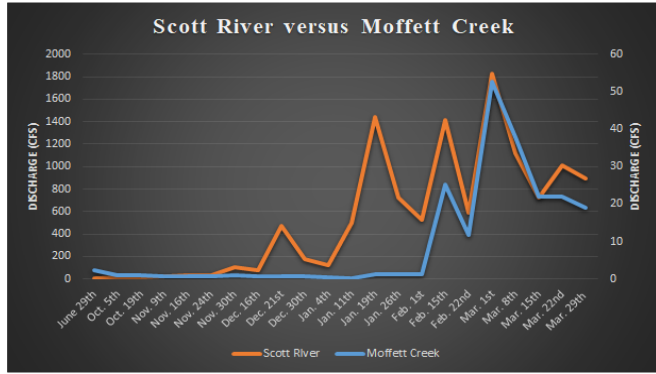
Figure 11: Moffett Creek and Scott River flow data from 2018-2019.

Data from the Moffett Creek flow station was evaluated against the flow data from the Scott River (USGS 2019). There is a strong correlation in the two hydrographs after the February 1, 2019 (Figure 11). This period was also the time when the surface of the groundwater increased substantially suggesting that the underlying aquifer may have gained some degree of recharge and therefore resulted in higher surface flows.

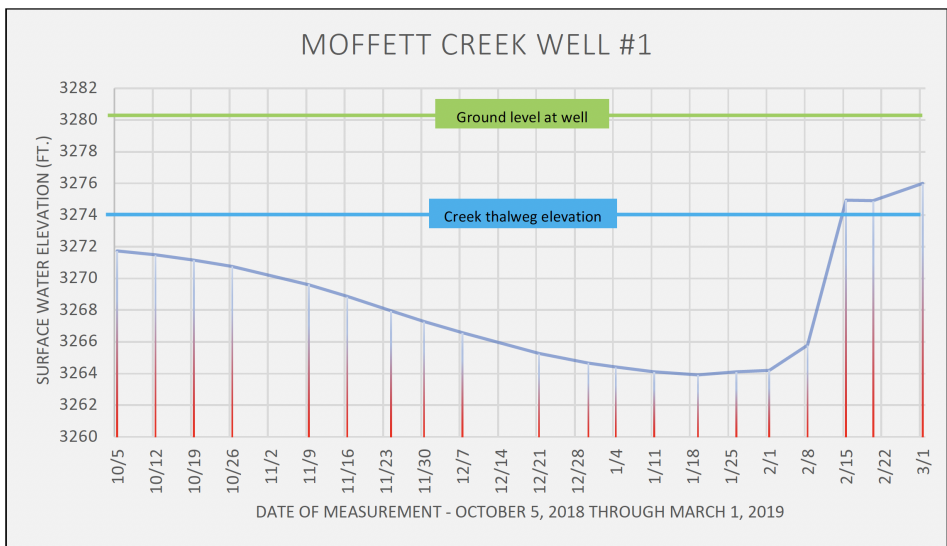
Figure 12: Moffett Creek well #1 surface water, creek thalweg and ground level elevations.

Water Surface Elevations: Over the past nine months, a groundwater and surface water monitoring network was established in order to better understand the hydrology of the basin. One of the goals of this project is to better understand the relationship between the groundwater aquifer and surface water flows (Figure 12).

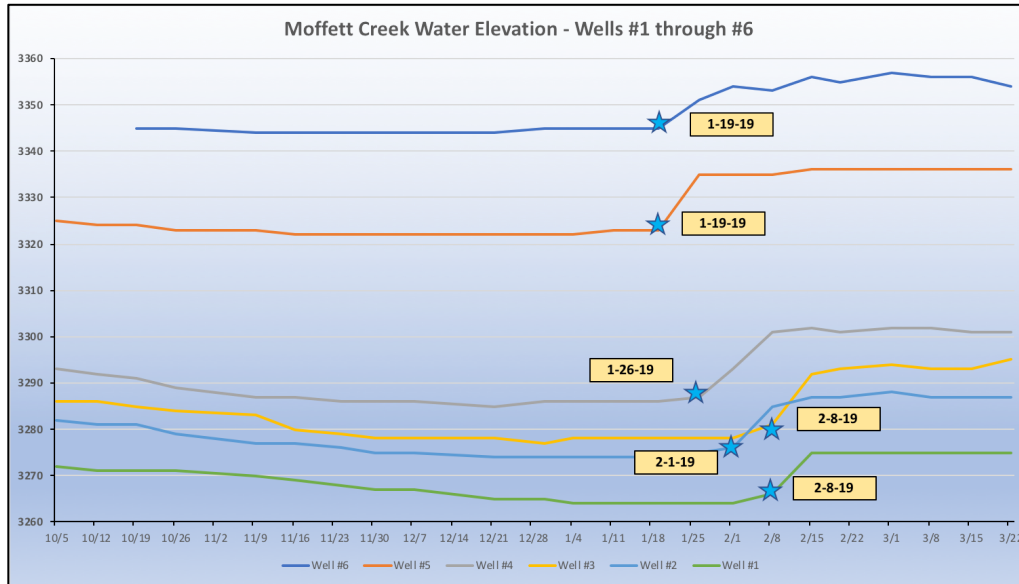
Figure 13: Groundwater data over time and when visible surface water was detected in creek.

A cross sectional survey was performed at six well locations obtaining surface elevations of the well reference point, adjacent ground level, stream channel, thalweg, channel toes and banks. A full analysis was conducted on all groundwater and surface water monitoring sites to establish the relationship between water levels and creek channel/thalweg. As the Moffett Creek aquifer recharged, there was an observed increase in the surface of the groundwater elevation over a relatively short period of time, which resulted in visible surface water flow in creek (Figure 13).

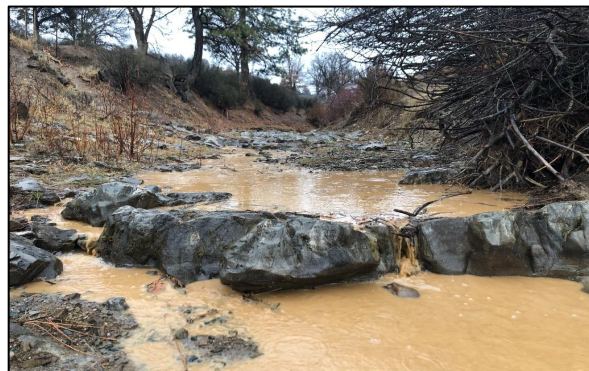
Figure 14: Moffett Creek flows during one of the first storms of the season. Photo taken 12/16/2018.

Turbidity: One of the main questions that MCCP tried to answer was how much actual sediment is being transported through the watershed. Ultimately, this was more difficult to obtain than originally estimated. Although sampling did occur, the results were mixed. There were different events that produced high levels of suspended sediment and therefore the equipment was unable to take readings (Figure 14).
