# Cabin Meadows and Rock Fence Creek Meadows Baseline Conditions Report

Scott River Watershed Council  
514 N Hwy 3 | PO Box 355  
Etna, CA 96027

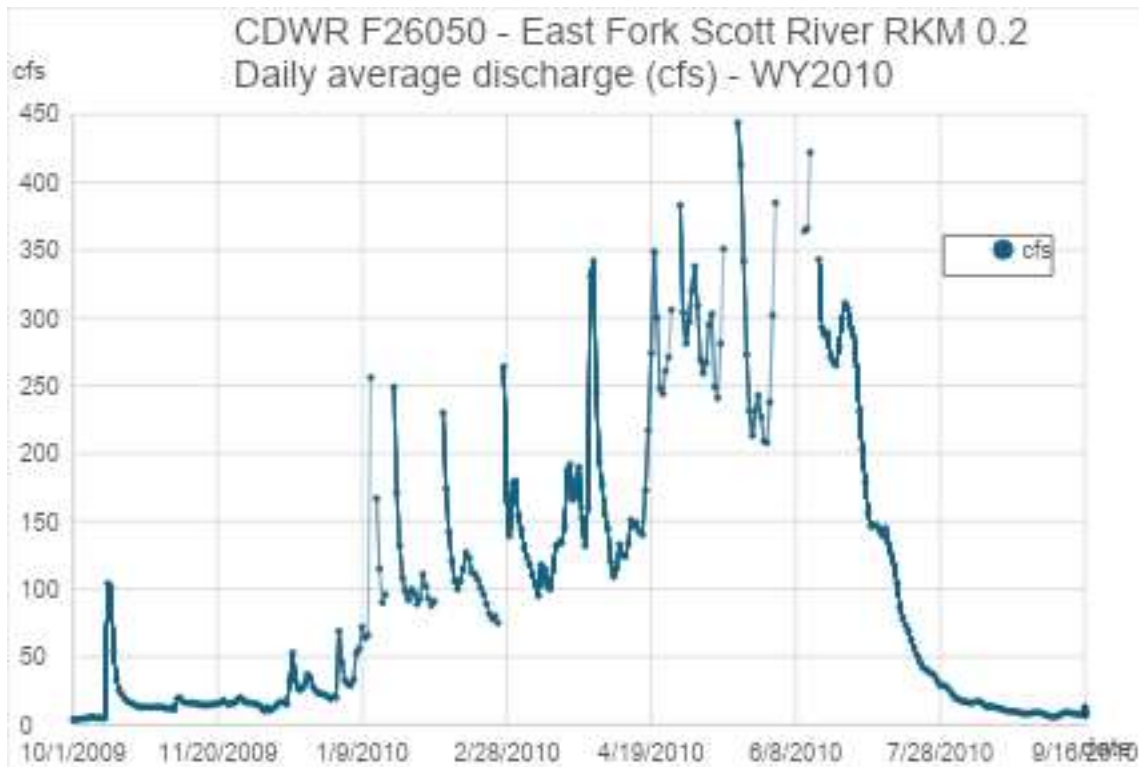
Figure 3-5. Representative hydrograph of the East Fork Scott River - WY2010.

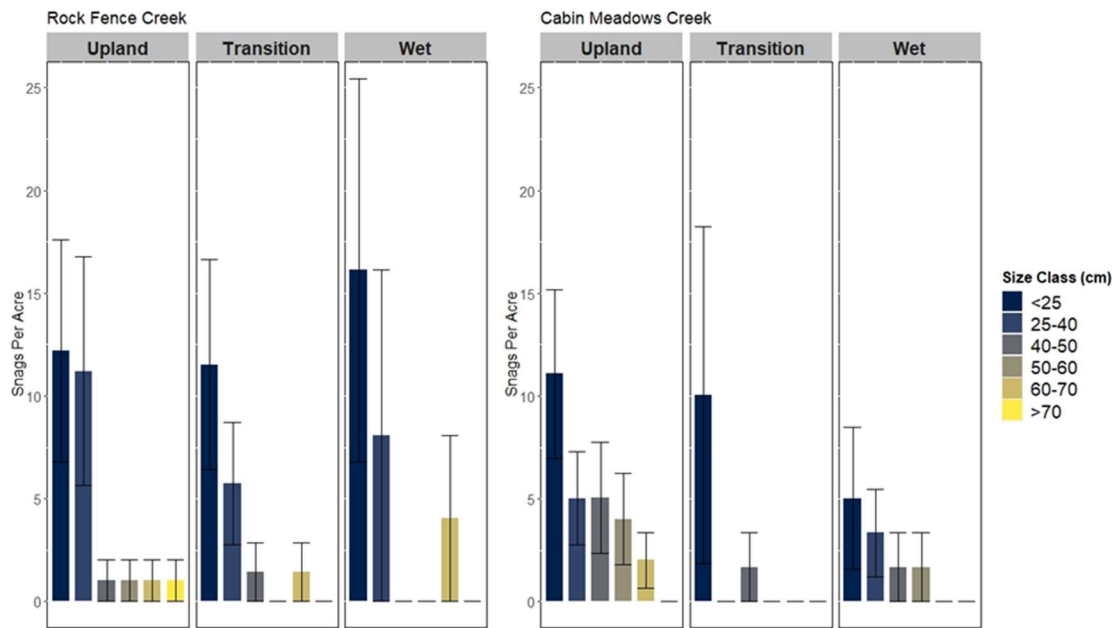
Snag densities ranged from 0-111 snags per acre in Rock Fence Creek and 0-91 snags per acre in Cabin Meadow Creek. For Rock Fence Creek, mean snag densities were similar between upland and wet meadow areas (27 and 28 snags per acre respectively) and lowest in the transition zone with 20 snags per acre. Cabin Meadow Creek on the other hand had the highest snag densities in the upland areas with a mean density of 27 snags per acre. Transition and wet meadow areas were similar to one another with mean snag densities of about 19 and 20 snags per acre respectively. Snag densities followed a similar pattern to tree densities with regard to size class with the majority falling in the smallest size classes (Figure 4-5).

**Figure 4-5.** Mean snags per acre with standard error bars shown for Rock Fence Creek and Cabin Meadow Creek watersheds separated by position and broken down by size class.

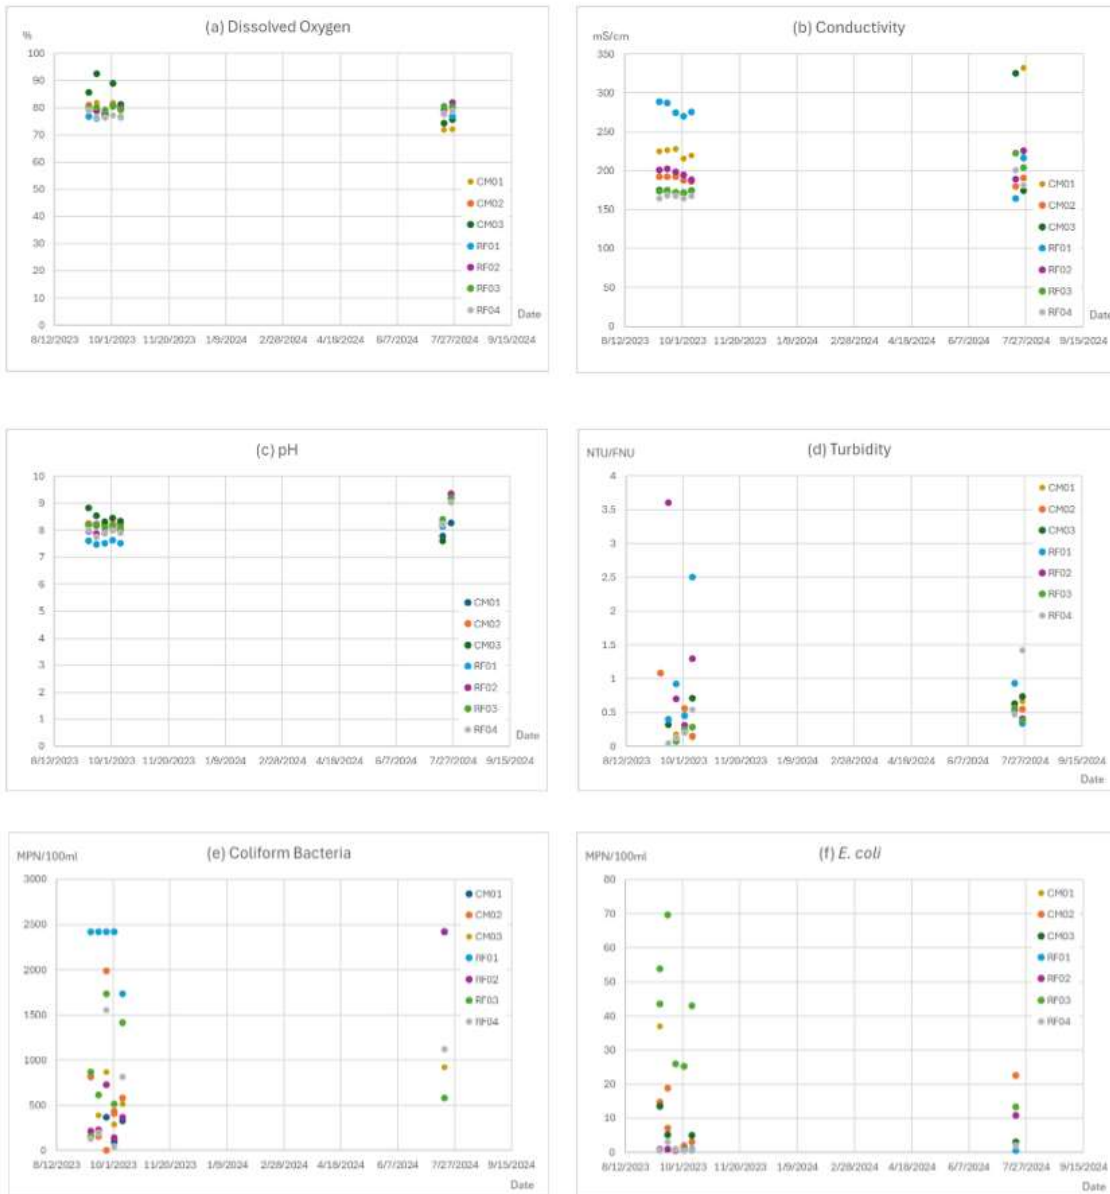
**Figure 4-37.** General water quality parameters for Cabin Meadow Creek and Rock Fence Creek. (a) Dissolved oxygen; (b) Conductivity; (c) pH; (d) Turbidity; (e) Coliform bacteria; (f) *E. coli*.

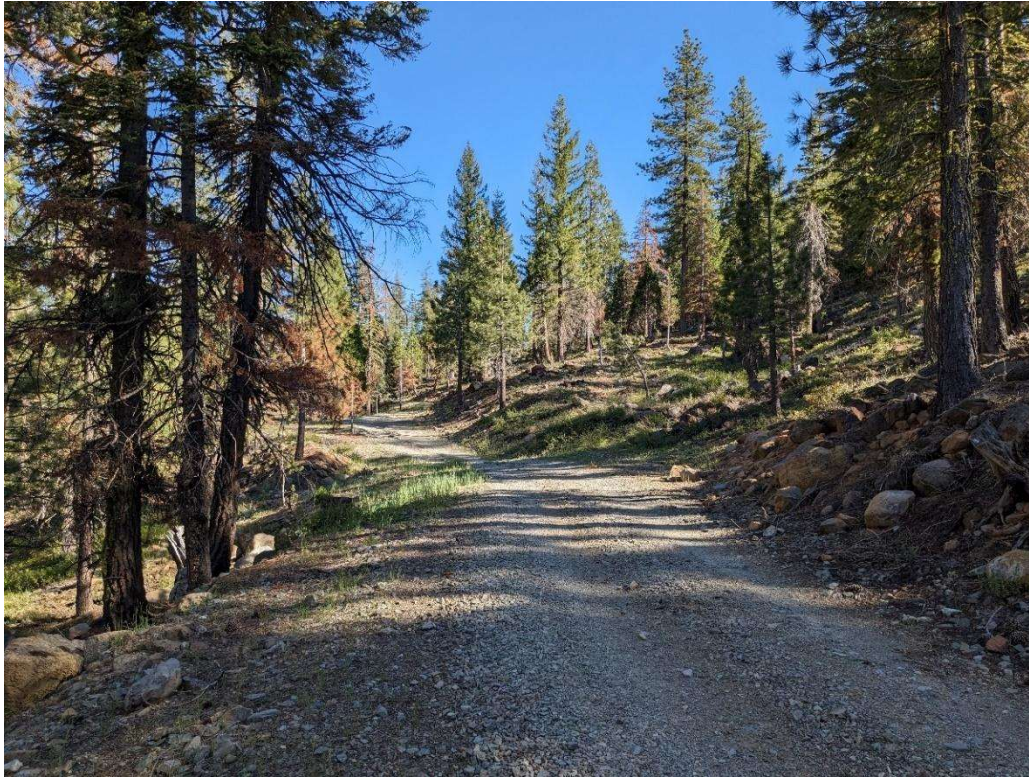
**Figure 4-38.** Looking south along the primary seasonal access road in the Cabin Meadow Creek basin (segment CM-15).

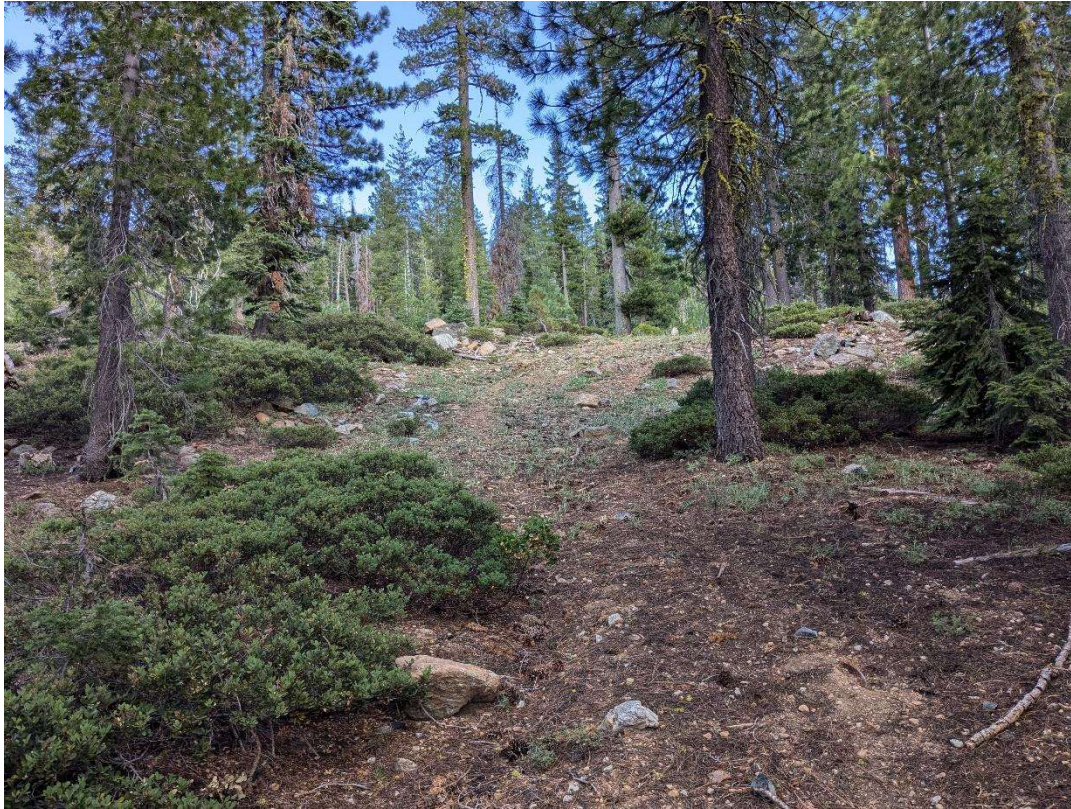
**Figure 4-40.** A not trafficable, legacy spur road in the Rock Fence Creek basin that intersects segment RF-4.

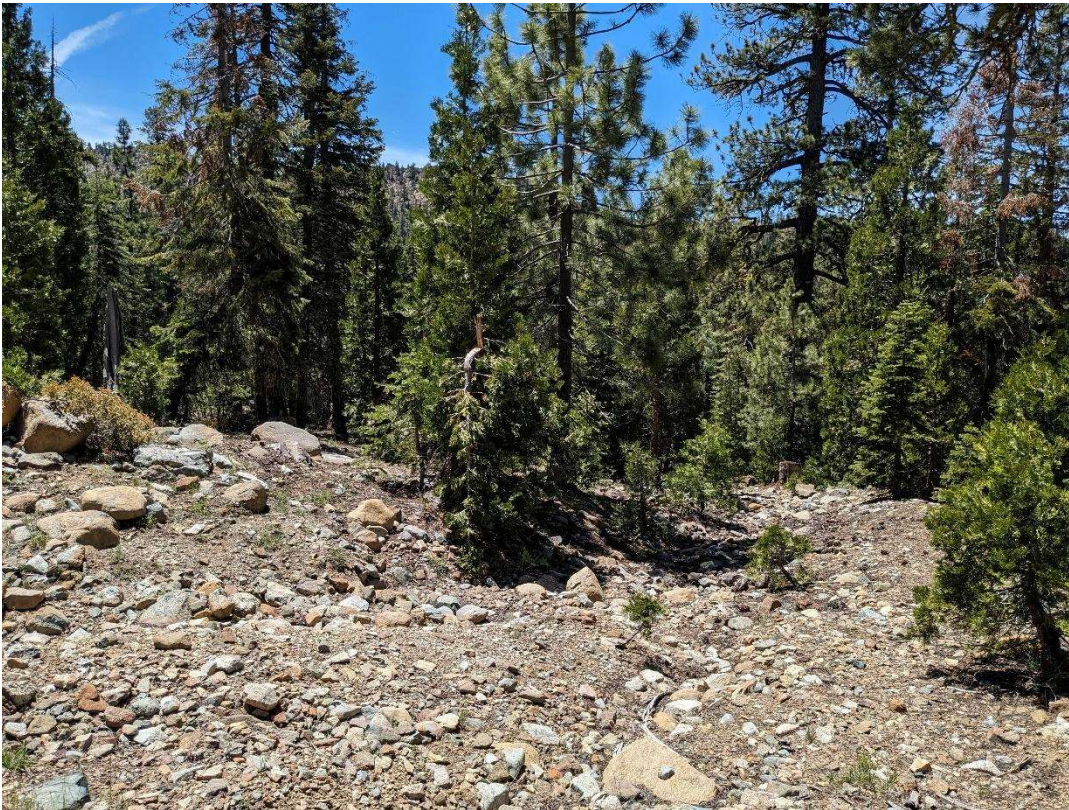
**Figure 4-44.** Looking downslope from STX-2, where a small watercourse has been diverted down the CM-5 road segment, resulting in surface erosion.

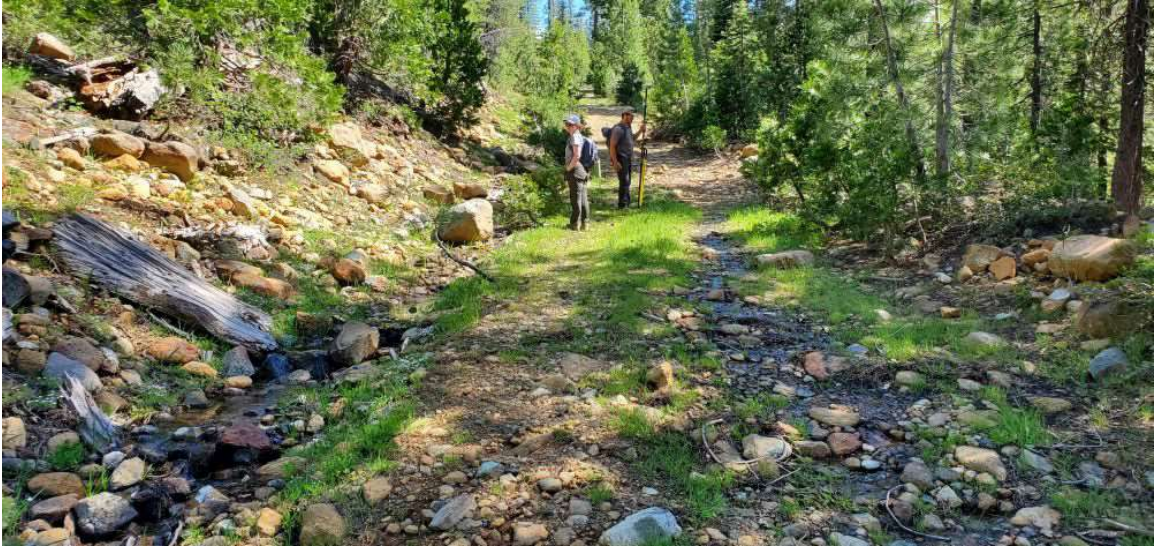
**Figure 4-45.** Looking upslope at road segment CM-8, with active flow visible in the inboard ditch to the left, as well as on the road surface to the right.

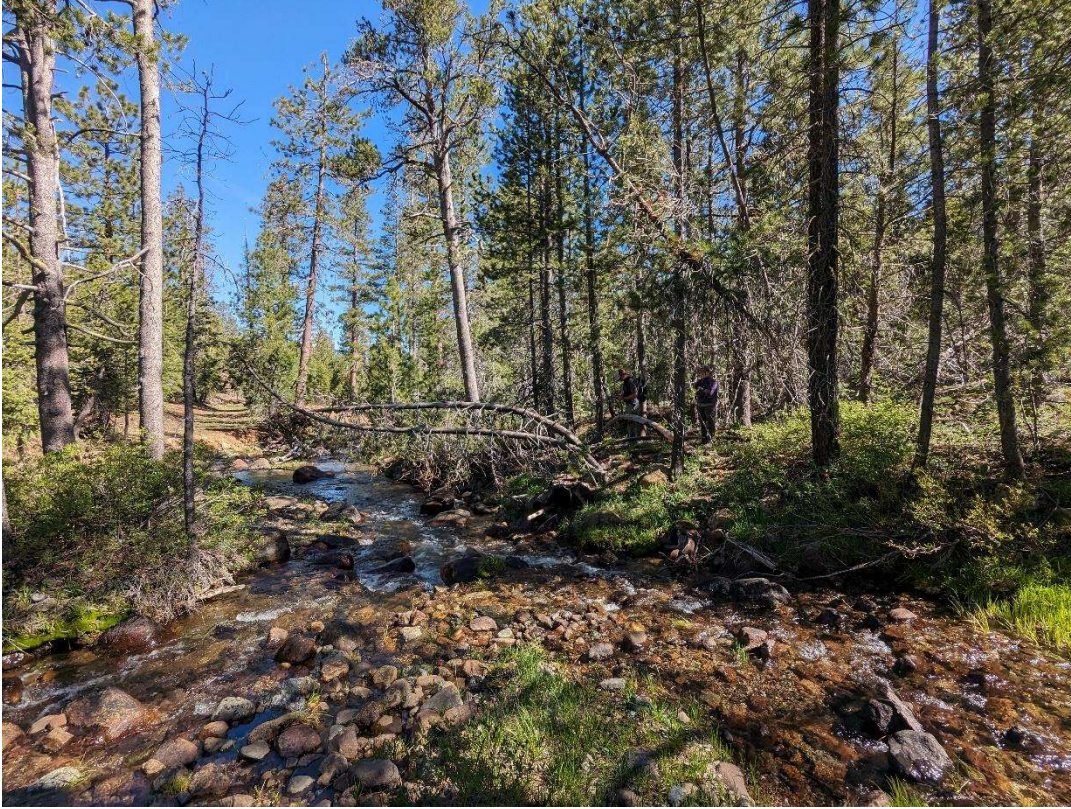
**Figure 4-46.** Looking downstream at STX-11. Legacy road fill protrudes into the channel along the right bank where the people are standing.

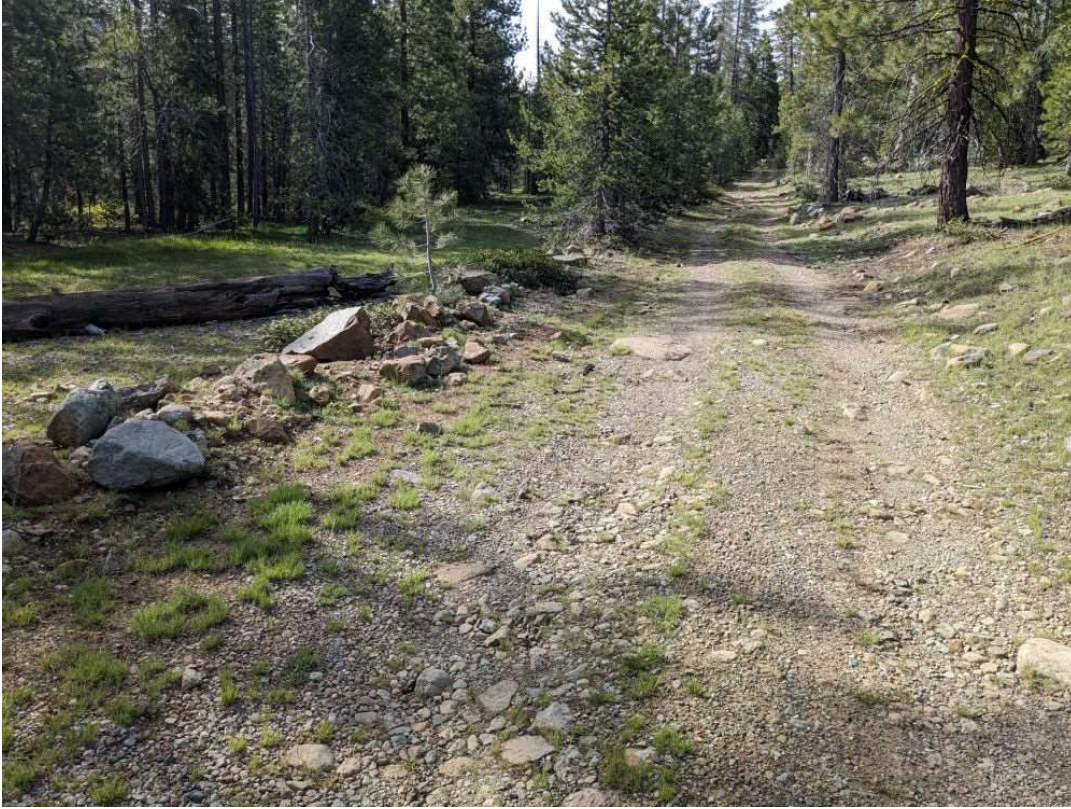
**Figure 4-47.** Looking south and upslope along road segment CM-17. An outboard berm is visible to the left which concentrates runoff on the road surface.

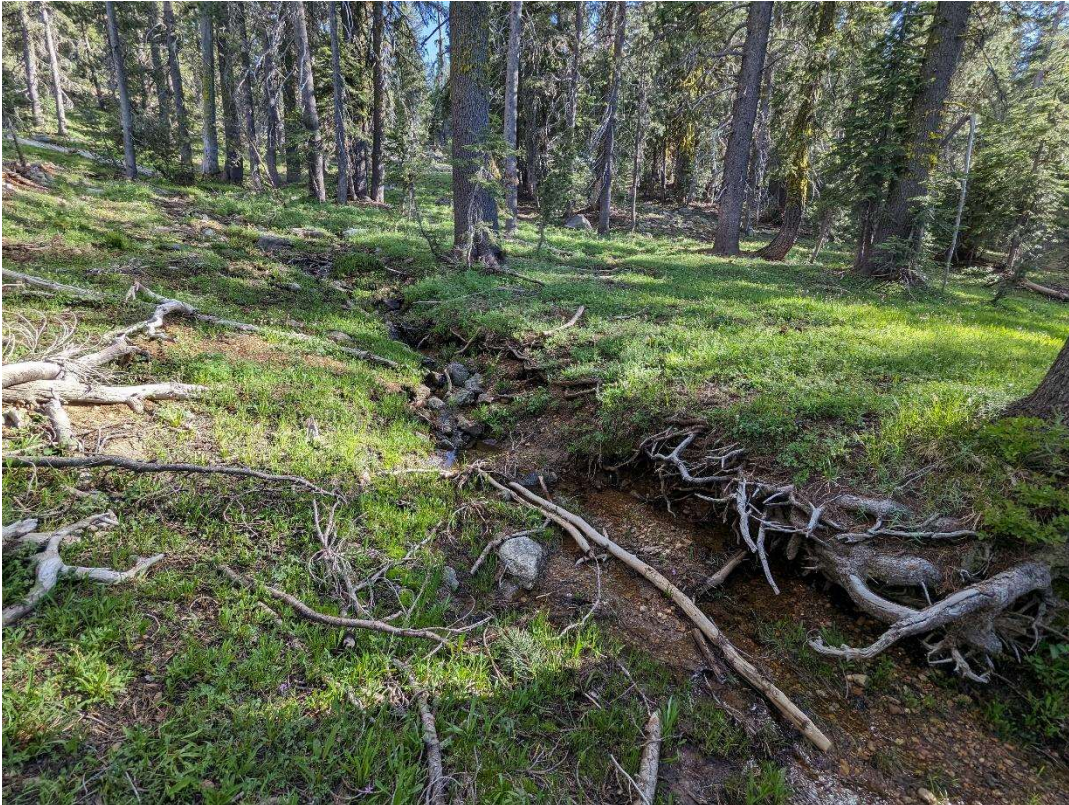
**Figure 4-50.** A watercourse which receives substantial road runoff from road segment RF-1 appears to show signs of active channel incision.

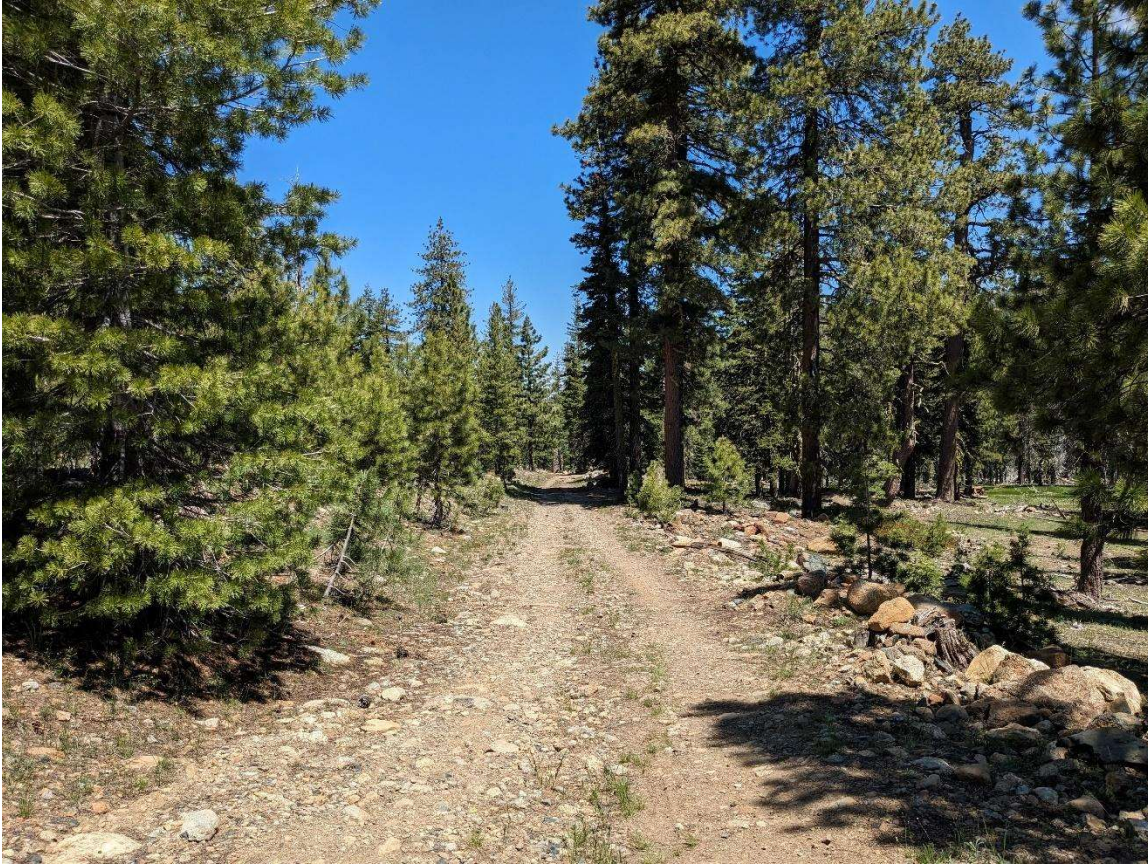
**Figure 4-51.** A representative section of road segment RF-2 looking north, showing the generally flat road profile and outboard berm which tends to concentrate flow from the western hillslope.

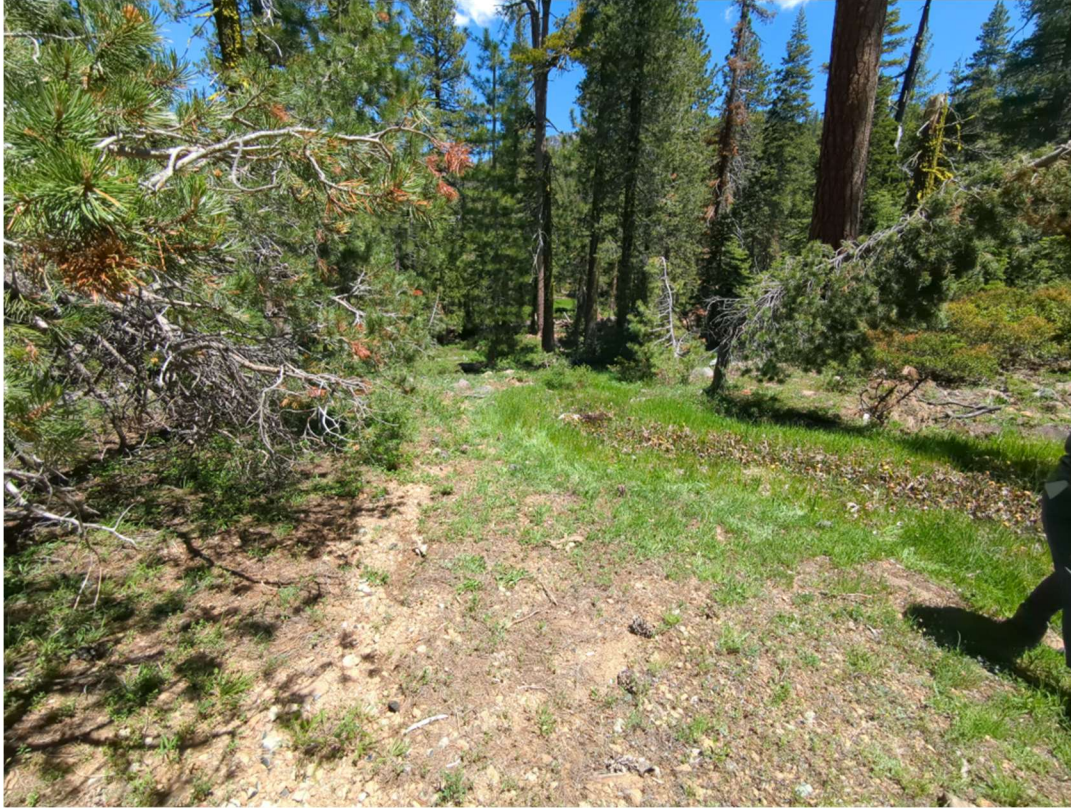
**Figure 4-52.** Concentrated runoff from road segment RF-9 has scoured vegetation along the left bank of a meadow watercourse.

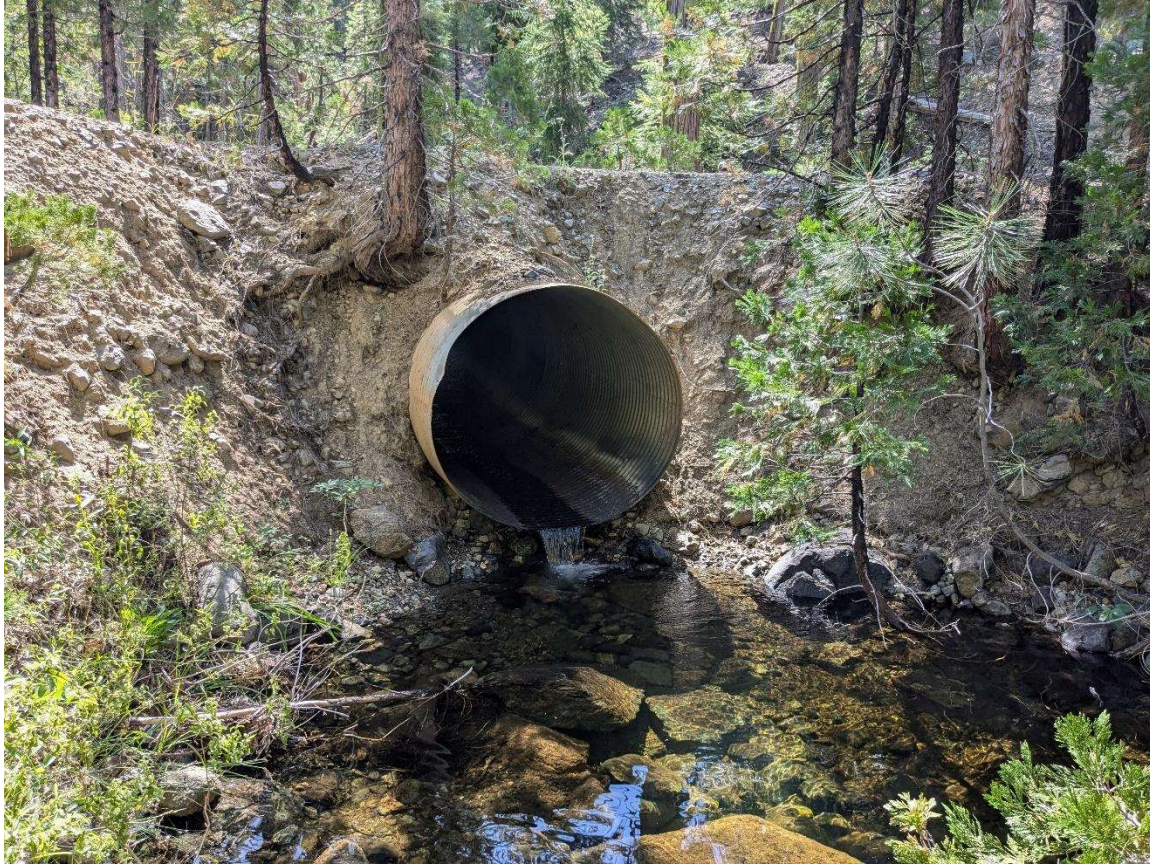
**Figure 4-53.** The outlet of STX-7. Severe erosion of the road fill prism is evident.

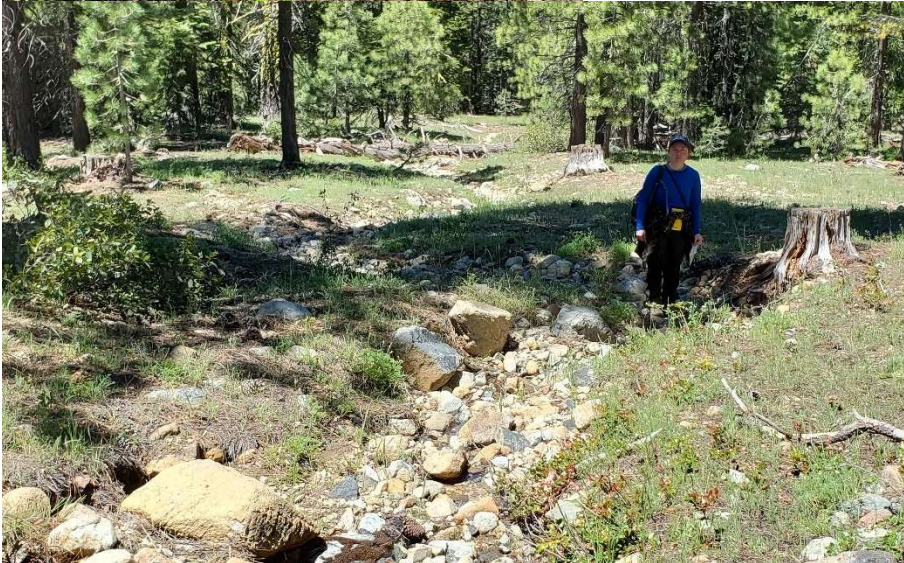
Figure 4-54. Ephemeral tributary channels in the upper portions of the Project basins.

There are a wide range of channel types represented within the Project Area. Channels are less defined in the upper portions of each project basin, comprised of a dense network of small seasonal and ephemeral tributaries emanating from within the valley floor and surrounding hillslopes (Figure 4-54). These channels are typically at the valley grade but may become incised one to three feet where affected by concentrated runoff from roads and other legacy land uses or where channel substrates are finer (e.g., sand and silt). The perennial mainstem channels range from boulder, cobble, and gravel bedded pool-riffle to cascade morphology (Figure 4-55). Channel morphology is typically controlled by glacial

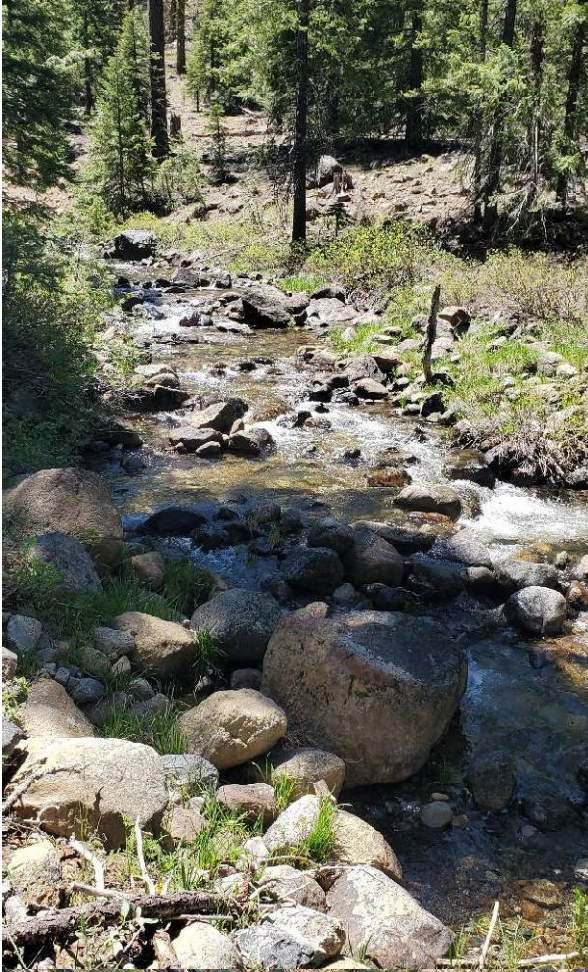
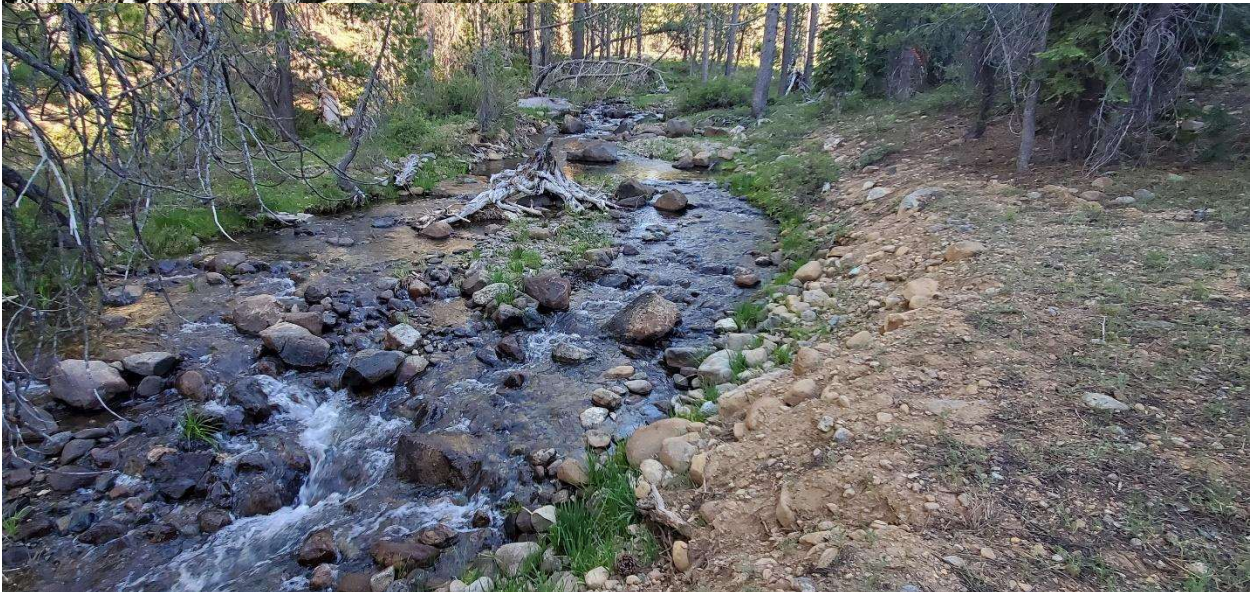
**Figure 4-55.** Perennial mainstem channels in the Project basins.

The mainstem channels are more meandering, contain more complex secondary floodplain flow paths and side channels, and are typically composed of finer gravel and sand substrates in lower gradient reaches (i.e., less than 2 percent). An analysis of points and/or channel segments where main channel flow may diverge into secondary flow paths across the floodplain (referred to as switch points) was conducted to inform channel and floodplain restoration and enhancement opportunities. The mainstem channels in both basins become incised four to eight feet in the more downstream portions of each Project Area. Additional assessment and description of site-specific channel conditions will be included for select reaches addressed in the restoration plans.

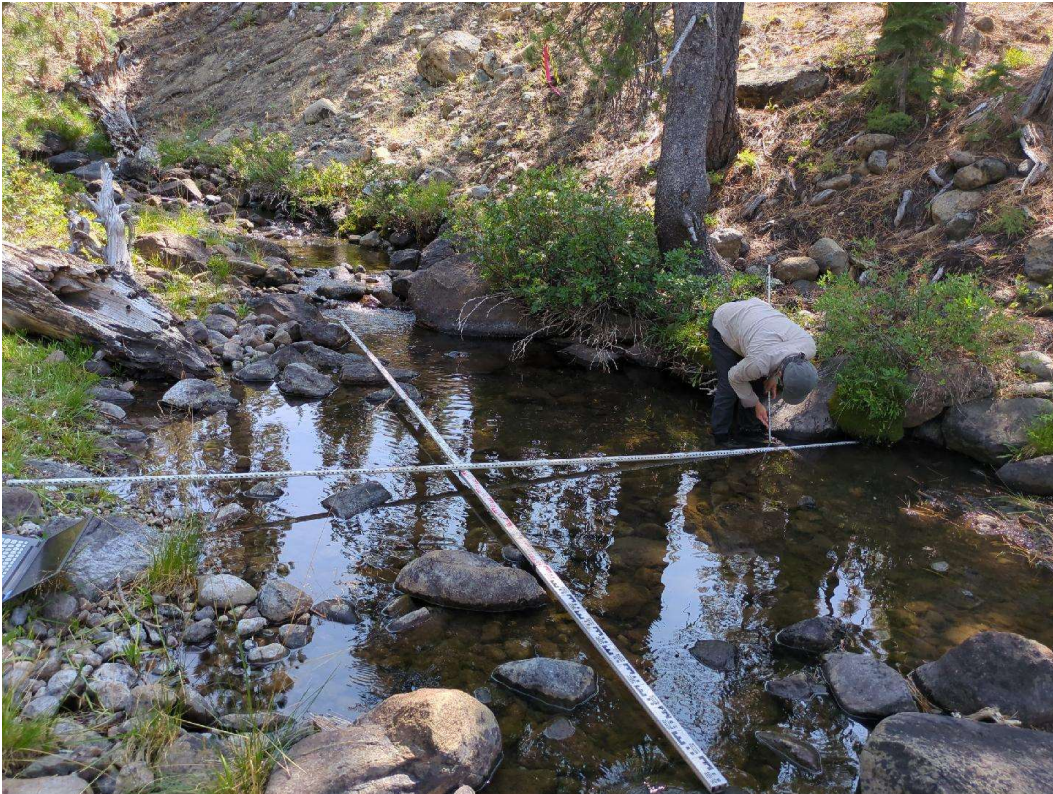
Figure 4-56.  $V^*$  survey of Pool 7.

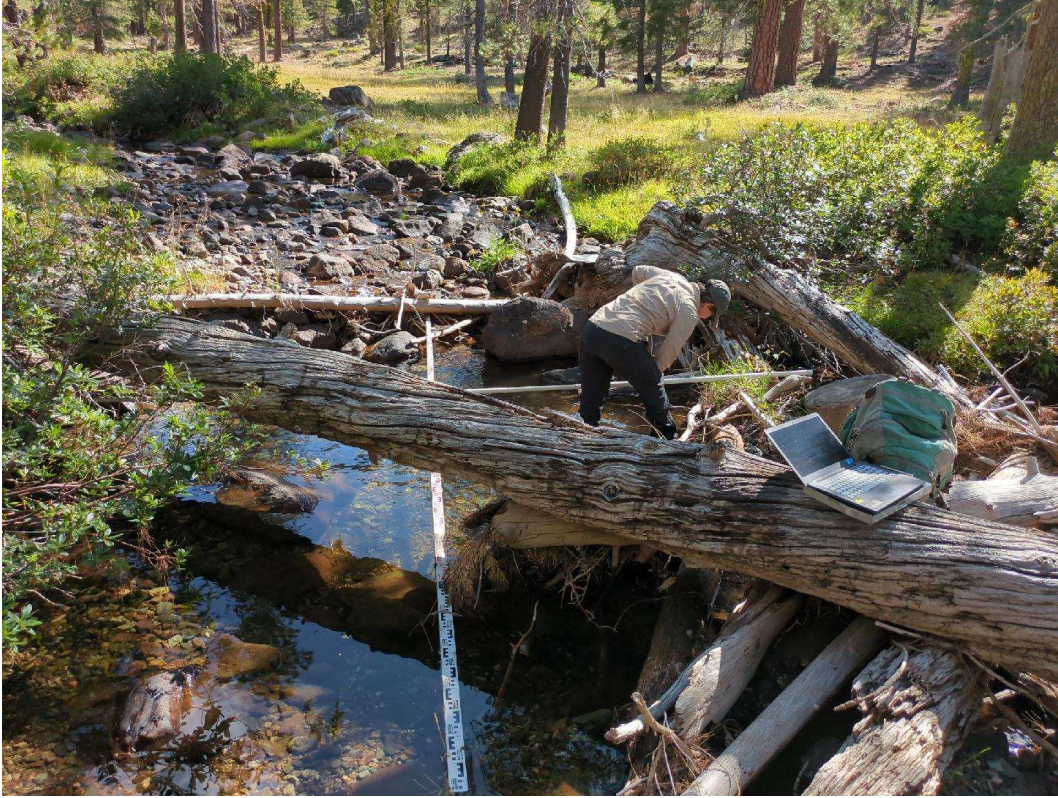
Figure 4-57. V\* survey of Pool 10.

In 2024 in-channel sediment deposition in pools was measured to create a baseline condition of sedimentation ahead of the 2025 winter and spring flows. Pools are defined as mostly still water with greater than three times the depth of the surrounding channel and a clearly defined riffle crest. The V star ( $V^*$ ) method (Lisle and Hilton 1992) was used to measure the volume of fine sediment and particulate that accumulated in every other pool encountered while walking up the main and some side channels through both).  $V^*$  is the fraction of the total pool volume occupied by fine sediment and was calculated for 12 pools in Cabin Meadow Creek and 11 pools in Rock Fence Creek. Six pools of the pools were behind recently constructed BDAs in Rock Fence Creek and the rest were naturally formed. See Figures 4-54 to 4-56 for images showing substrate and survey method.

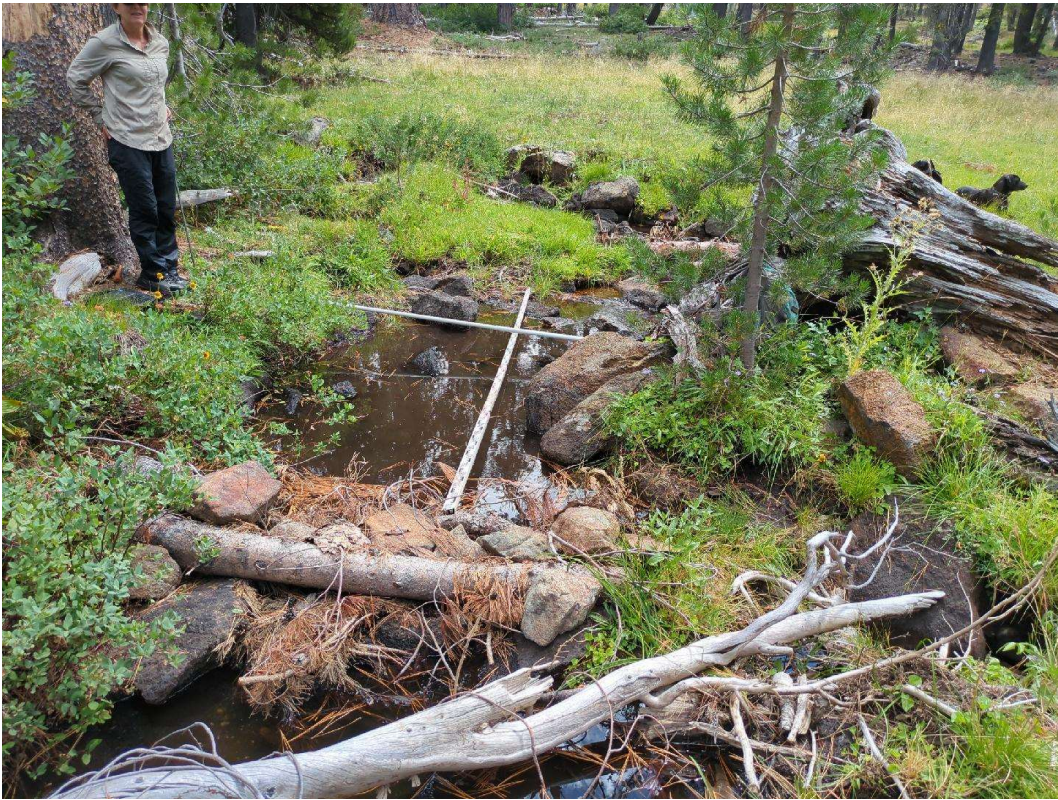
Figure 4-58. V\* survey of Pool S6.
