Beaver Valley Headwaters Preserve: SRWC Final Report

A Compendium of Natural Resource Information
Collected to Inform Management Decisions
Related to Riparian Habitat, Stream Channel
Restoration and Enhancement & Forest Health
Resiliency

*Prepared by Scott River Watershed Council
May 1, 2024*

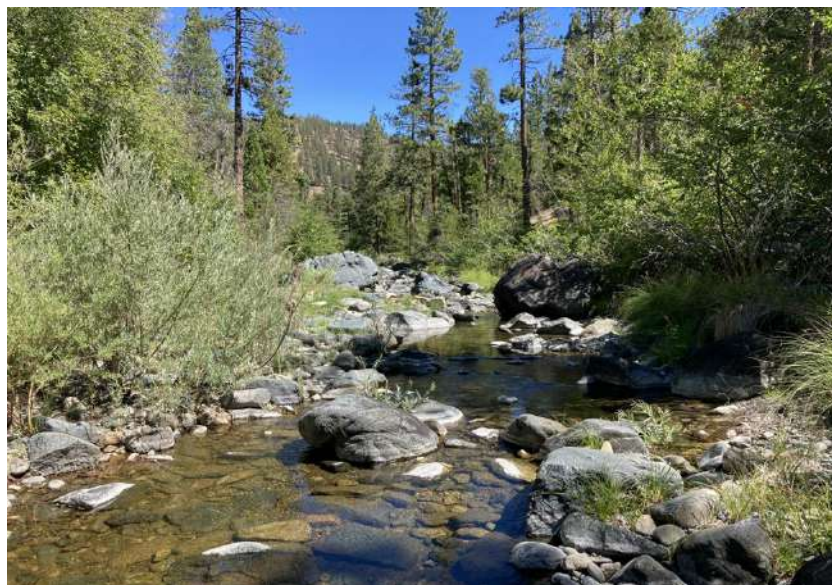
Photo 1.1: Transect EF-04 looking upstream at a healthy and diverse riparian understory along the banks of the East Fork. August 24, 2022.

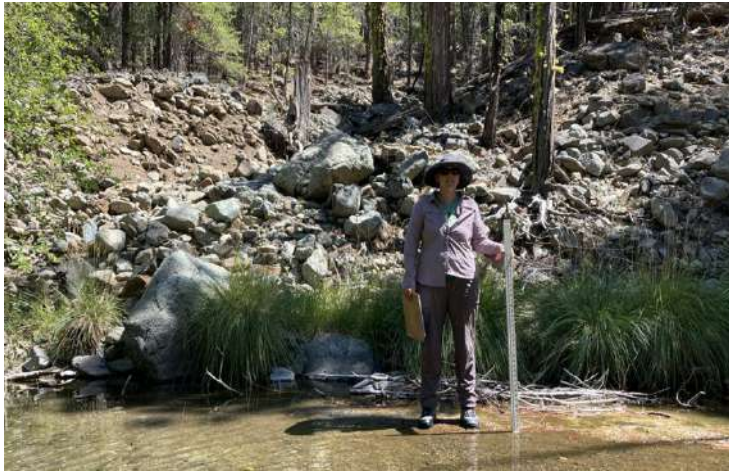
The first site where active erosion was documented in this reach is at transect EF-05, however, at this site the erosion was considered insignificant. But at the next transect (EF-06) severe and active erosion was documented (Photo 1.2). As illustrated in Figure 7, this is the site of a drainage entering the East Fork on river left that is causing instability of the streambank. In addition, due to the deposition of bedload into the East Fork from the unnamed gully, streamflow is impinged, creating a gravel bar and a large shallow pool which is likely subject to warming in the summer sun. While active erosion was documented at transect EF-07, this erosion was also considered insignificant.

Photo 1.2: Severely eroded gully located on river left at transect EF-06. August 24, 2022.

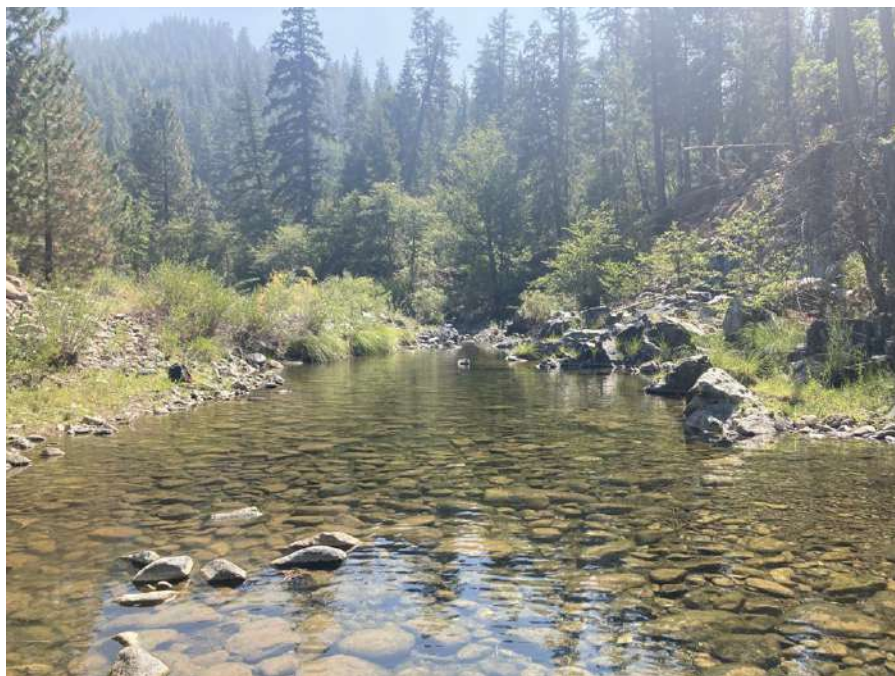
Erosion was also documented at transect EF-09 and it was considered moderate (Map 1.2). However, if left unchecked this erosion does have the potential to undercut the road at this location. The stream width at EF-10 widens significantly, likely due to changes in the topography, which provides a break to define the middle reach. The stream width at EF-09 is 19 feet and the width at EF-11 is 22 feet (Photo 1.3).

Photo 1.3: Photo taken at EF-11 looking upstream illustrates how the East Fork channel widens significantly as the topography changes. In addition, the riparian species diversity is more limited. September 1, 2022.

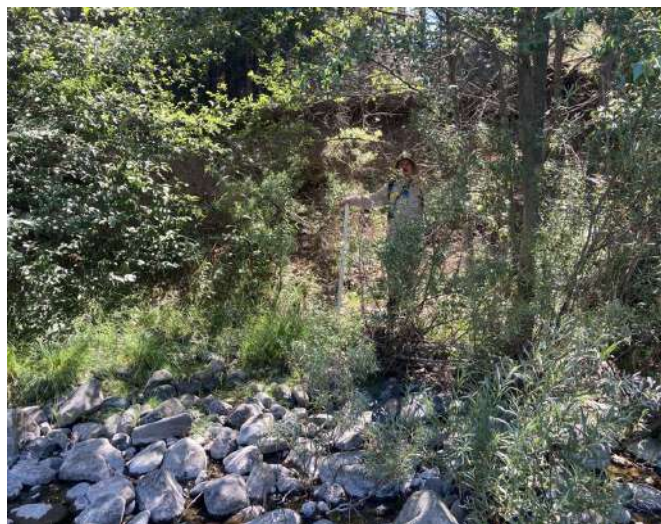
There is significant and severe erosion at transect EF-14 (Photo 1.4). Two types of erosion were observed here, a gully entering the East Fork Scott River and a large cut bank. The cut bank is approximately 12 feet high (Figure 1.4) and 165 feet long. There is a wide bar in the river due to depositional materials opposite the site of the erosion. Based on the topography the gully likely sends flashy flows into the East Fork and therefore, has created a cut bank. The erosion at EF-14 is addressed more completely elsewhere (Roads and Gullies in Chapter 2). At site EF-15, the field crews noted that the flows on September 1, 2022, were insufficient to keep the river connected and the flow goes underground. Cattle were observed in the creek at this location. As mentioned above and illustrated in Table 1.3, vegetation in the area is considered sparse.

Photo 1.4: Severe erosion site located at transect EF-14. September 1, 2022.

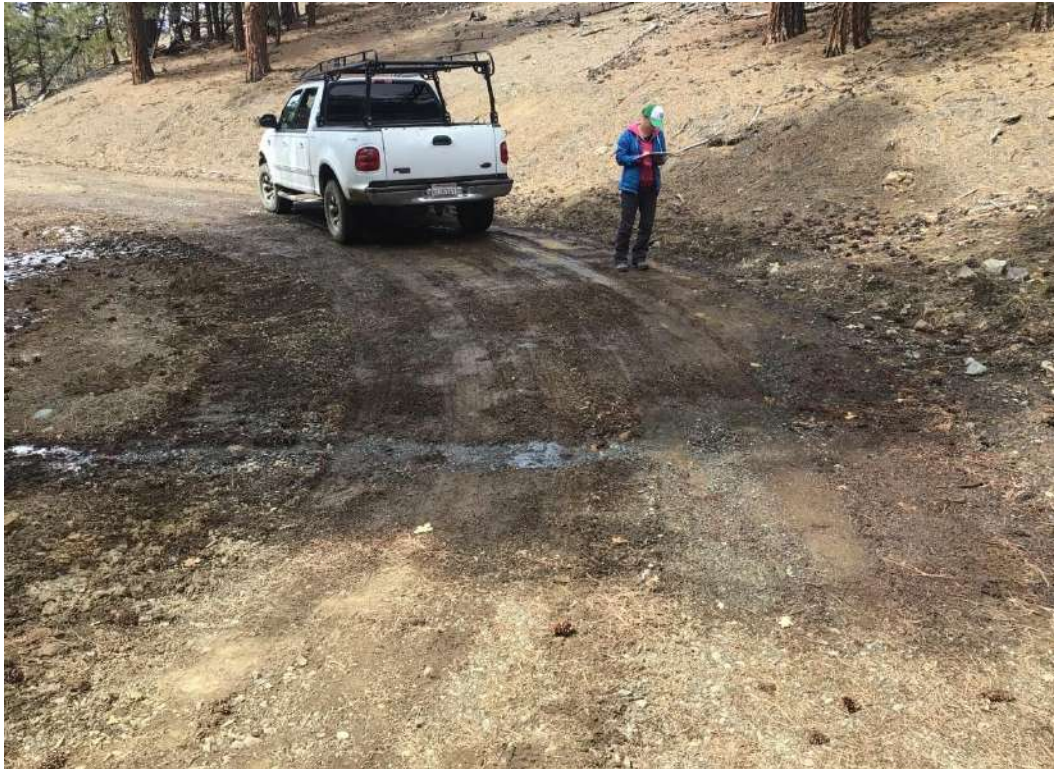
Photo 2.1: Example of mild erosion point. HRR20, April 18, 2023.

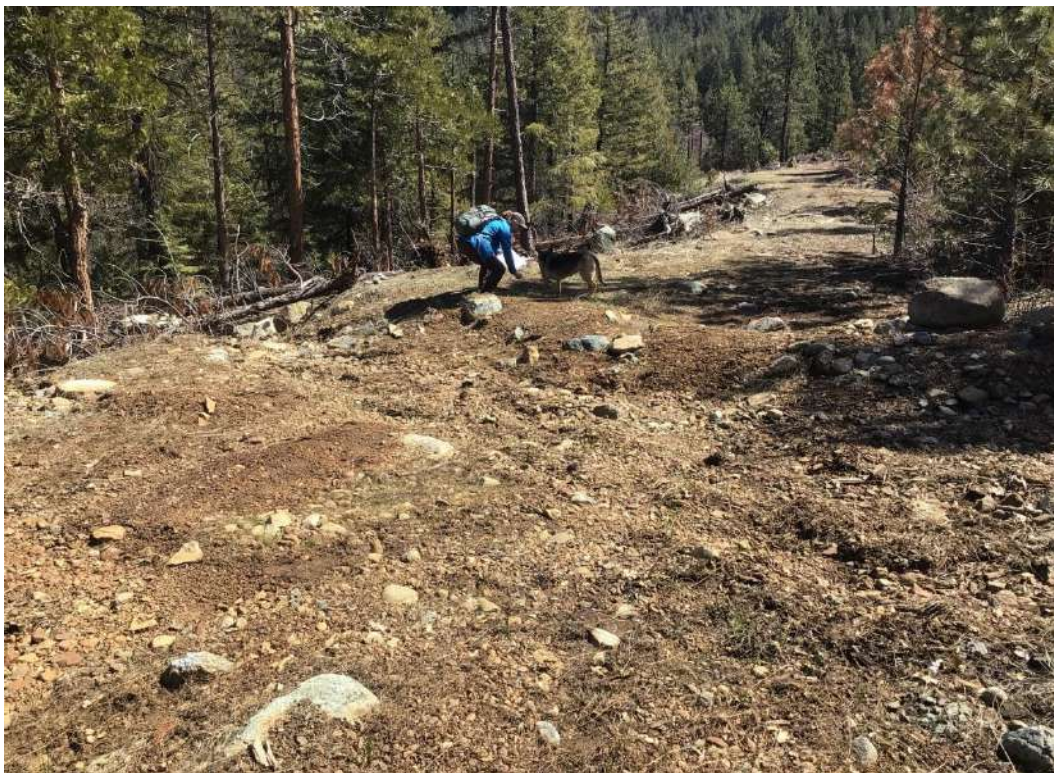
Photo 2.2: Example of moderate erosion point. EFR11.2, April 13, 2023.

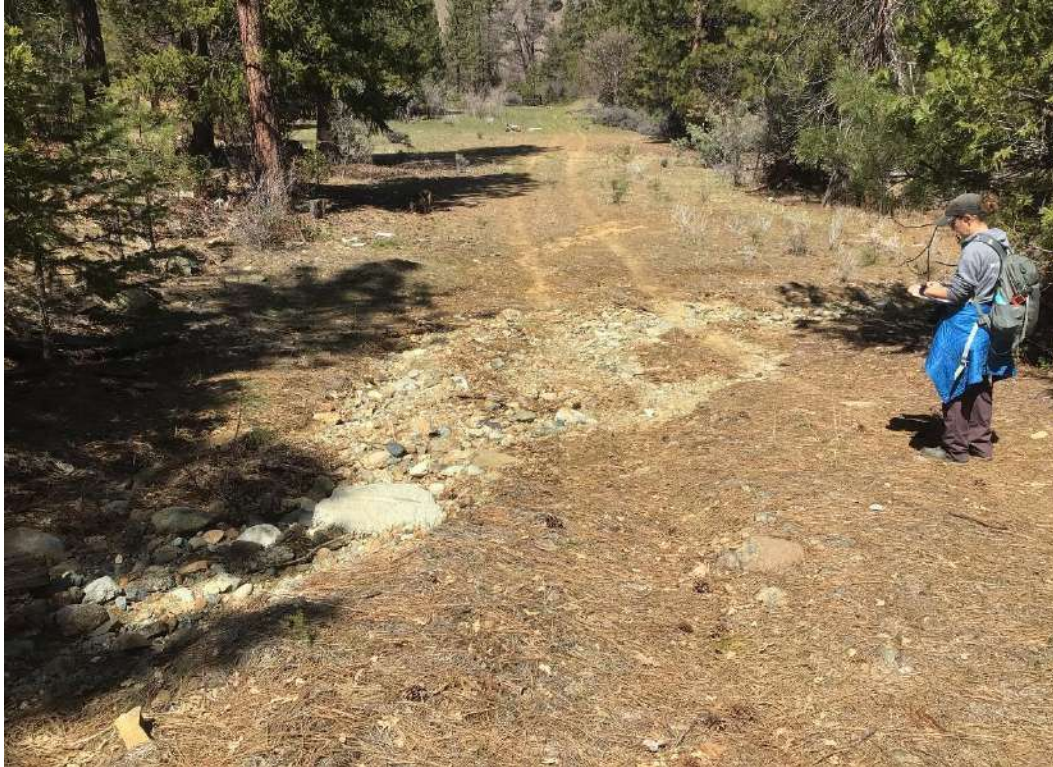
Photo 2.3: Example of extreme erosion point, EFR13.1; April 13, 2023.

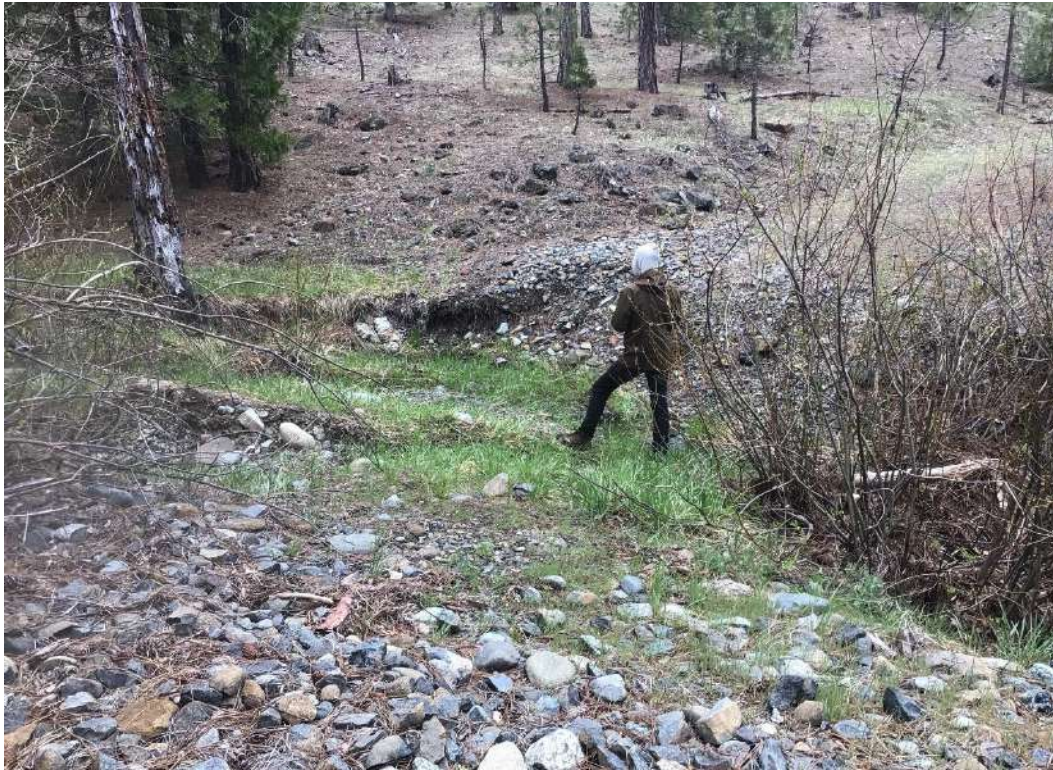
Extreme road or fill erosion were identified at 19 points. Of those, 12 were associated with gullies (Table 2.3) and will be incorporated into the gully analysis. Five of the remaining seven points did not discharge sediment to a stream or gully connected to a stream. Two of them are points where a road crosses an unnamed tributary that enters Noyes Valley Creek at RKM 1.6 (Photo 2.4 & 2.5).

Photo 2.4: Road crossing unnamed tributary to Noyes Valley Creek. EFR30. May 5, 2023.

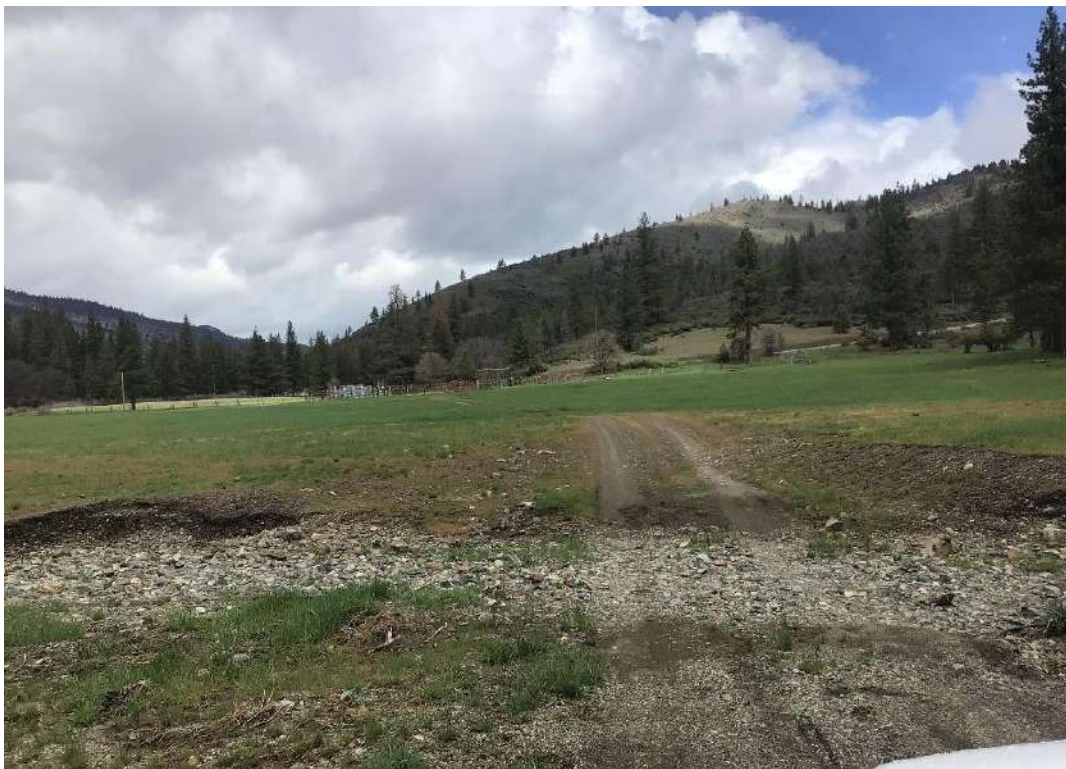
Photo 2.5: Road crossing unnamed tributary to Noyes Valley Creek. EFR49. August 5, 2023.

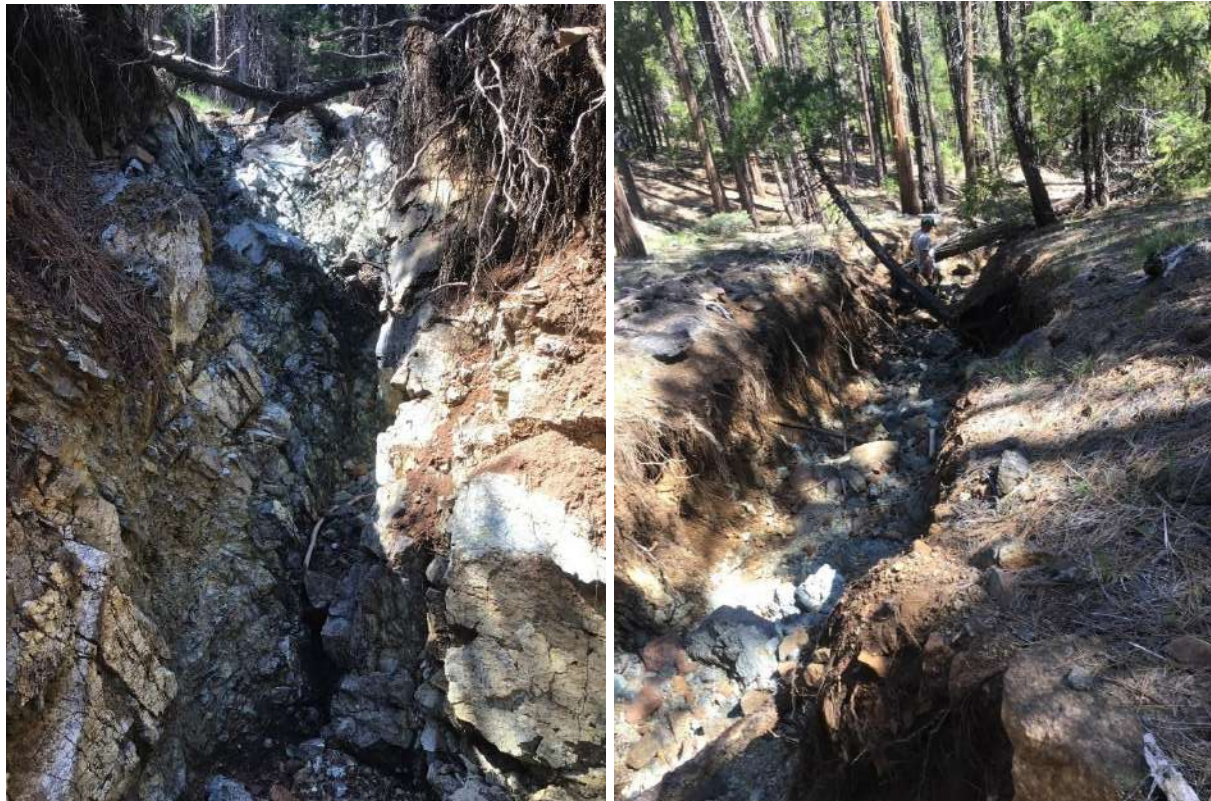
Gully Complex 12 (Table 2.7) begins where a culvert under Highway 3 and an outboard ditch discharge water into the same area. It bifurcates once and the two segments discharge at roughly the same place into Mule Creek, which converges with the East Fork Scott River, approximately 160 feet downstream. Gully Complex 12 only crosses a road once, at the confluence of the two segments, but erosion at that point was rated extreme (Photos 2.13 and 2.14).

Photos 2.13 and 2.14: Greatest cross-section of Gully Complex 12 is 32 ft²; looking up and down the gully at that point. EFG12b; May 23, 2023.

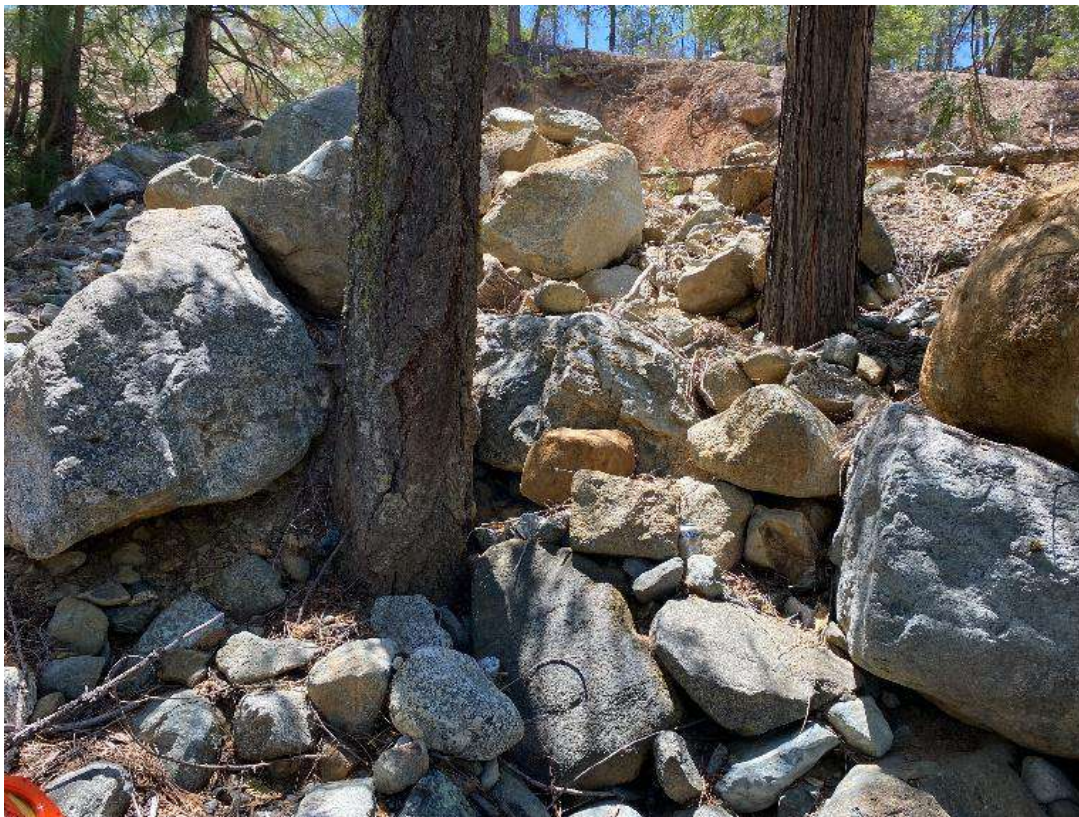
Gully Complex 5 (Table 2.8) originates at two points: a culvert and an outboard ditch, both associated with Highway 3 (Photo 2.15). It consists of three segments that converge as they cross the private road (Photo 2.16), at a point with extreme erosion, and then discharges into the East Fork of the Scott River.

Photo 2.15: Below Highway 3 outboard ditch. EFG6.5.2c; June 2, 2023.

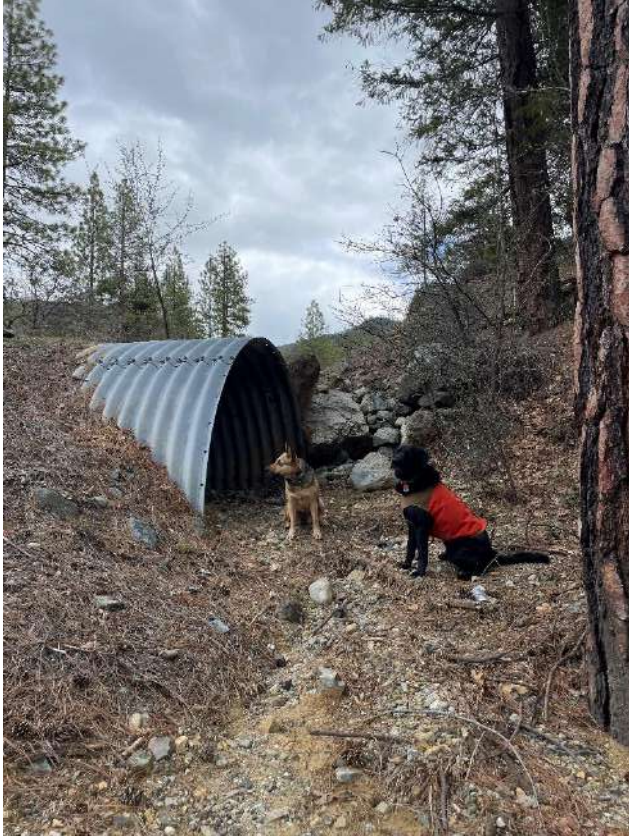
Gully 24 (Table 2.9) begins where the inboard ditch on Highway 3 flows past the mouth of a culvert instead of being directed into the culvert (Photo 2.17). Gully 24 continues on the inboard side of the highway, crosses the private road dirt road (extreme erosion) (Photo 2.18) and cuts down the bank to discharge in Big Mill Creek (Photos 2.19 and 2.20). Big Mill Creek joins the East Fork Scott River about 90 feet downstream.

Photo 2.17: Beginning of EFG 24. Inboard ditch flows past culvert. EFG24a; April 5, 2024.

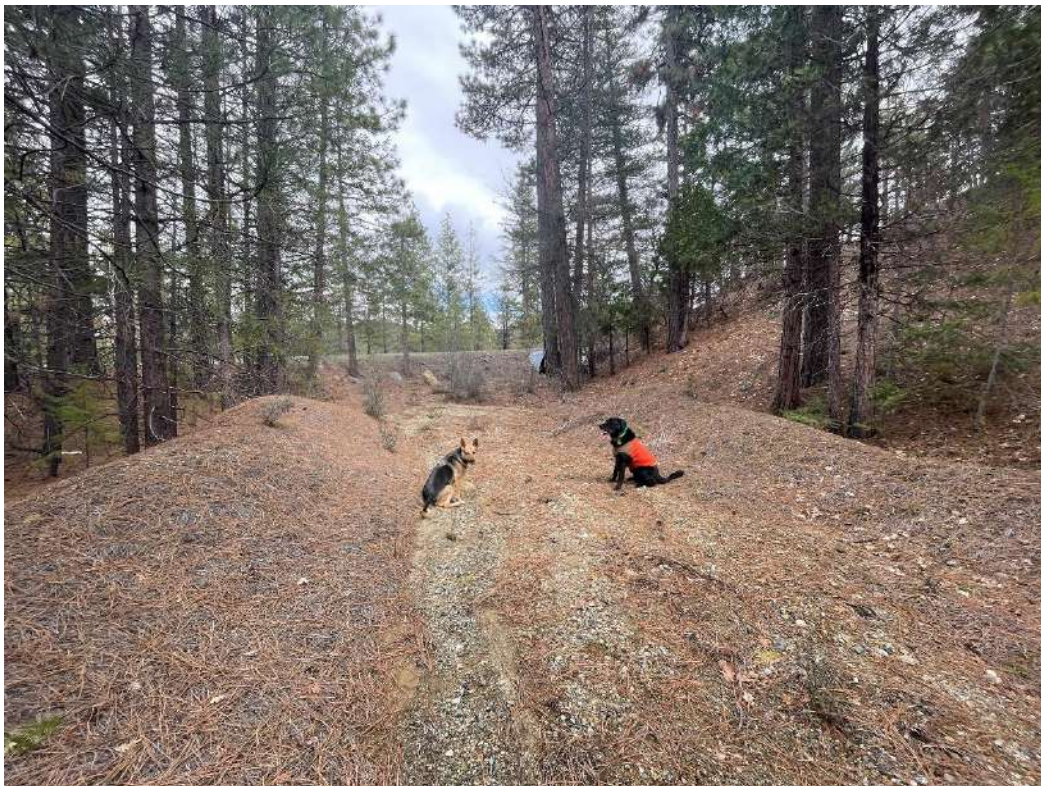
Photo 2.18: EFG 24 downstream of bypassed culvert. April 5, 2024.

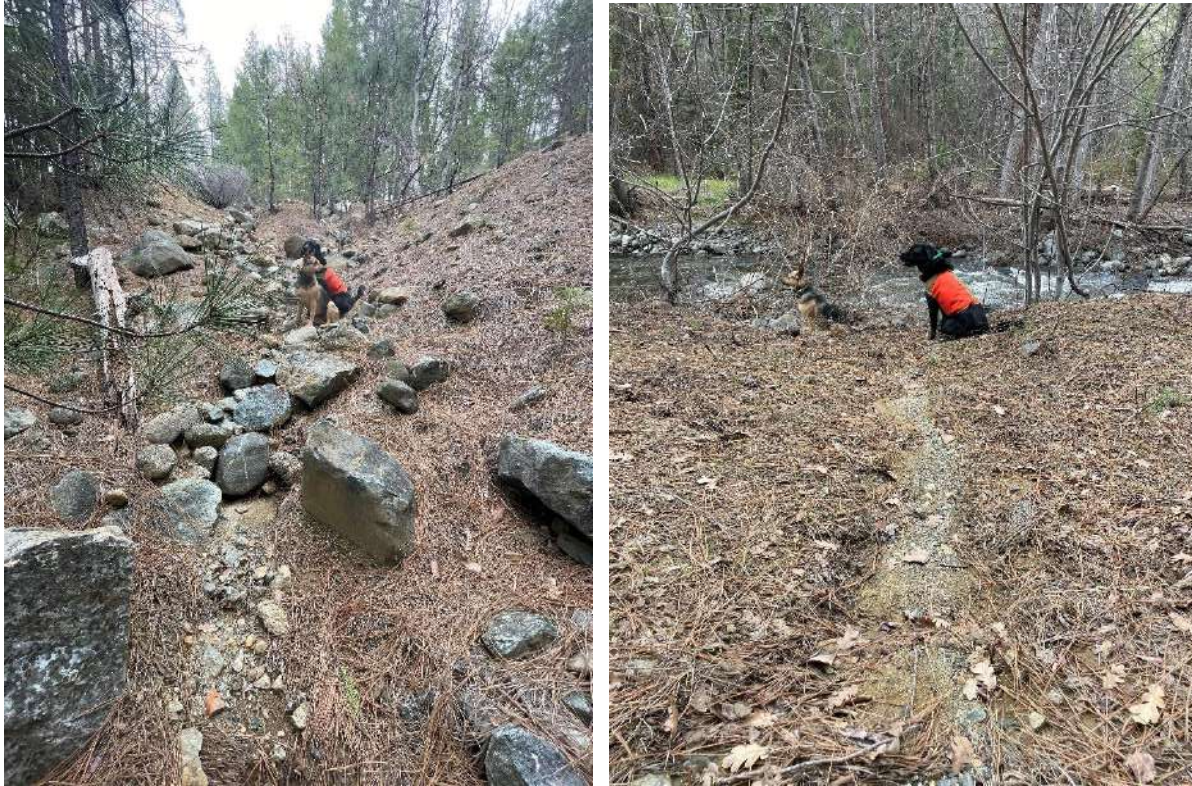
Photos 2.19 and 2.20: EFG 24 below private road. EFG24b (left photo); EFG 24 discharges into Big Mill Creek. EFG24e (right photo). April 5, 2024.

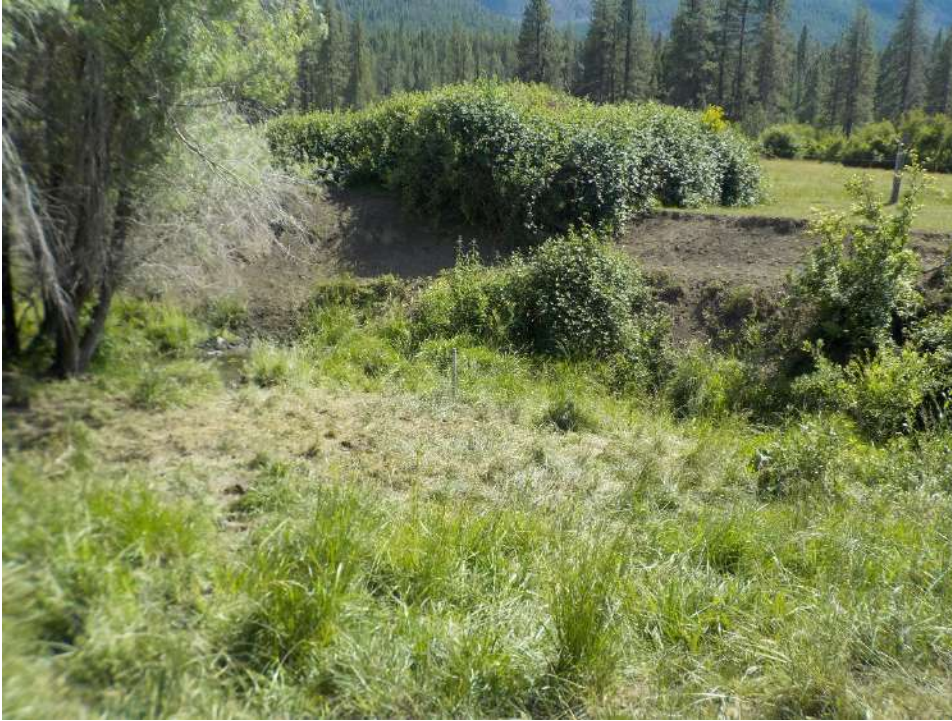
Photo 6.6: Limited riparian vegetation with blackberry encroachment and actively eroding stream bank. June 21, 2023.

The SRWC installed cattle exclusion fencing along the East Fork Scott River and two stock water systems in the fall of 2022. Cattle exclusion fencing along Noyes Valley Creek is proposed (Map 6.15). Restoration designs are being developed for Lower Noyes Valley Creek with a potential realignment of the downstream section and confluence with the East Fork Scott River.

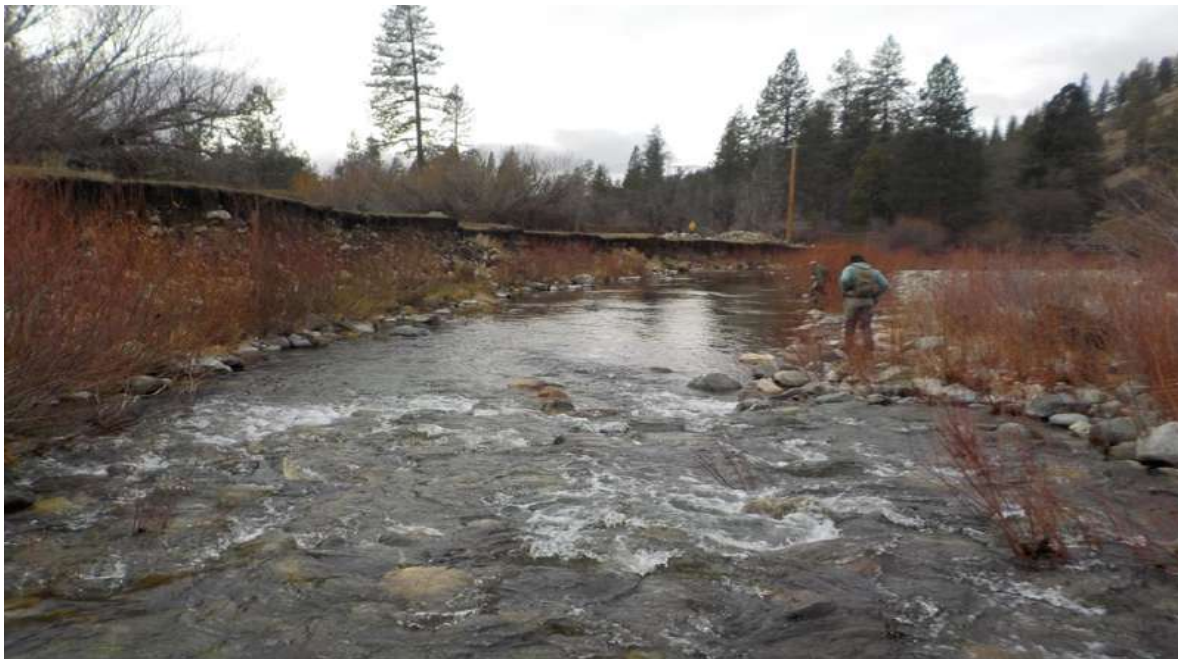
Cutbank at RKM 4.2 with thin band of willow on river left and river right bar - looking downstream

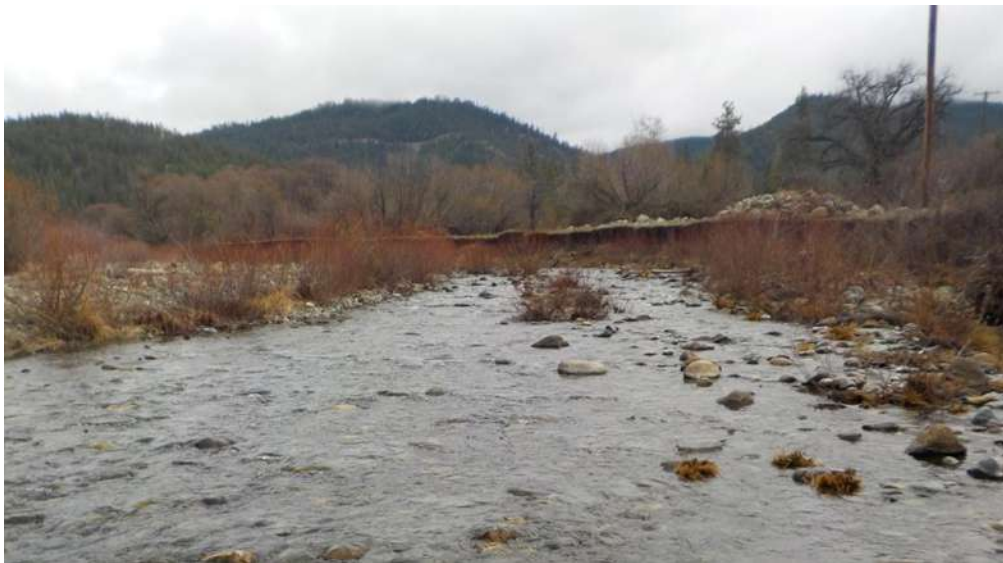
Cutbank at RKM 4.2 - looking upstream - December 2022

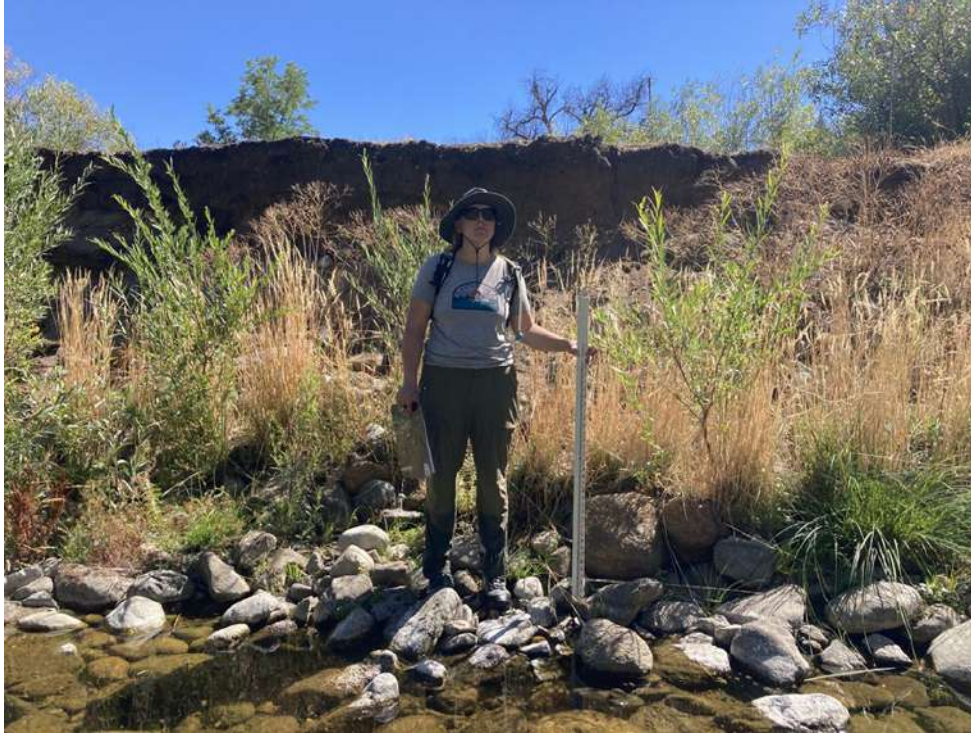
Cutbank at RKM 4.2 - illustrating riparian vegetation at toe of eroding bank

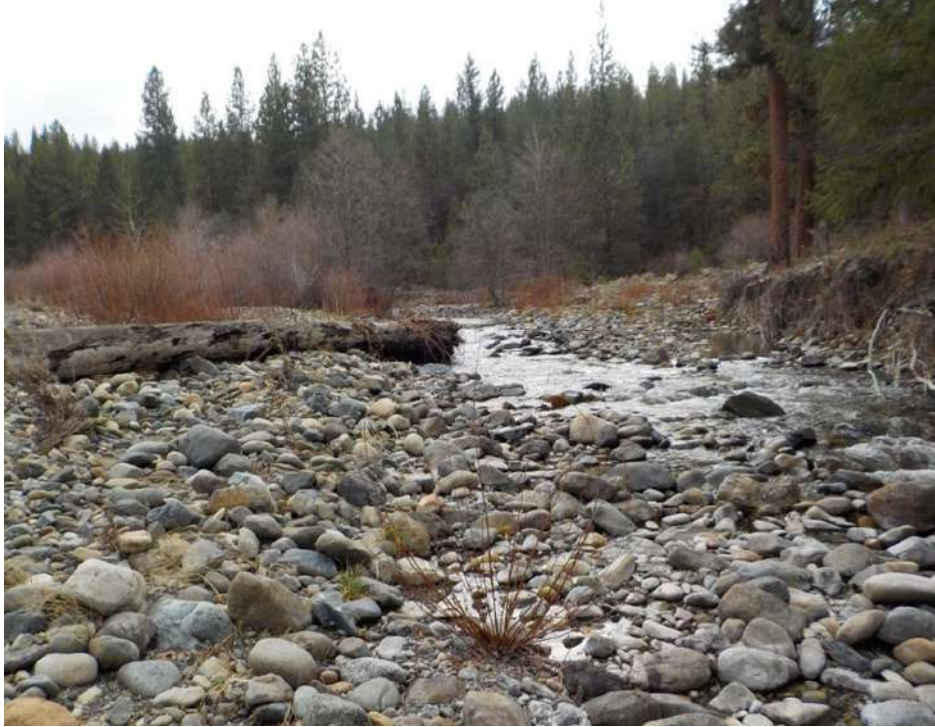
Upstream end of incised channel at RKM 5 with river left cutbank - looking upstream

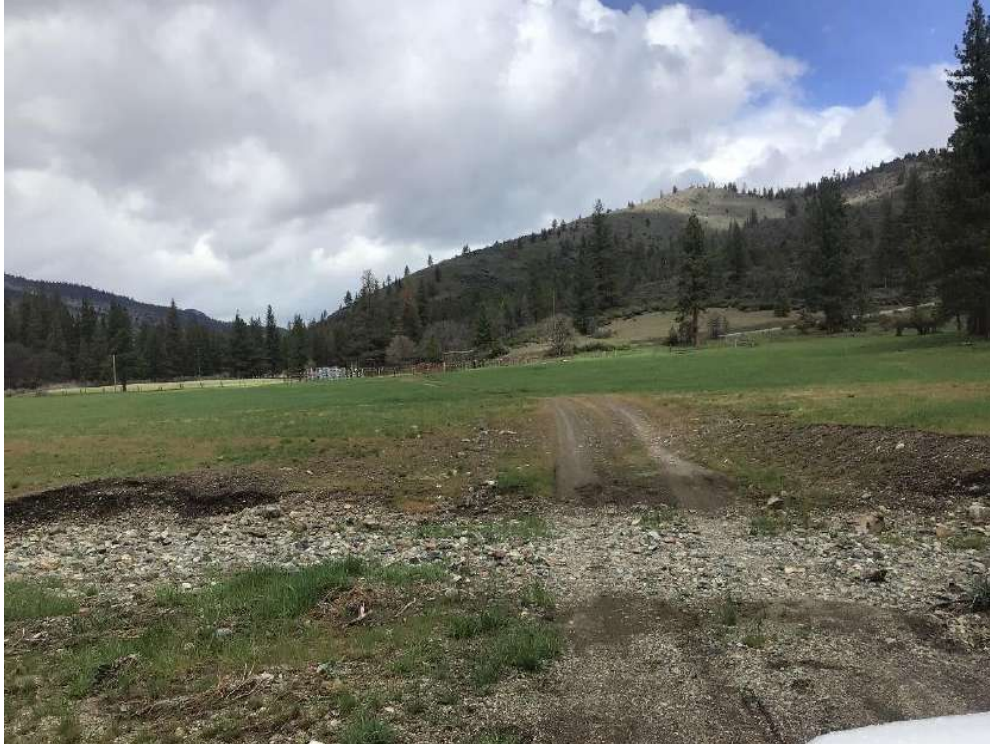
Photo 2.2: road crossing Gully Complex 49 (natural stream). EFR49. August 5, 2023.

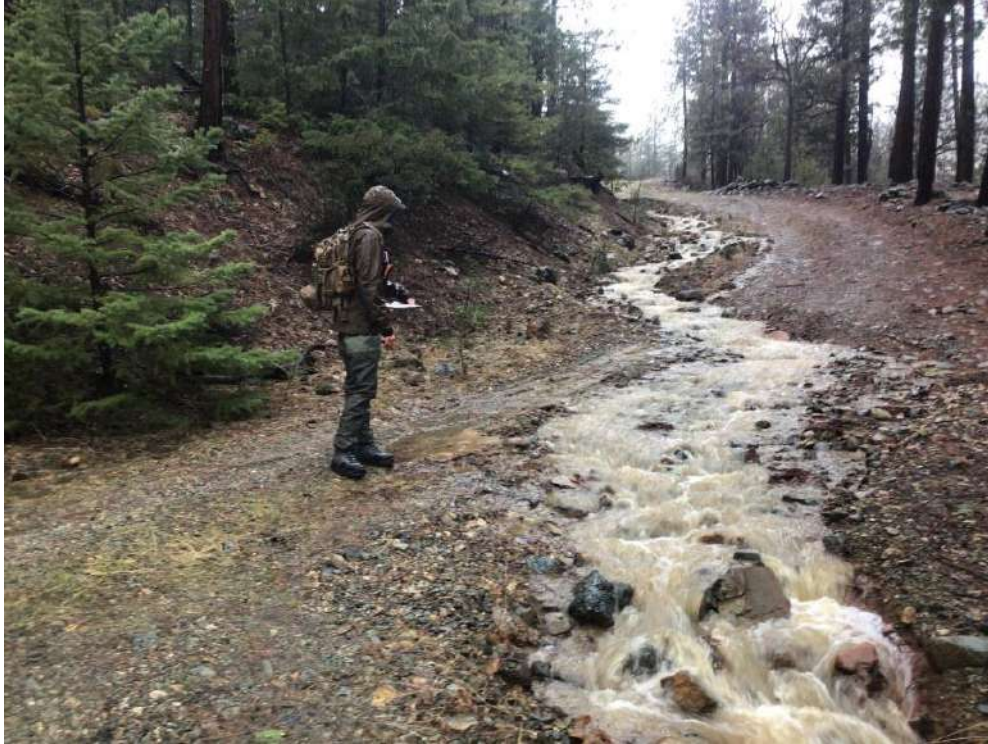
Photo 2.5: Water during runoff event crossing road, looking upslope. EFR2. January 13, 2023.

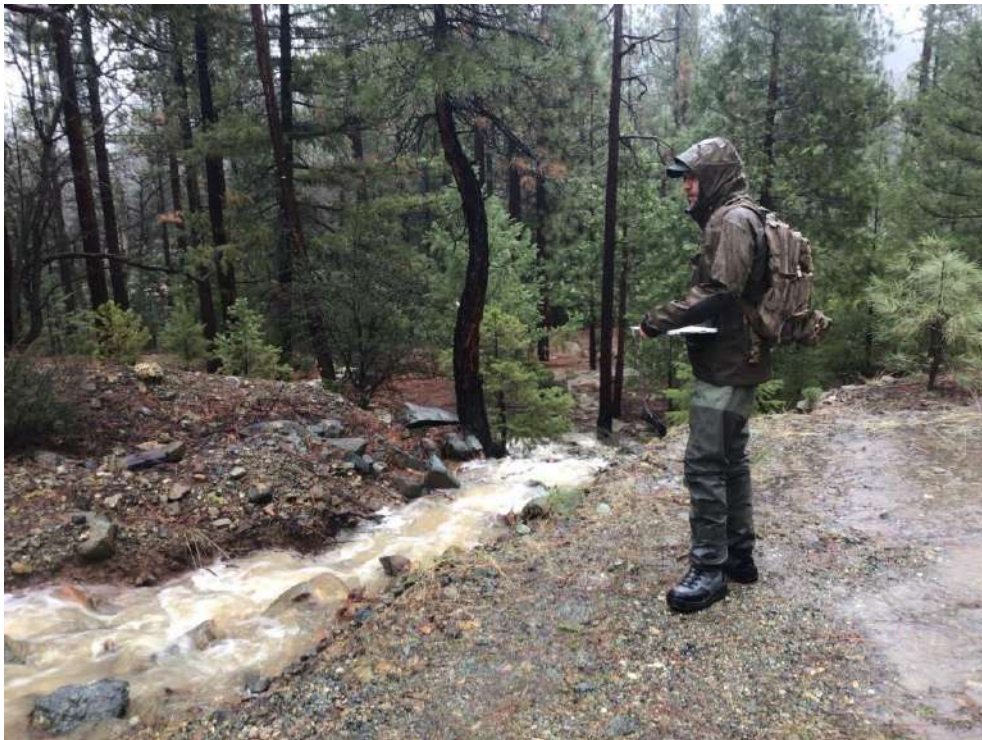
Photo 2.6: Erosion of road fill. EFR2. January 13, 2023.

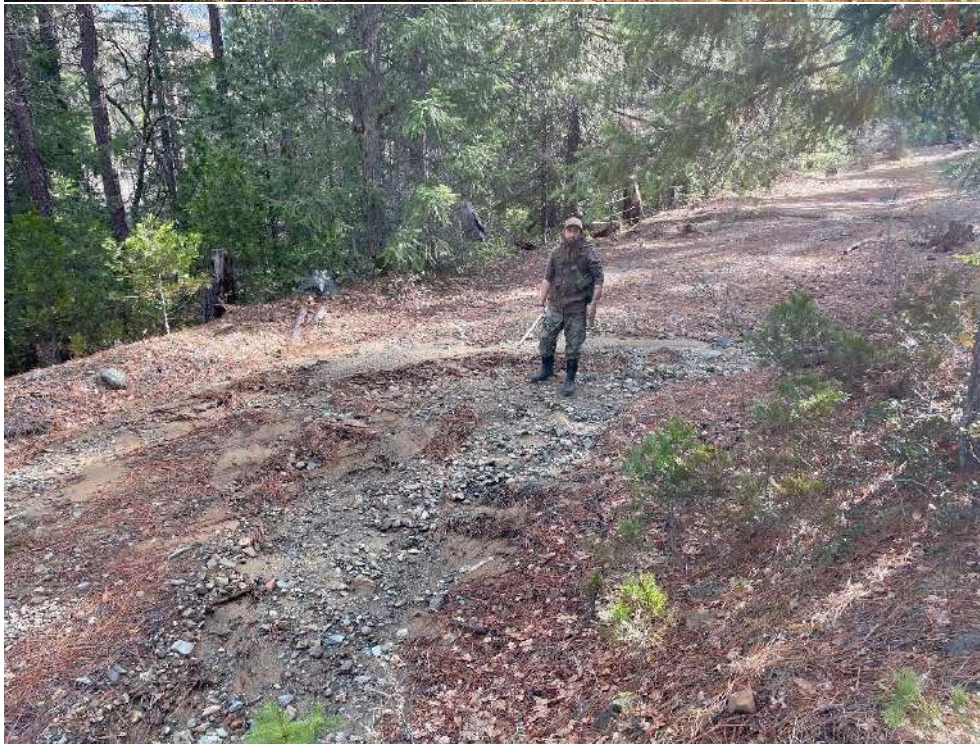
Photos 2.8 & 2.9: Flow path on road. EFR14; January 20, 2023. EFG2e. January 19, 2024.

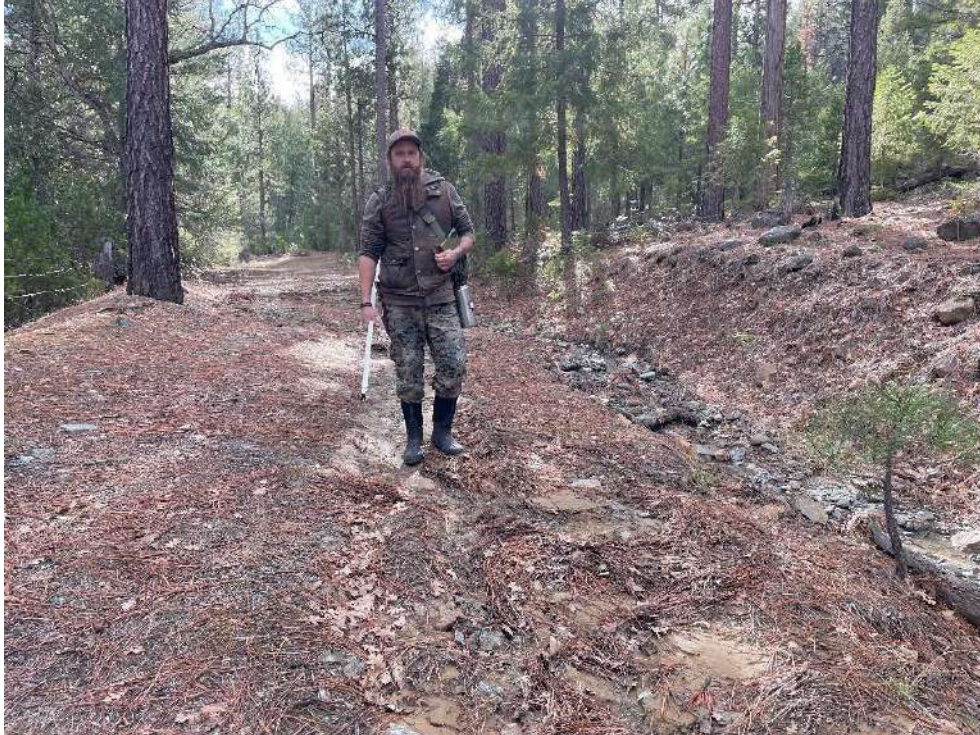
Photo 2.10: Flow divided between road and un-engineered inboard ditch. EFG2e. January 19, 2024.

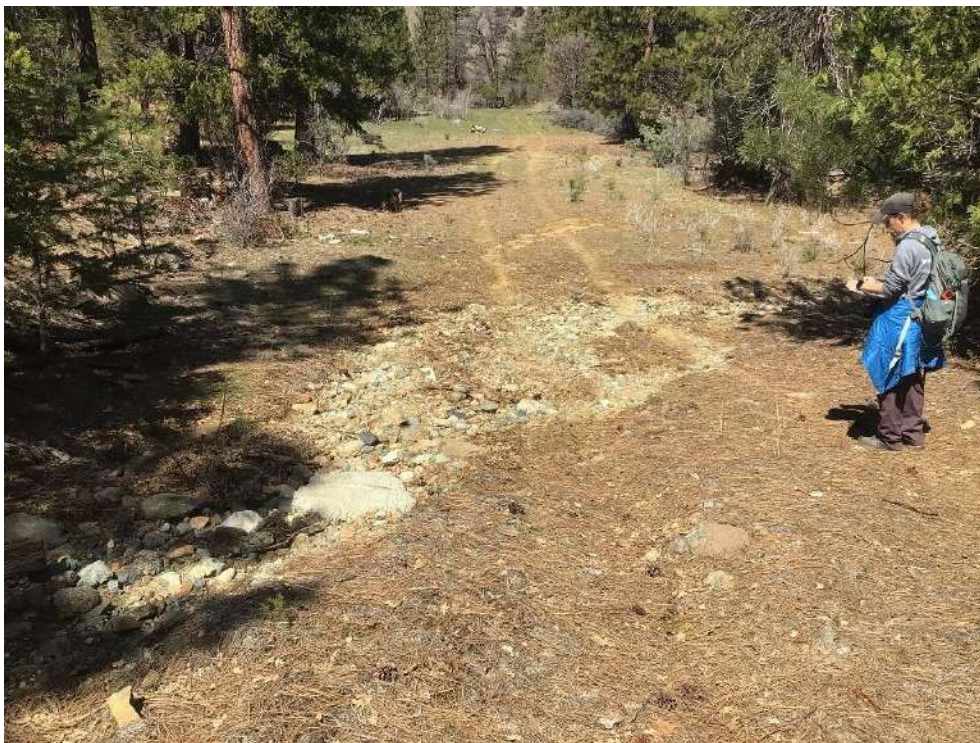
Photo 2.11: Gully 2 crosses road again. EFR13.1. April 13, 2023.

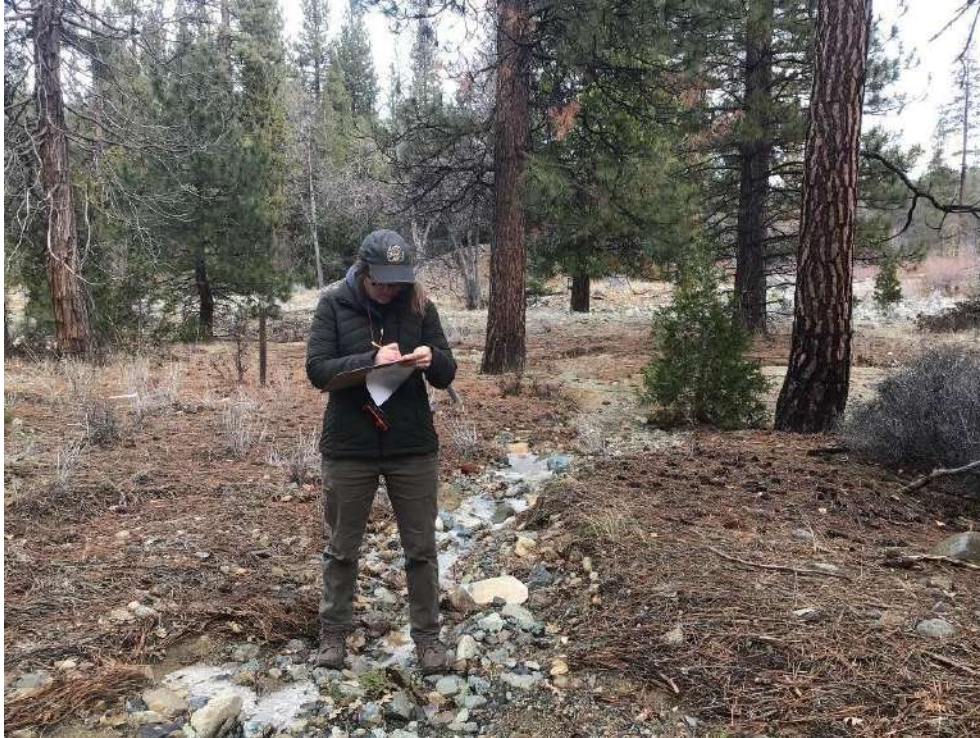
Photo 2.12: Flow path leaving road. EFR13.1. February 10, 2023.

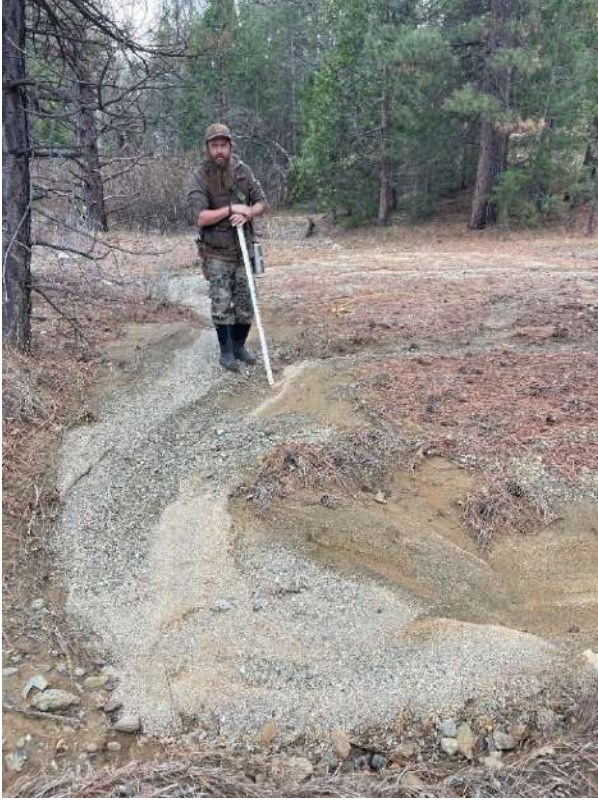
Photo 2.13: Sediment deposited by Gully Complex 2. EFG2f. January 19, 2024.

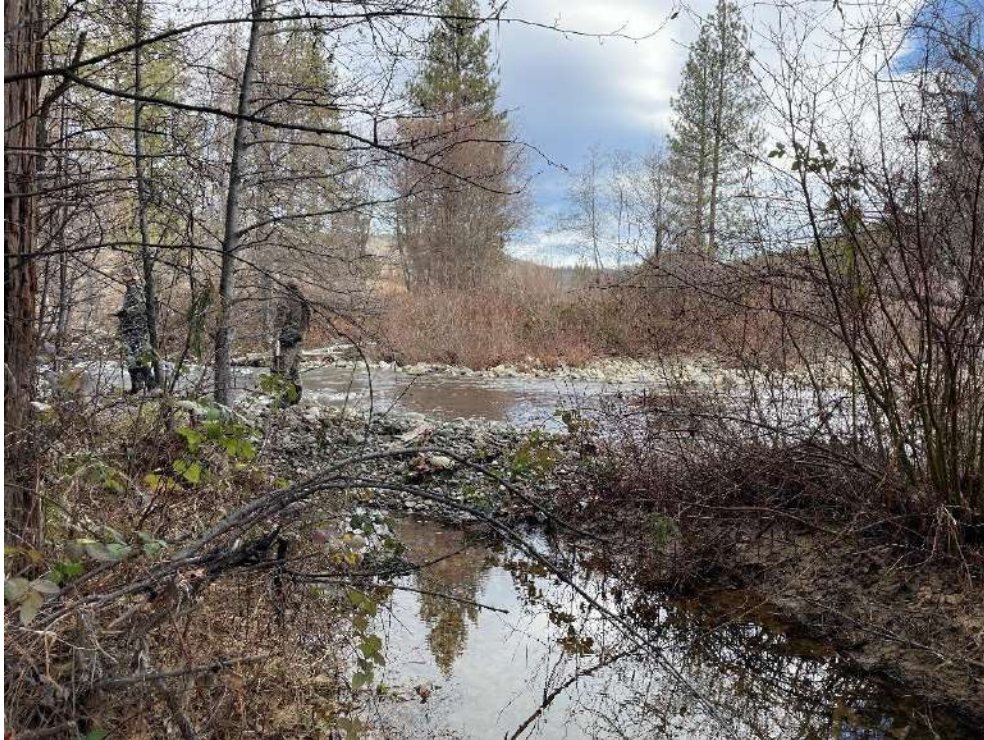
Photo 2.16: Gully Complex 2 discharges into the East Fork Scott River. EFG2j. January 19, 2024.

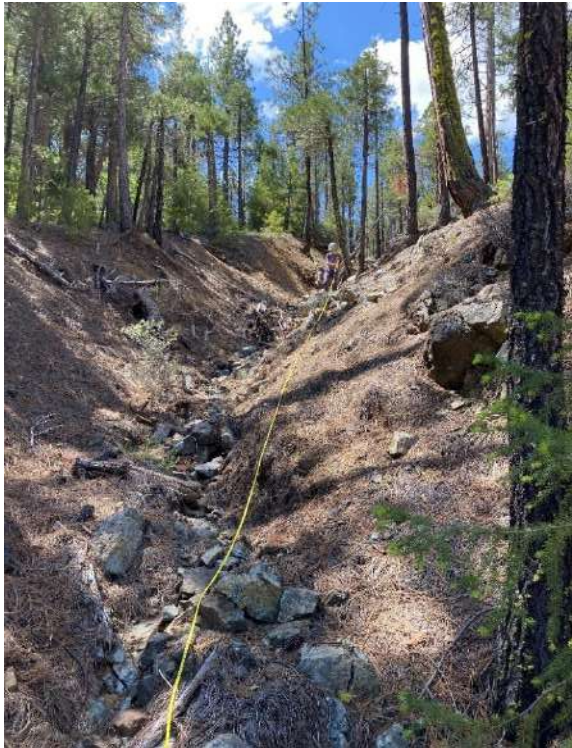
Photos 2.19, 2.20 & 2.21: Gully 8 above Highway 3. EFG8c, EFG8d and EFG8.; May 29, 2023.

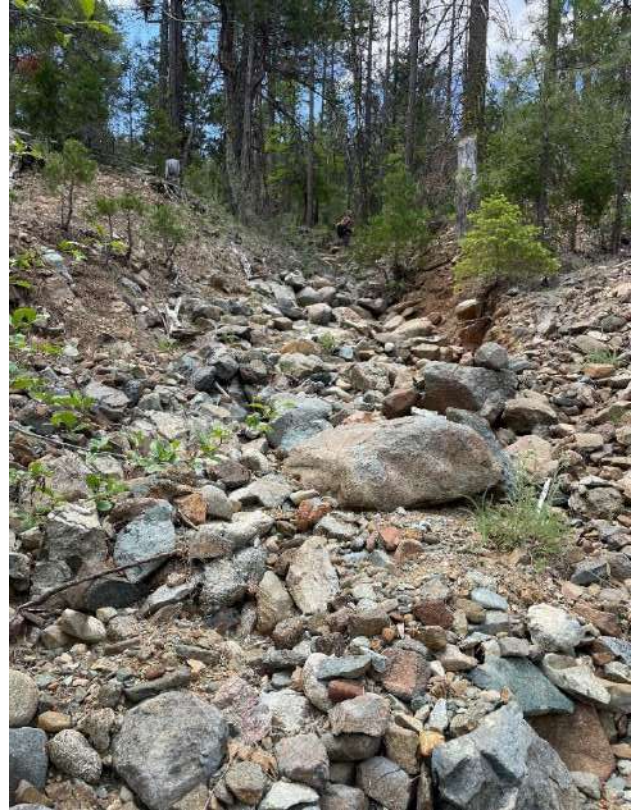
Photo 2.30: Looking upslope from the confluence of EFG 8.2 and the East Fork Scott River. EFG8j. April 5, 2024.

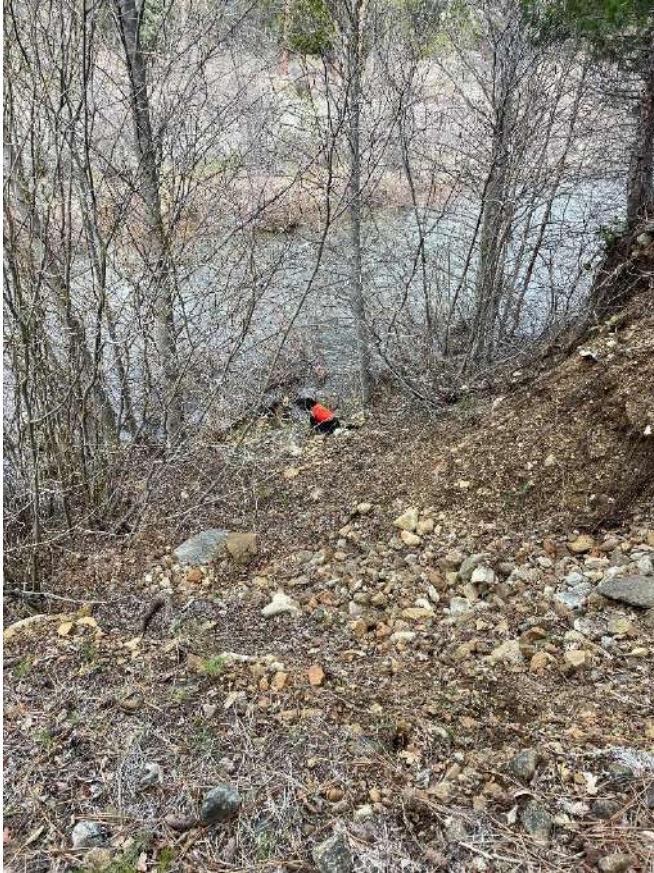
Photo 2.31: EFG 8.3 discharges into the East Fork Scott River. EFG9. April 5, 2024.
