Beaver Valley Headwaters Preserve: SRWC Final Report

A Compendium of Natural Resource Information
Collected to Inform Management Decisions
Related to Riparian Habitat, Stream Channel
Restoration and Enhancement & Forest Health
Resiliency

*Prepared by Scott River Watershed Council
May 1, 2024*

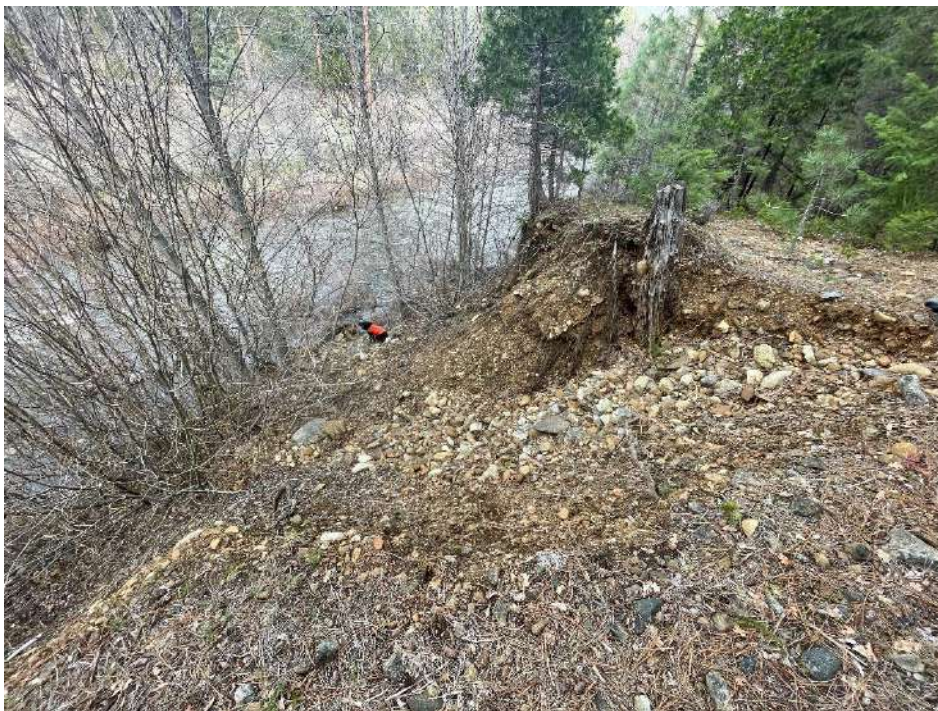
Photo 2.32: Deep incision where EFG 8.3 discharges into the East Fork Scott River. EFG9. April 5, 2024.

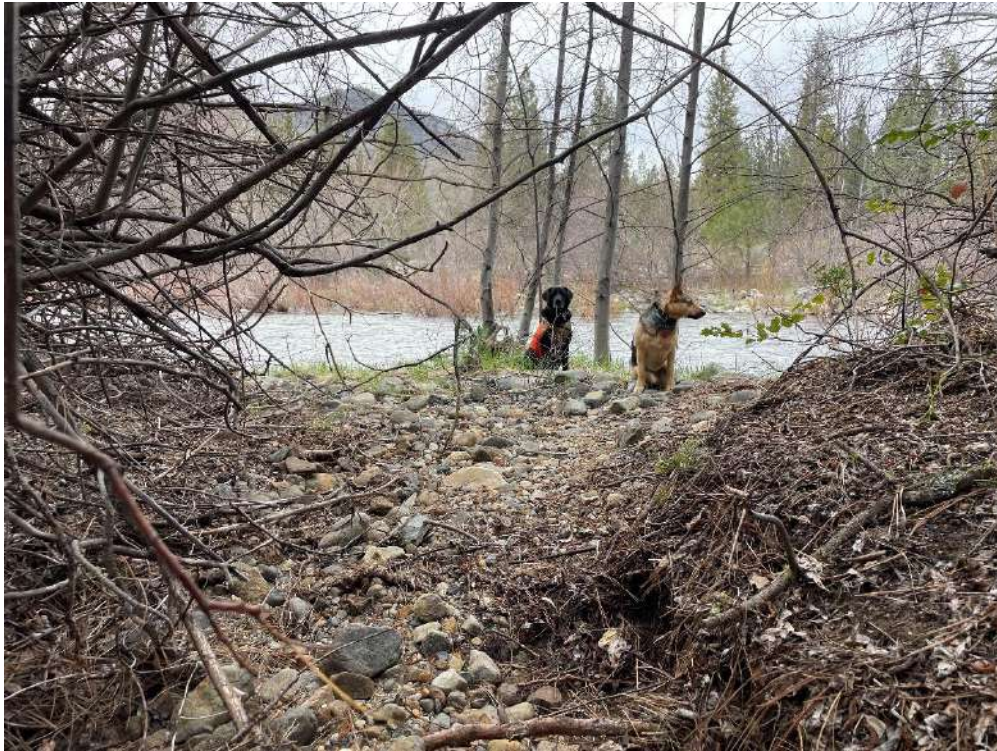
Photo 2.33: EFG 8.4 discharges into the East Fork Scott River. EFG10e. April 5, 2024.

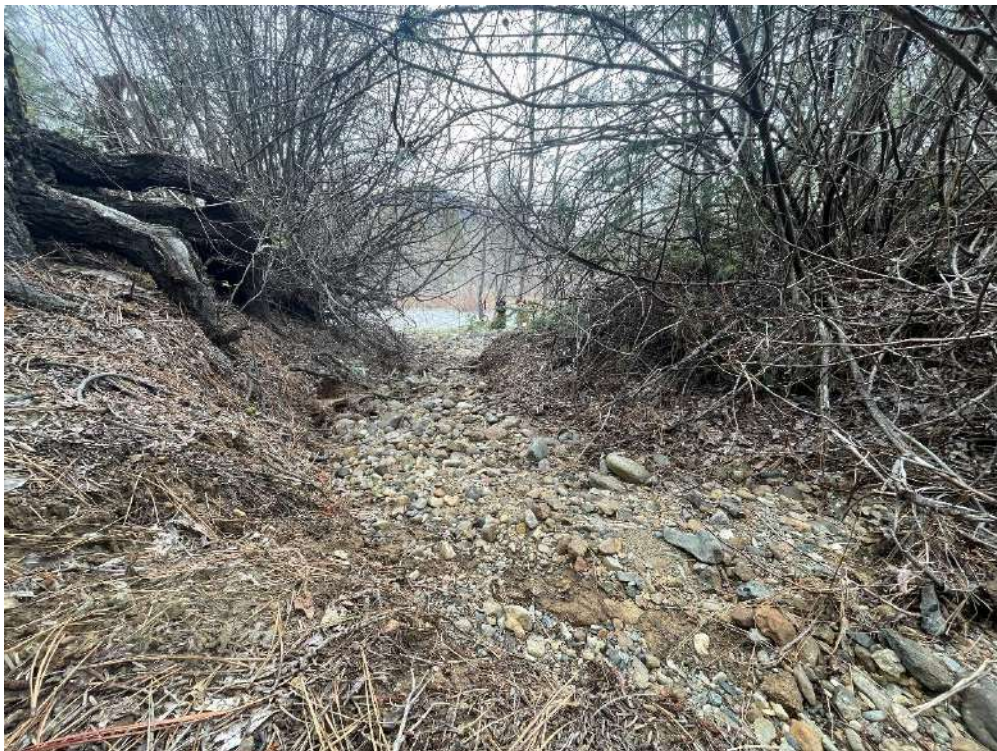
Photo 2.34: Incision where EFG 8.4 discharges into the East Fork Scott River. EFG10e. April 5, 2024.

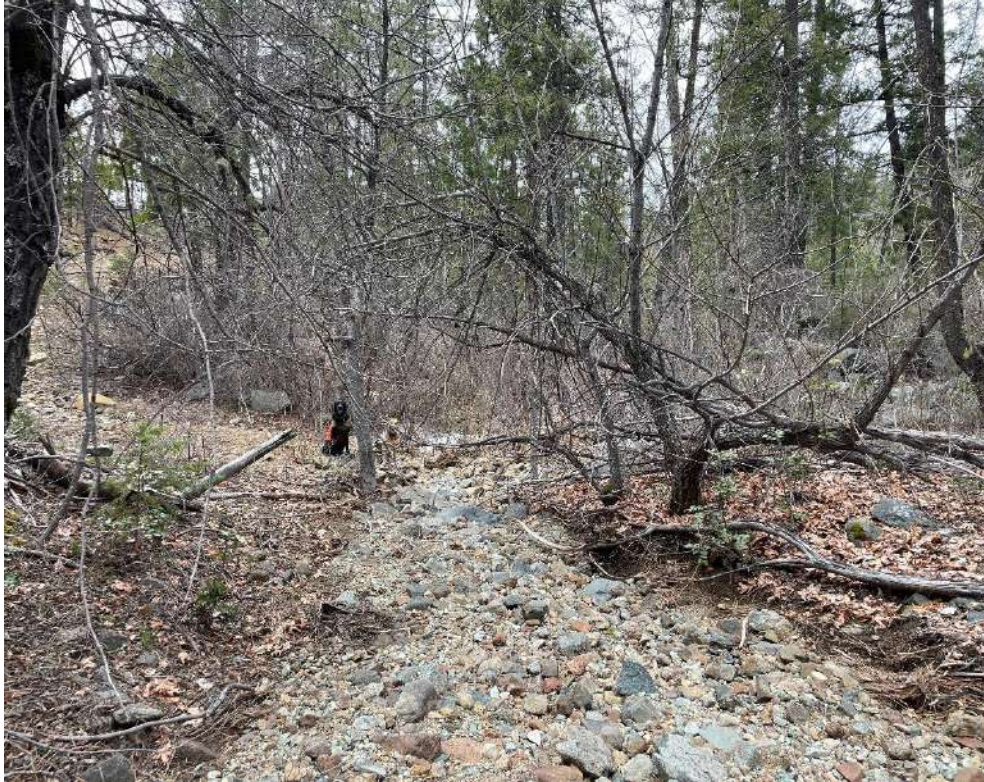
Photo 2.43: The two branches of Gully Complex 12 flow into Mule Creek at the same point. EFG12e. April 5, 2024.

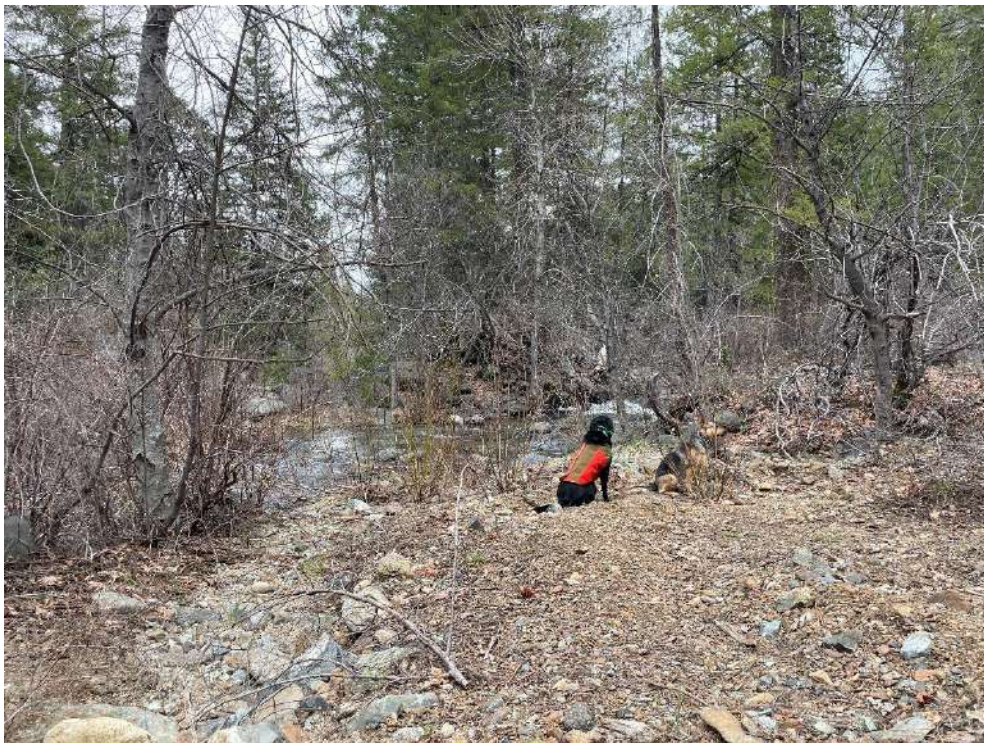
Photo 2.44: The two branches of Gully Complex 12 flow into Mule Creek at the same point. EFG12e. April 5, 2024.

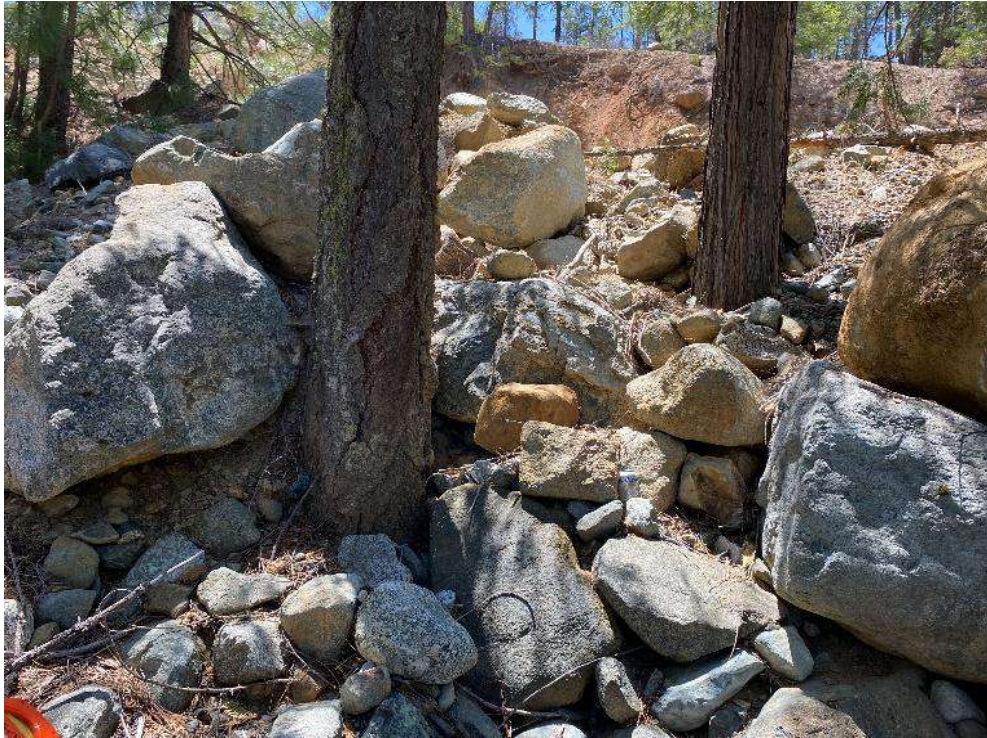
Photo 2.45: Below Highway 3 outboard ditch. EFG6.5.2c. June 2, 2023.

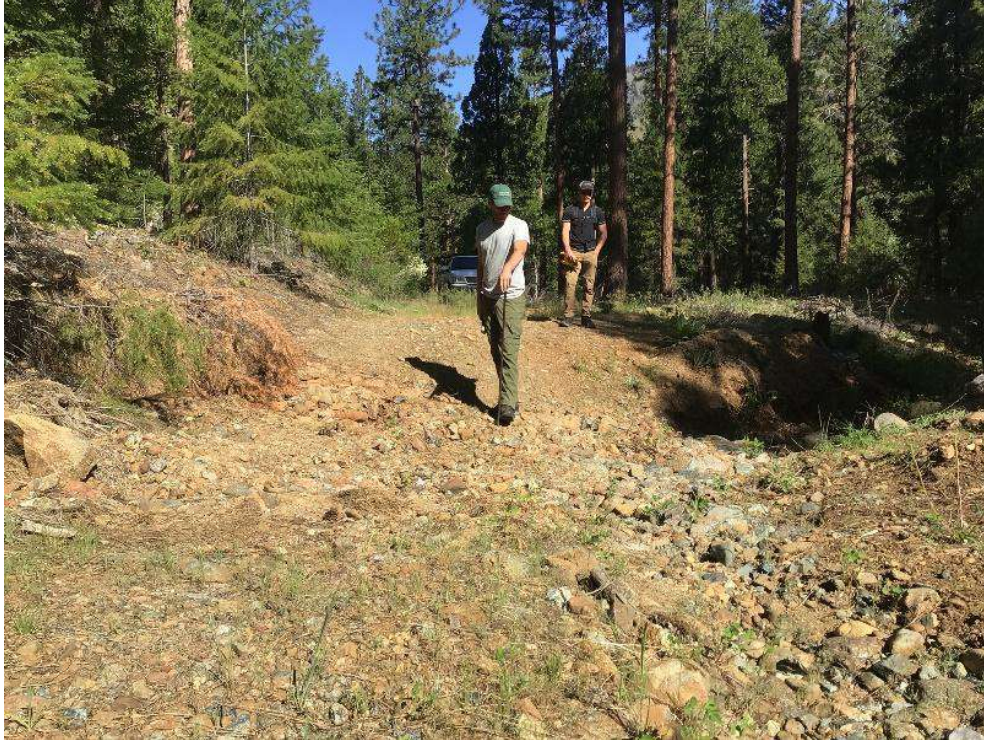
Photo 2.47: Gully Complex 5 road crossing. EFR6. May 23, 2023.

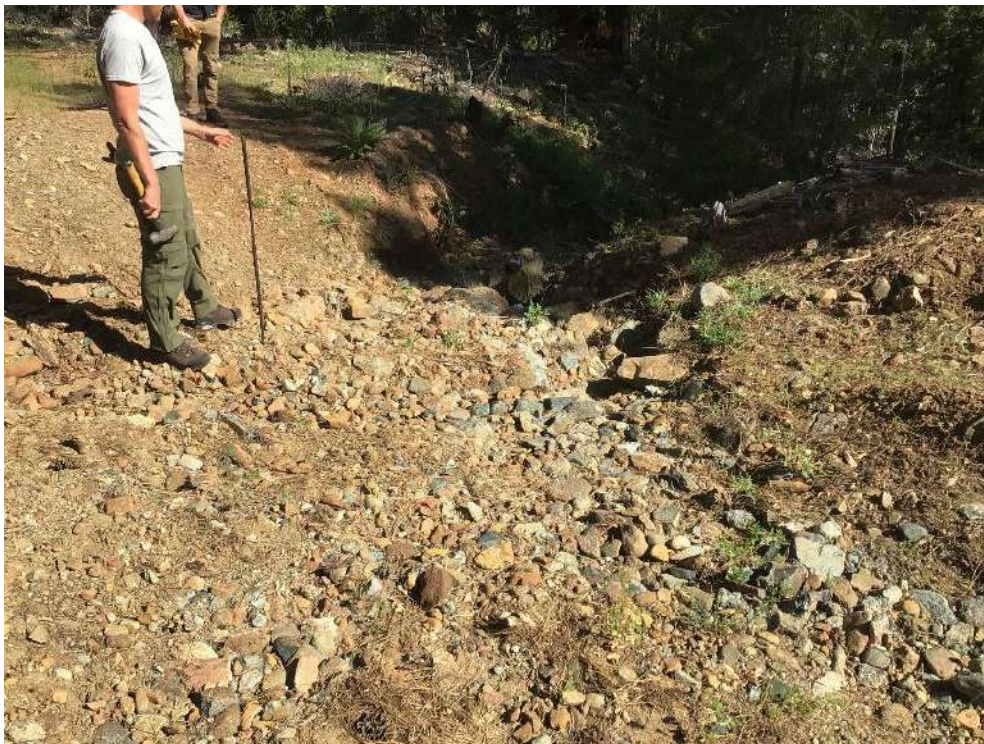
Photo 2.48: Gully Complex 5 road crossing. EFR6. May 23, 2023.

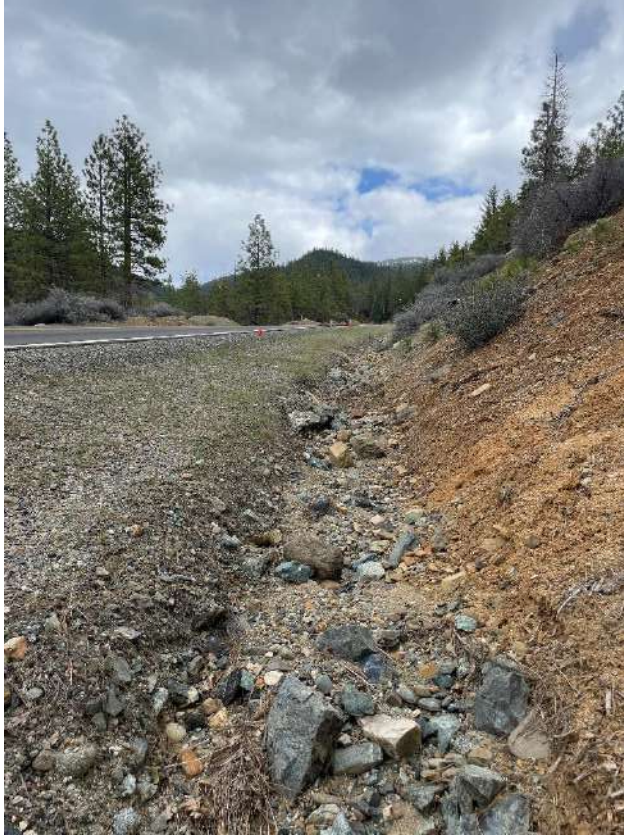
Photo 2.50: This inboard ditch on Highway 3 is the source for EFG 24. EFG24a. April 5, 2024.

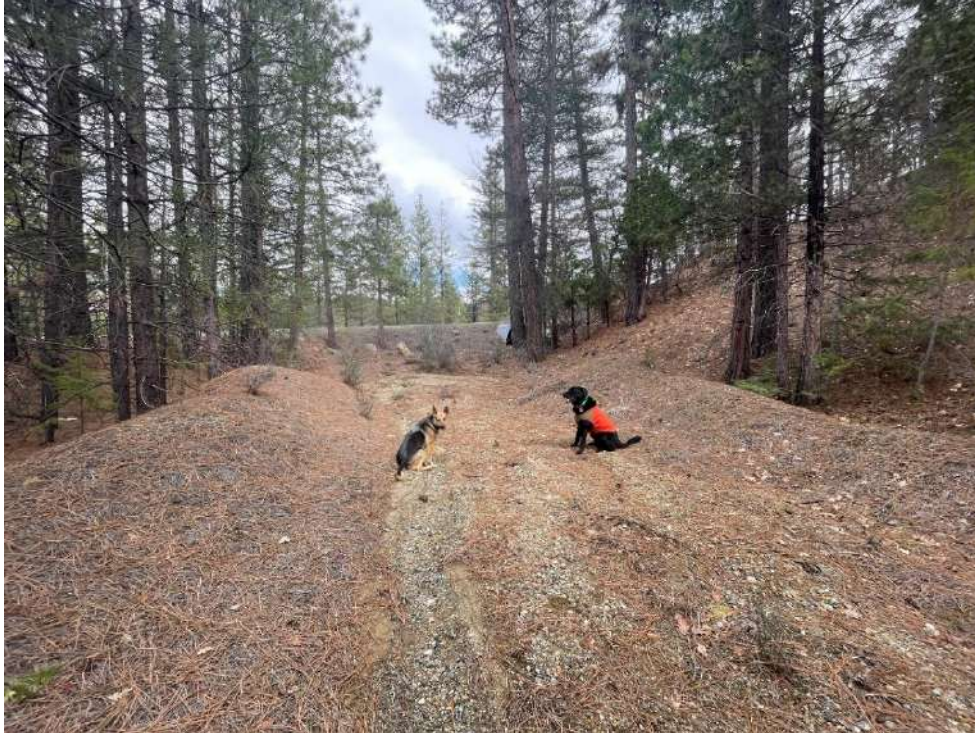
Photo 2.52: EFG 24 downstream of bypassed culvert. April 5, 2024.

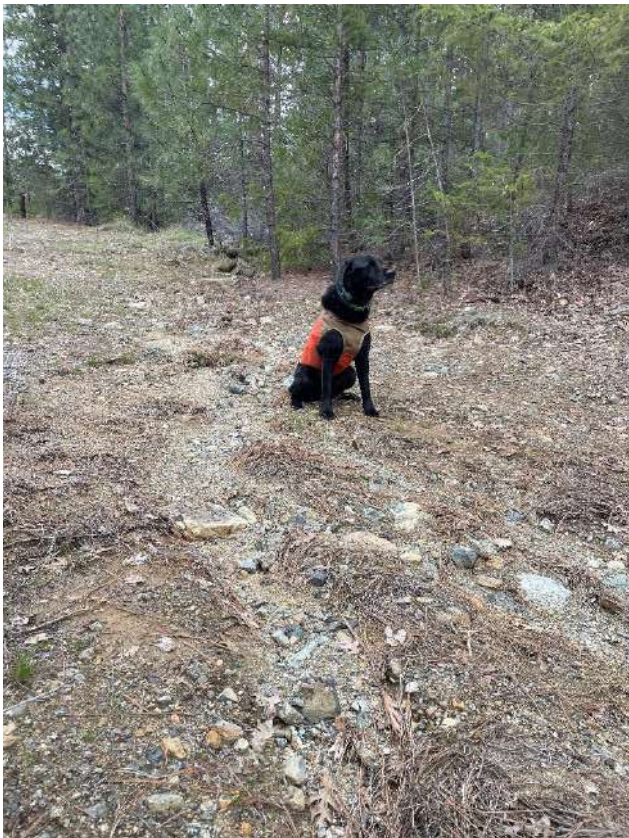
Photo 2.53: EFG 24 crosses the private road. April 5, 2024.

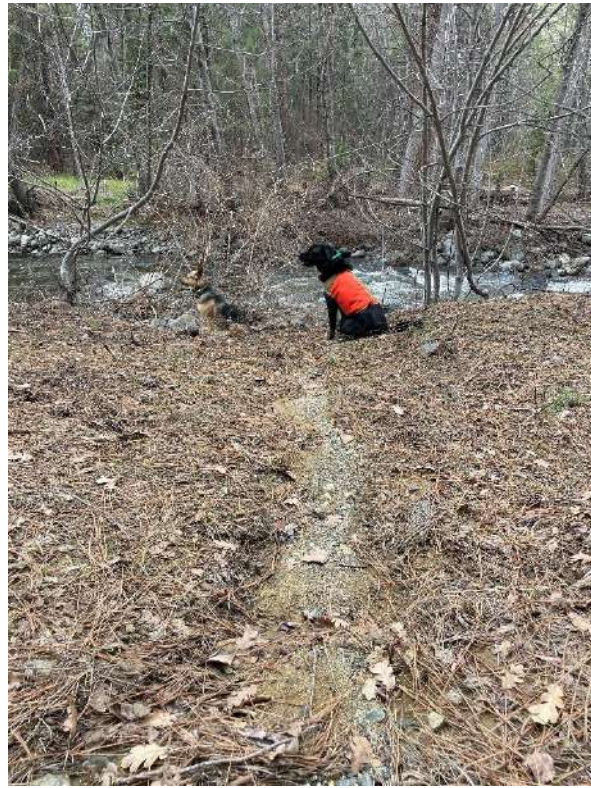
Photo 2.55: EFG 24 discharges into Big Mill Creek.
