Beaver Valley Headwaters Preserve: SRWC Final Report

A Compendium of Natural Resource Information
Collected to Inform Management Decisions
Related to Riparian Habitat, Stream Channel
Restoration and Enhancement & Forest Health
Resiliency

*Prepared by Scott River Watershed Council
May 1, 2024*

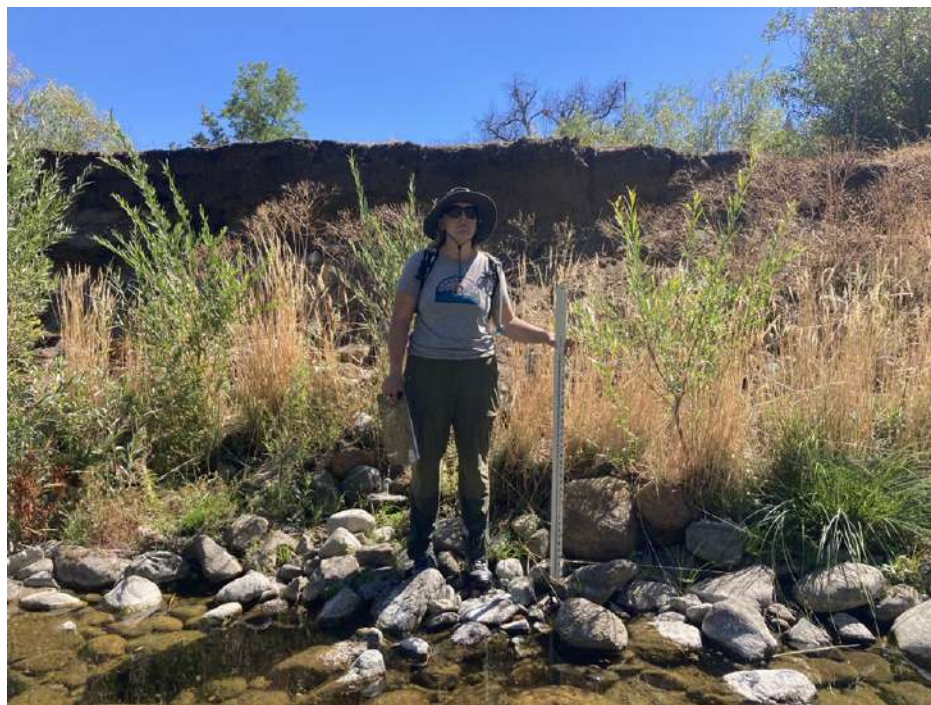
Photo 1.5: Significant active erosion occurring at Transect EF-20. September 1, 2022.

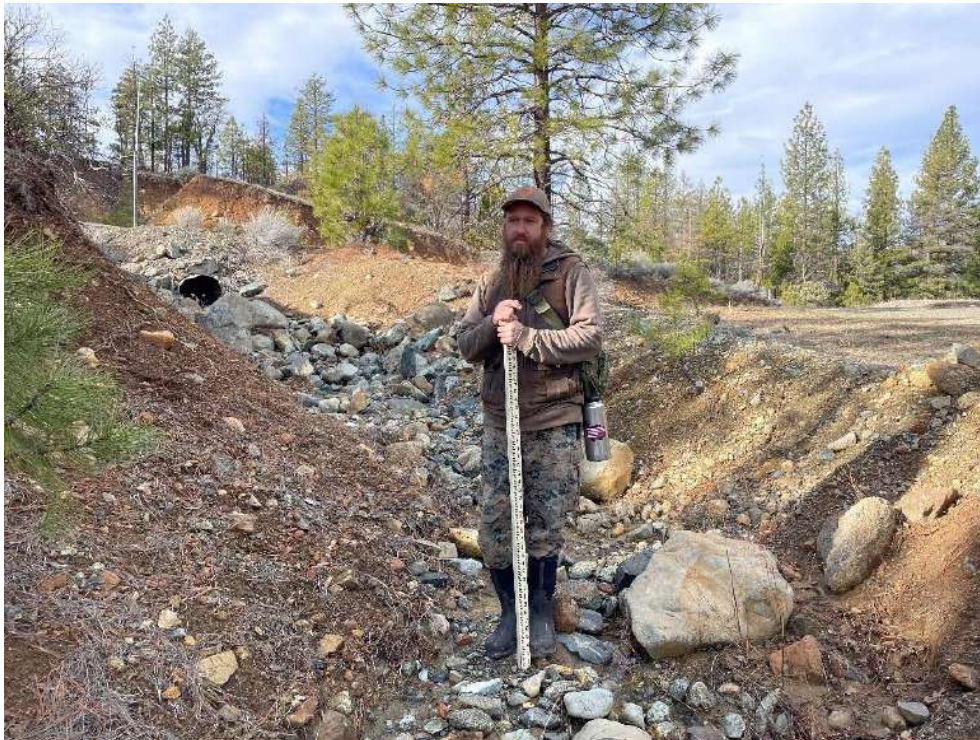
Gully Complex 2 begins at a culvert under Highway 3. It flows downstream as an inboard ditch on an old county road. The ditch is eroding and has no engineered outlet (Photo 2.6). This gully has four associated road erosion features. At two of the road points, the water flows down the road, causing extreme erosion (Photo 2.7). It terminates at the East Fork Scott River, discharging sediment into the river (Photo 2.8).

Photo 2.6: Outlet of Highway 3 culvert and ditch, looking upslope. EFG2a. January 19, 2024.

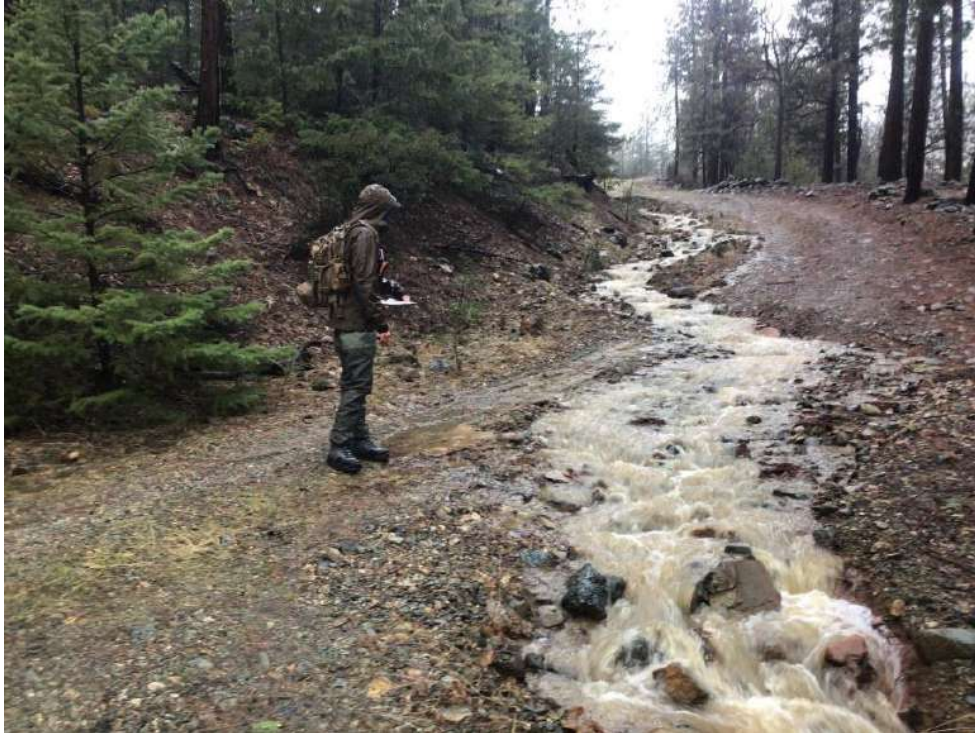
Photo 2.7: Water during runoff event crossing road. EFR2. January 13, 2023.

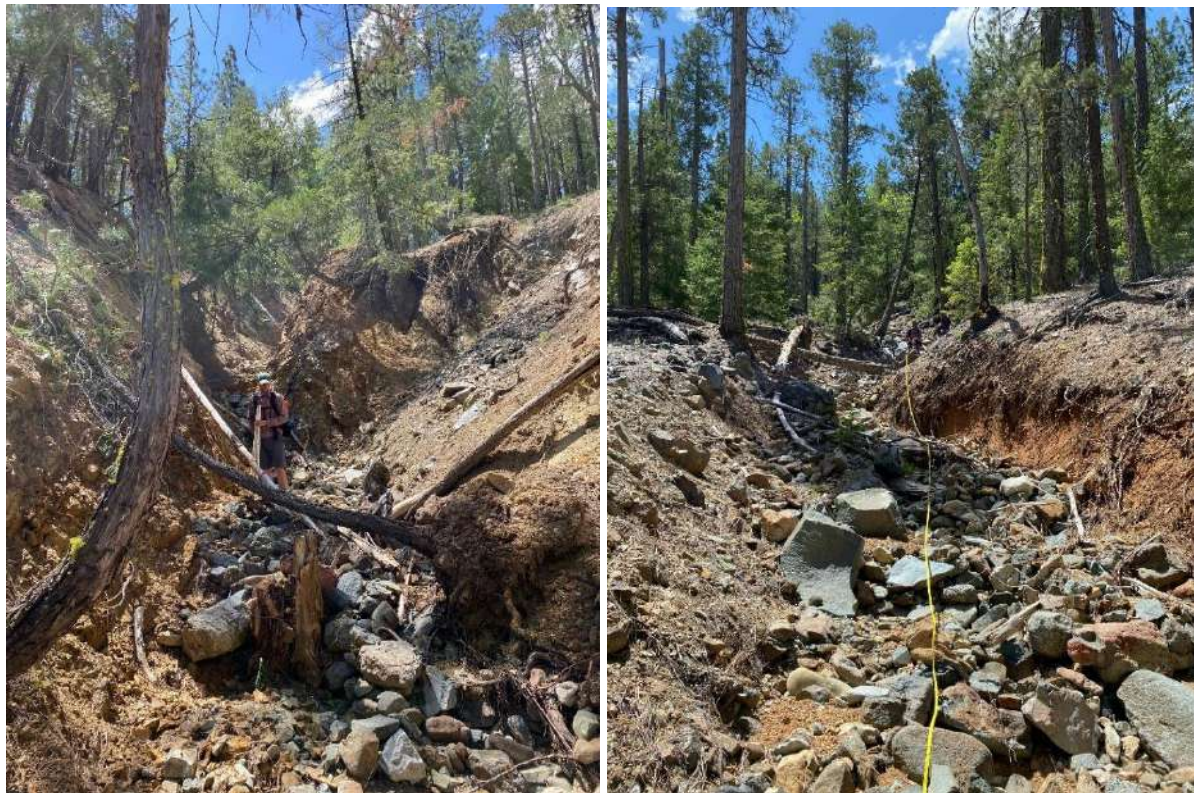
Gully Complex 8 (Table 2.6) begins above Highway 3, collects the discharge from the inboard ditch on Highway 3, passes under Highway 3 through a culvert, and then almost immediately reaches its maximum cross section area of 63 feet wide and 26 feet deep (Photo 2.9 and Photo 2.10). Below that it bifurcates four times, into five gully segments that cross the road at four road points (three with extreme erosion, one with moderate erosion (Photo 2.11), before discharging into the East Fork Scott River (Photo 2.12).

Photos 2.9 and 2.10: Maximum cross-section of Gully Complex 8 is 800ft². EFG8f and EFG8g; May 29, 2023.

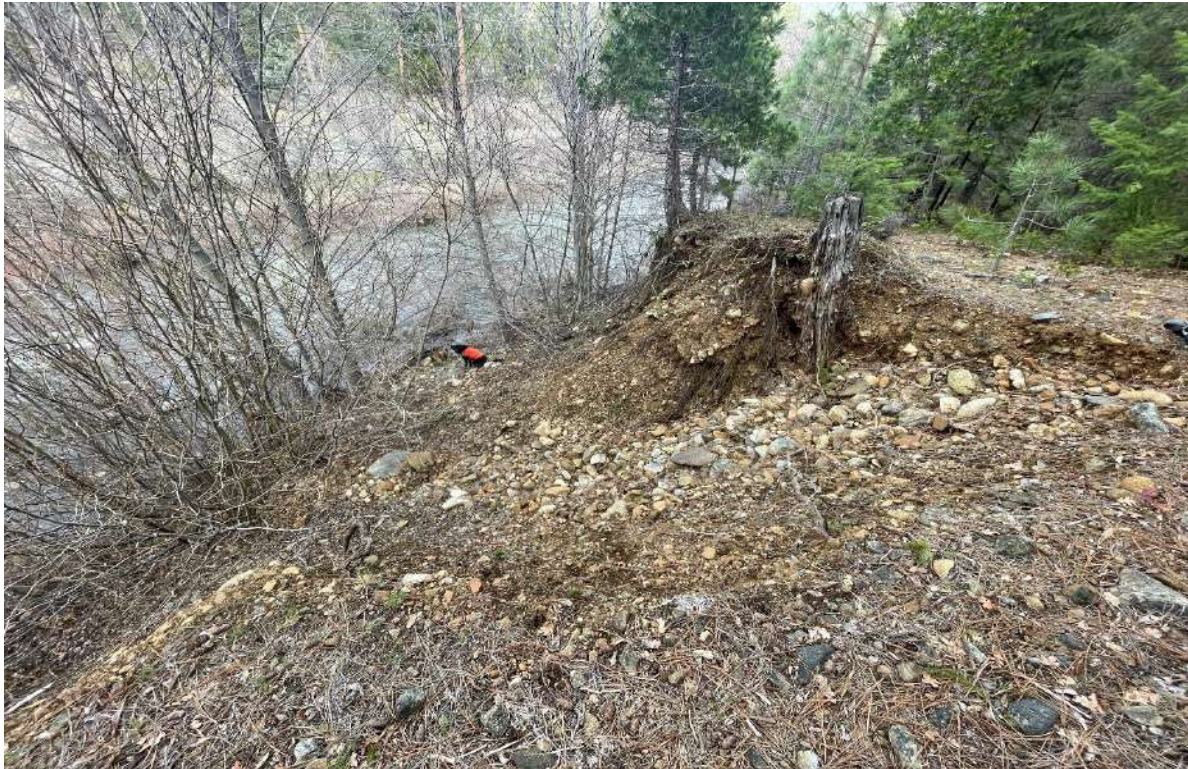
Photo 2.11: Discharge of Gully 8.3 into the East Fork Scott. EFG9e; April 5, 2024.

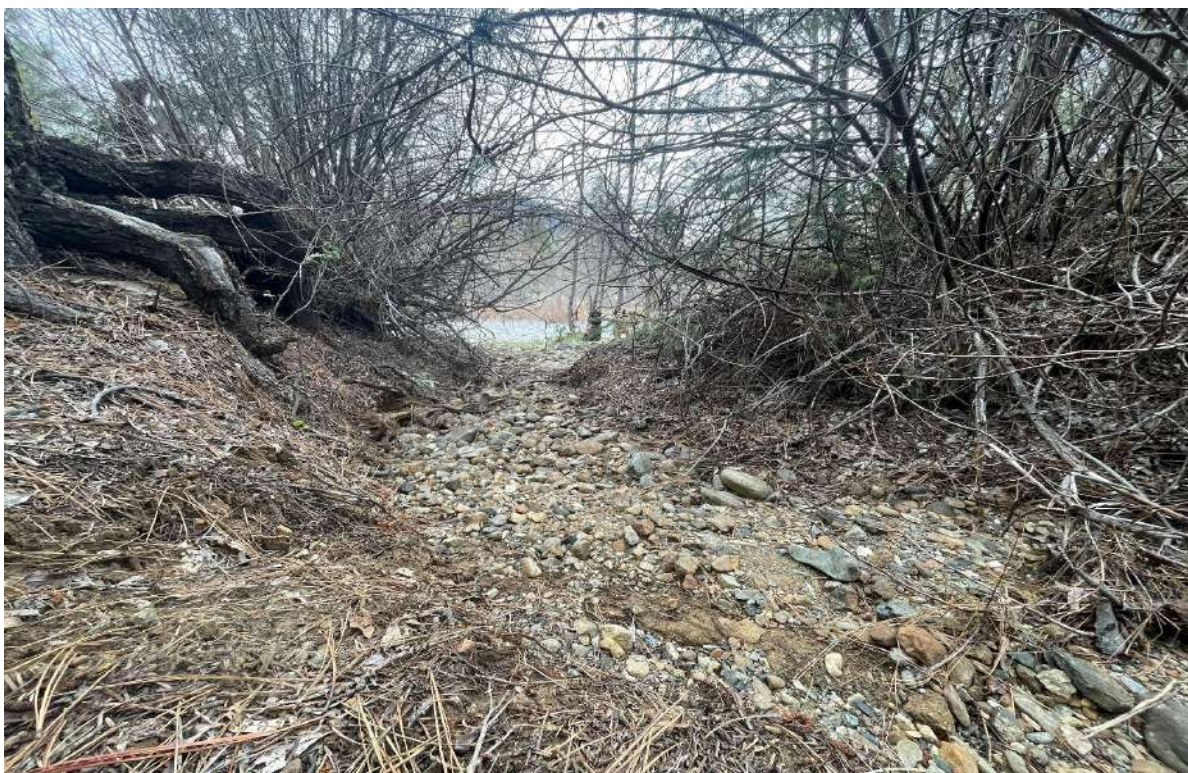
Photo 2.12: Gully 8.4 discharges into the East Fork Scott River. EFG10e; April 5, 2024.

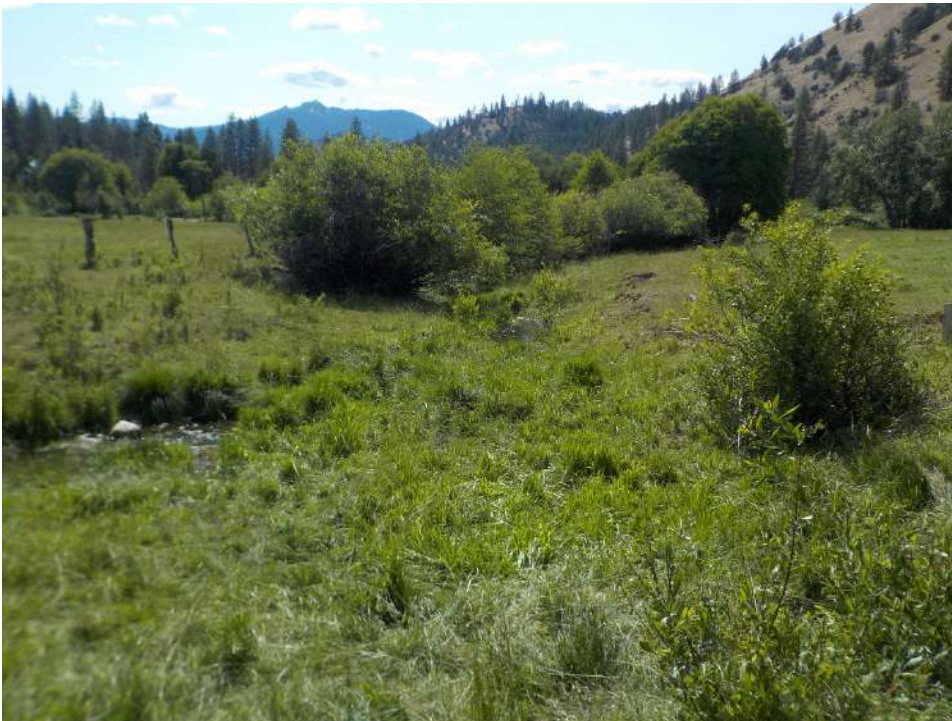
Photo 6.7: Unfenced Noyes Valley Creek with limited vegetation - looking downstream. June 21, 2023.

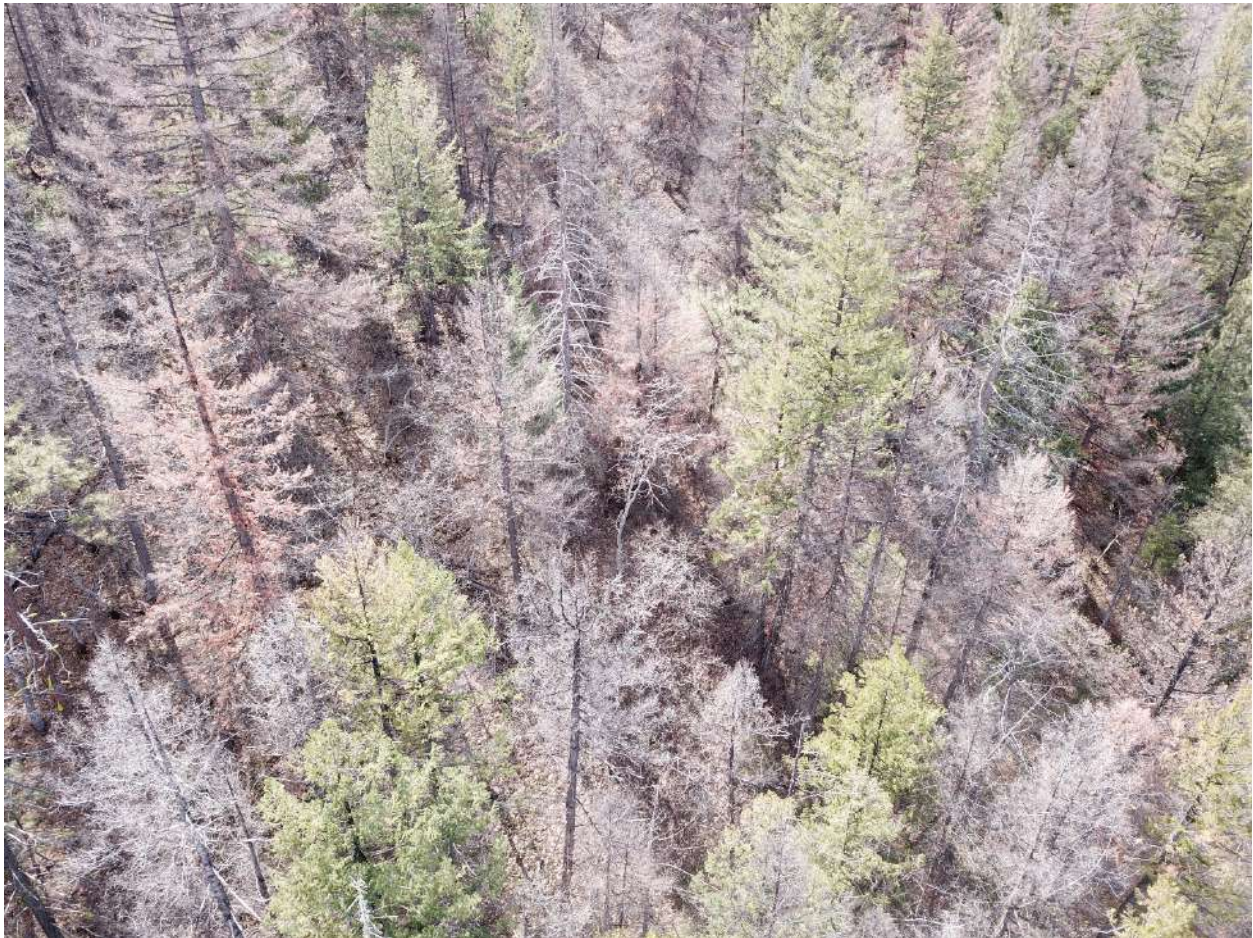
Photo 7.1: Dead and dying Douglas fir in proposed drought mortality treatment unit. March 25, 2024.

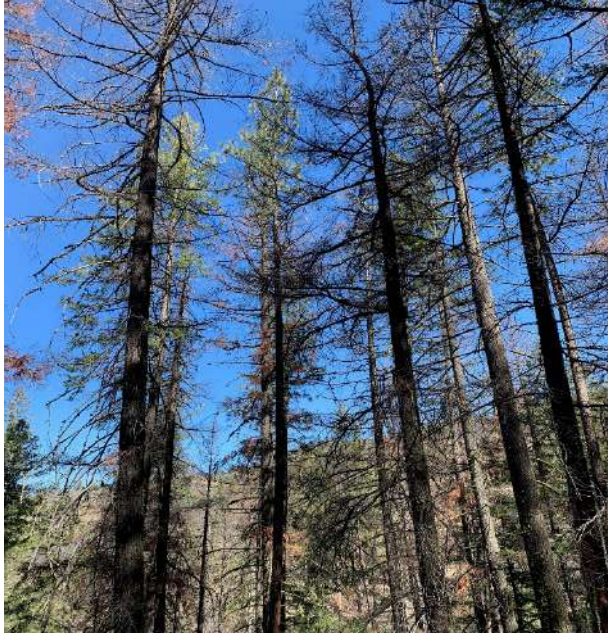
Photo 7.2: Dead and dying conifer in proposed drought mortality treatment unit. March 25, 2024.

Douglas-fir dominant mixed-conifer forests in the East Fork watershed are experiencing tremendous rates of mortality in areas near and below 3,500 feet in elevation. Plot data collected shows that approximately 83% of mature Douglas-fir trees within the proposed treatment units are either dead or dying (Photo 7.2). Stands on north-facing aspects are experiencing high levels of mortality in Douglas-fir while pine and oak, which are more tolerant of drought conditions, remain viable (Photo 7.3). Treatment is proposed for 63 acres in mixed conifer stands and only dead or dying trees will be removed. The resulting stand post-treatment in these areas will be a more open pine-oak association with scattered Douglas-fir. Douglas-Fir that regenerates on these sites will likely die when it grows to a size where water is a limiting factor (Bennett and Adlam 2023). Historically, frequent low intensity fires would have kept Douglas-fir from regenerating in these areas (Photo 7.4).

Current proposed drought mortality treatments should be implemented as soon as possible to reduce hazardous fuel loading and to utilize trees while they are still economical to remove. By removing the dead and dying trees using a combination of commercial harvest and the production of chips, this allows for a large quantity of the bulk material to be removed, eliminating excess mastication and/or burning methods. There is also the ability to couple instream restoration activities with the need for large wood. Using material from TWC can also aid in the goals of removal of the excess biomass and put it to work in instream habitat restoration projects, both on TWC and other areas of the Scott River watershed. Post-treatment monitoring should be conducted to limit the spread of invasive species and ensure that erosion control measures are succeeding.

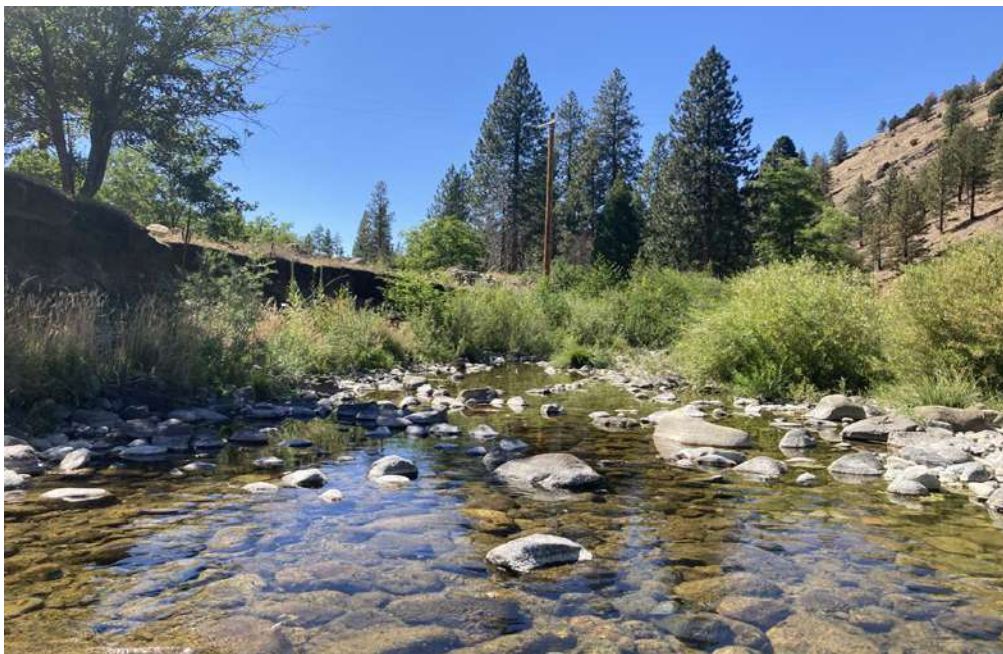
Cutbank at RKM 4.2 - Looking Downstream - Summer 2022

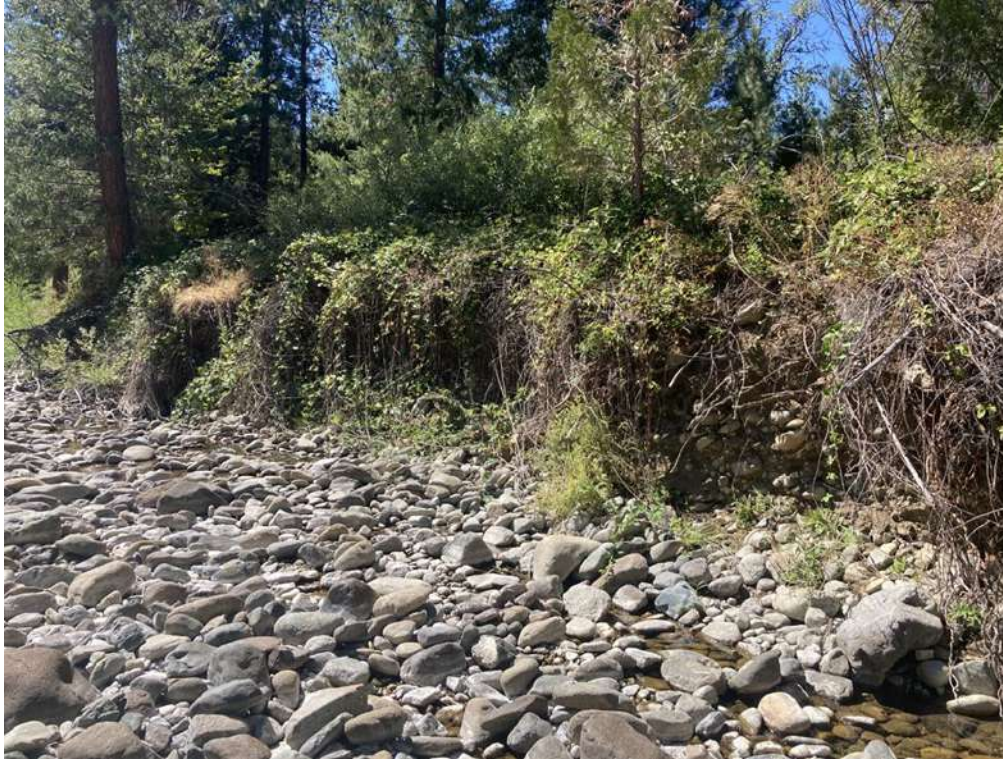
Upstream end of RKM 5.0 cutbank

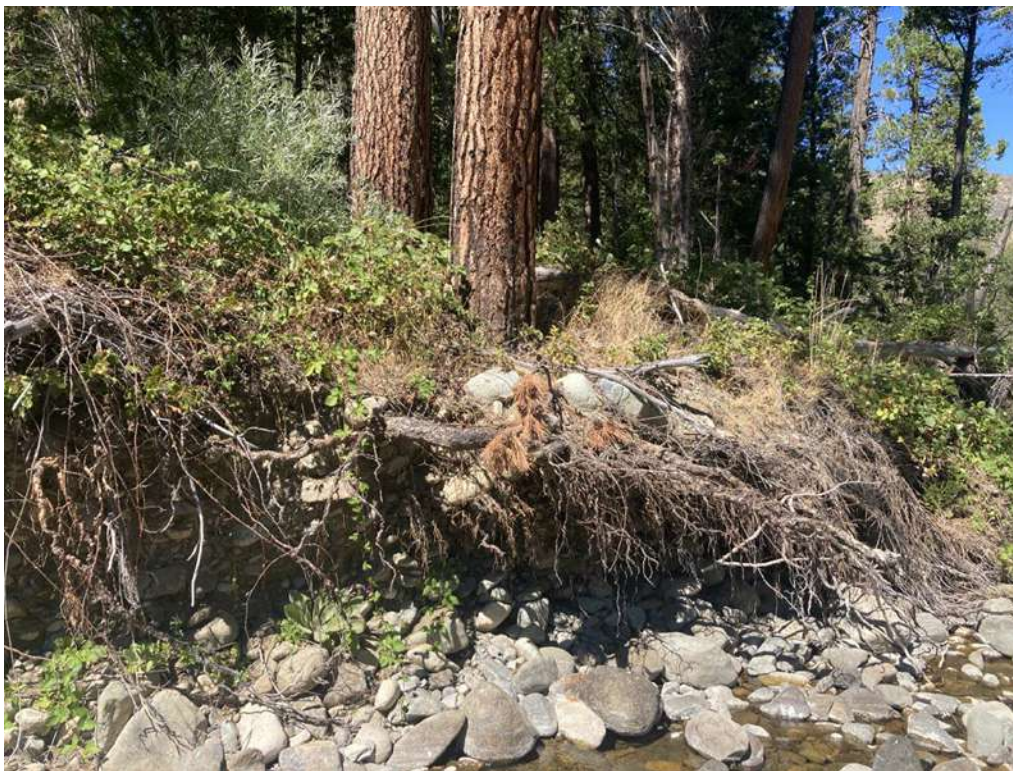
Undercut roots of ponderosa pine at RKM 5 cutbank

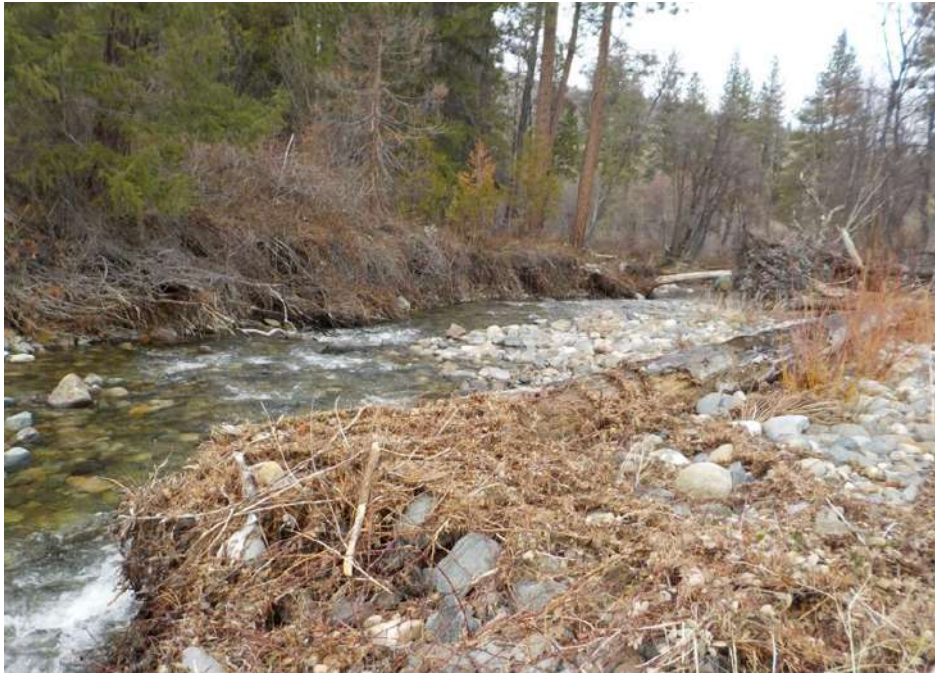
Incised channel at RKM 5.0 - 4.9 - looking downstream

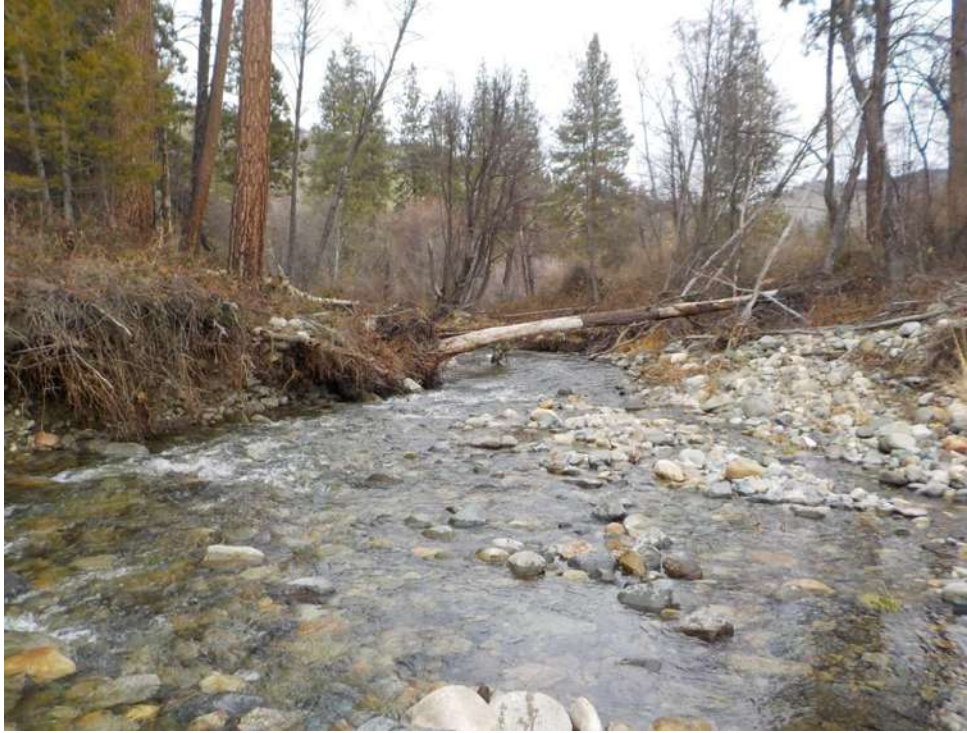
Large woody debris at the downstream extent of the incised channel

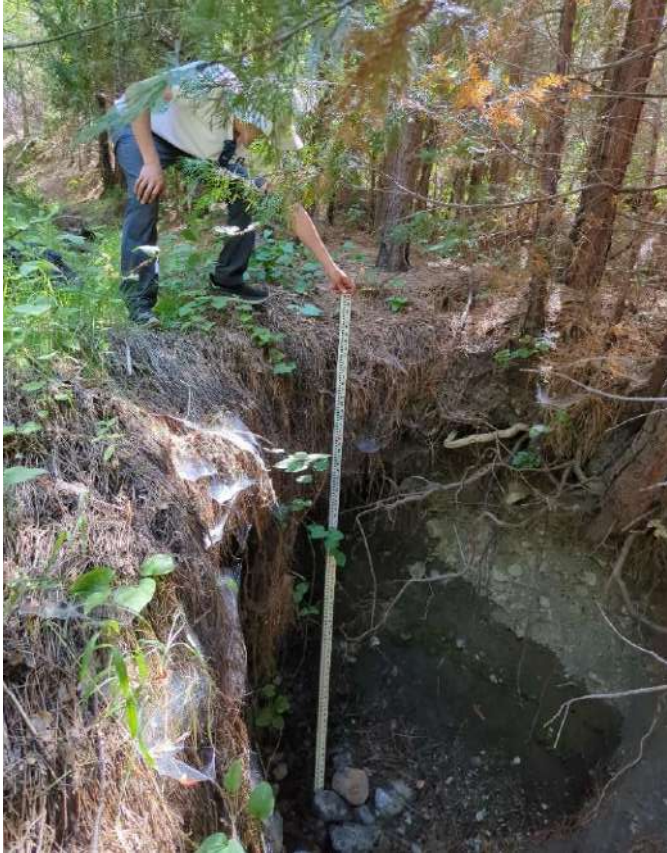
Photo 2.1: Gully Complex 49, upslope reach. EFG49g. July 25, 2023.

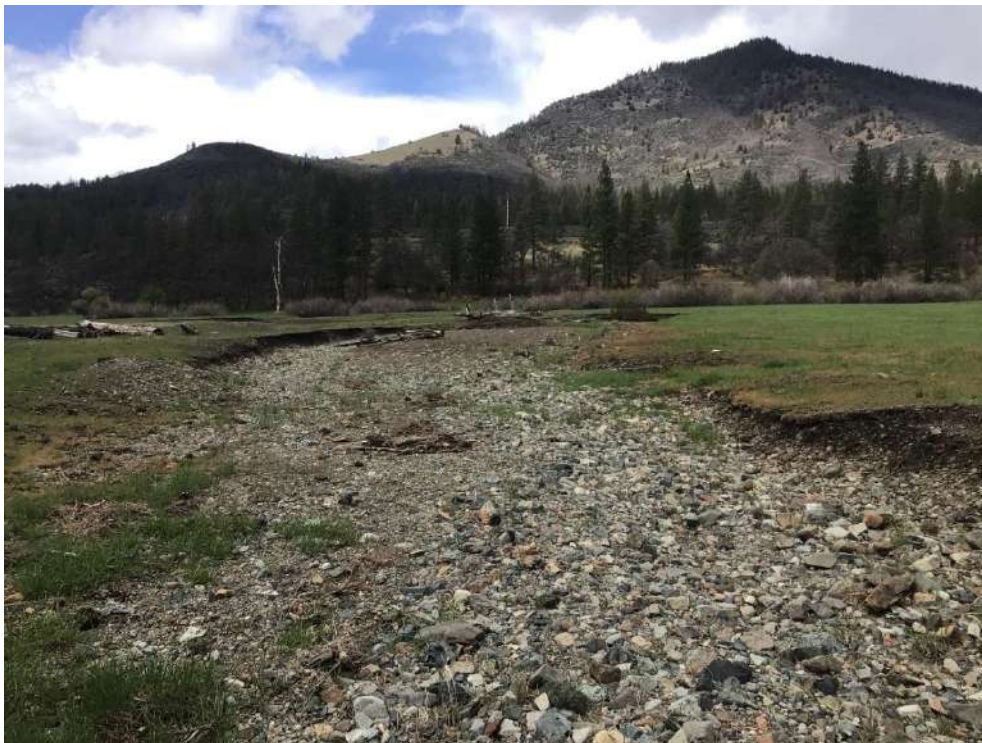
Photo 2.3: Gully Complex 49 (stream) Downstream of road crossing, looking downstream. Note incision. EFR49. August 5, 2023.

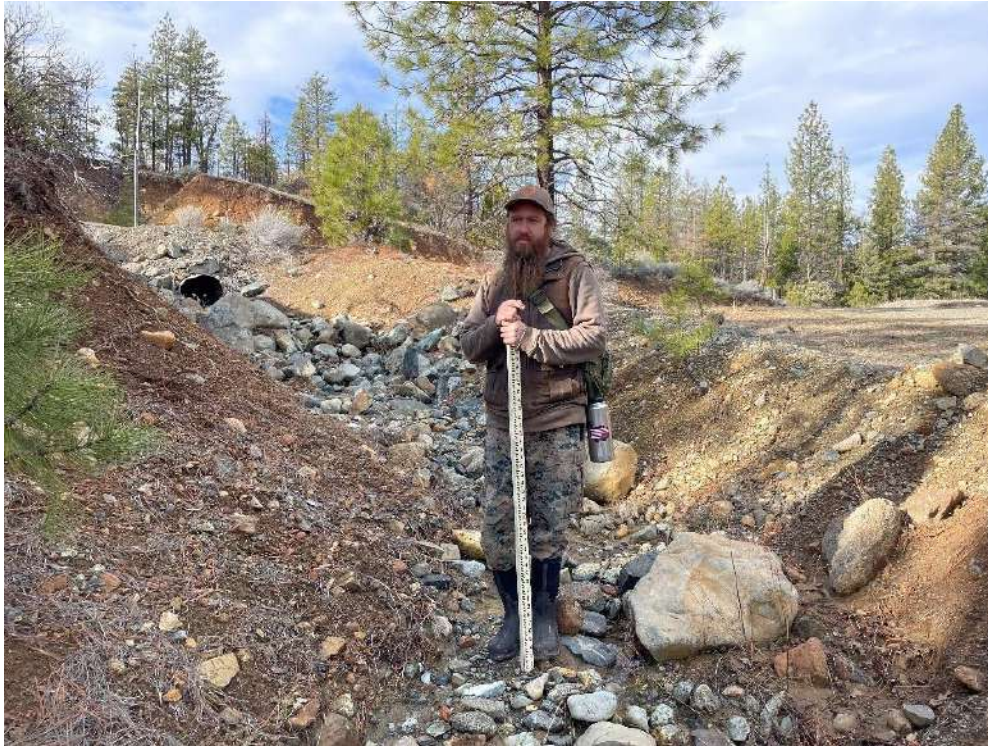
Photo 2.4: Outlet of Highway 3 culvert, looking upslope. EFG2a. January 19, 2024.

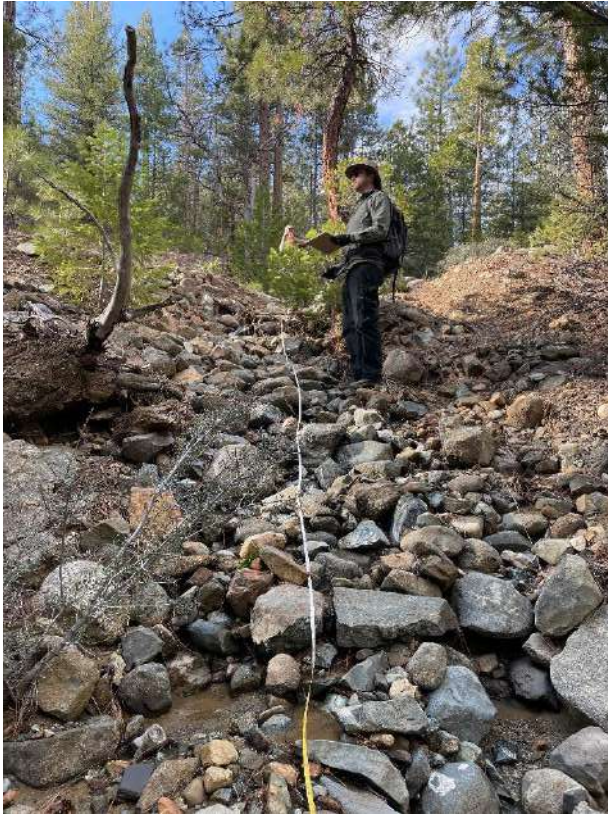
Photo 2.7: Looking upslope towards site of Figure 2.6, on a day without runoff. EFG2c. January 19, 2024.

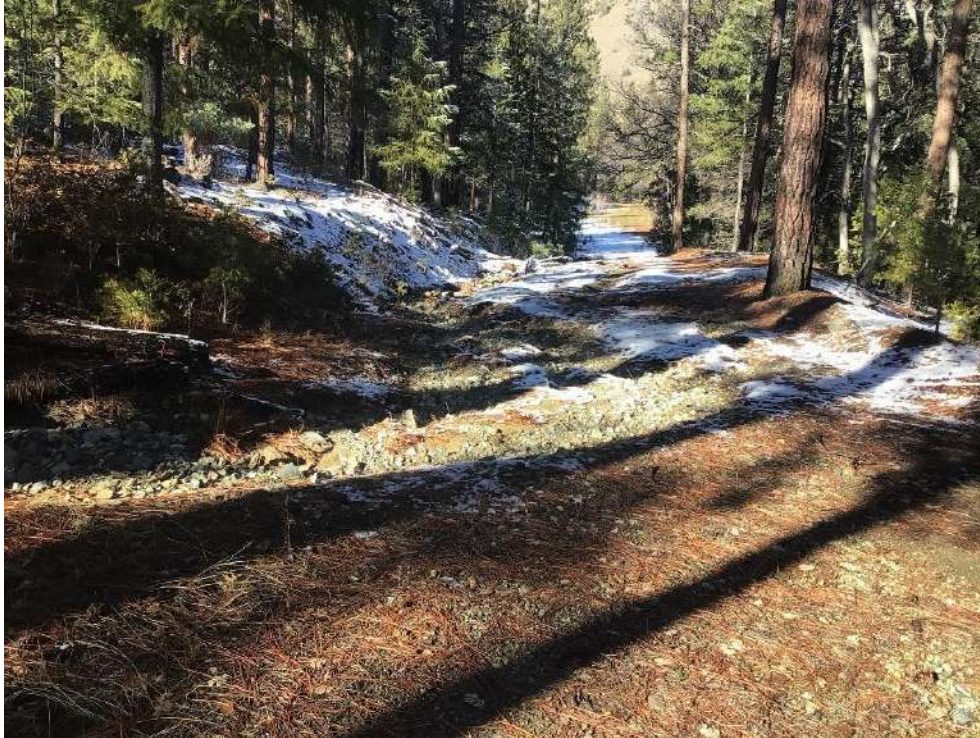
Photos 2.8 & 2.9: Flow path on road. EFR14; January 20, 2023. EFG2e. January 19, 2024.

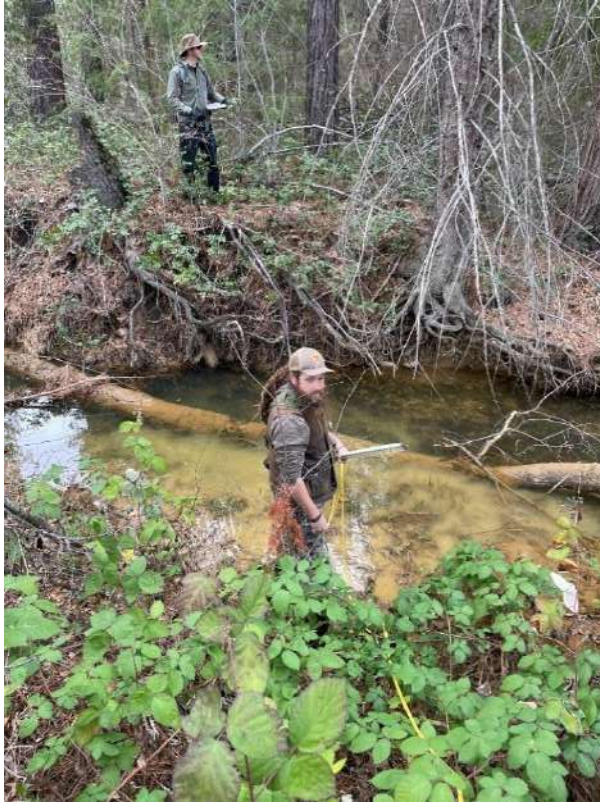
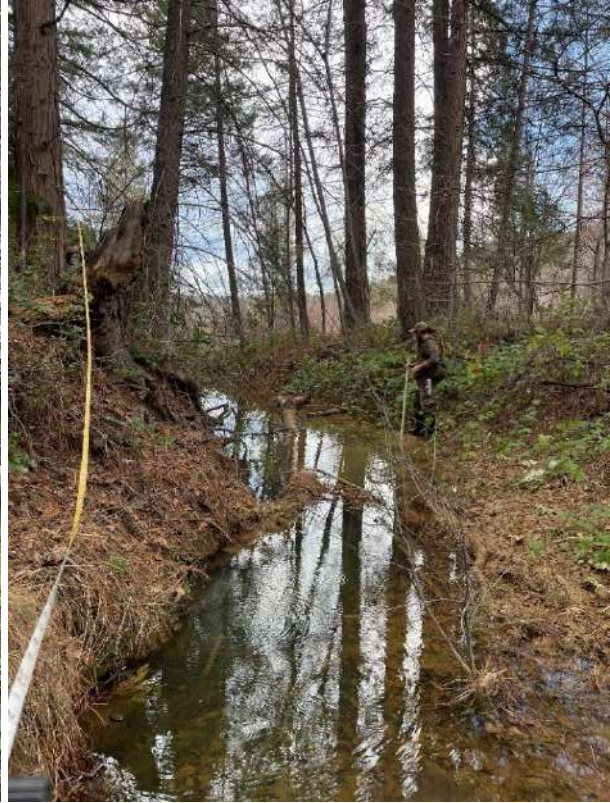
Photos 2.14 & 2.15: Maximum cross-section of Gully Complex 2 is 89 ft². EFG2i. January 19, 2024.

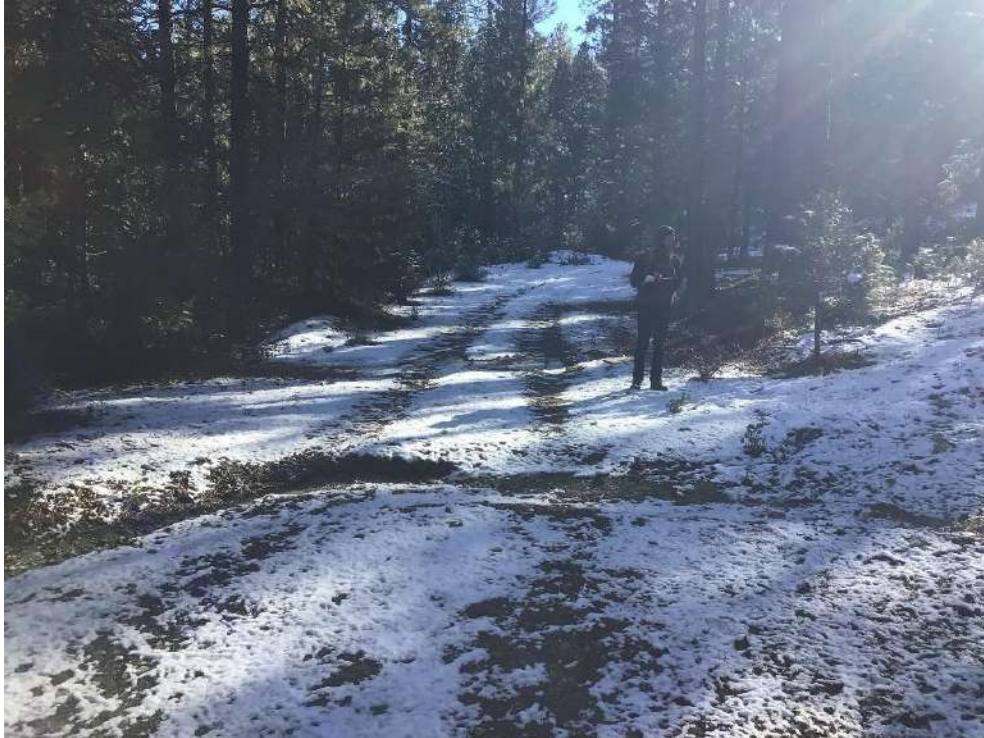
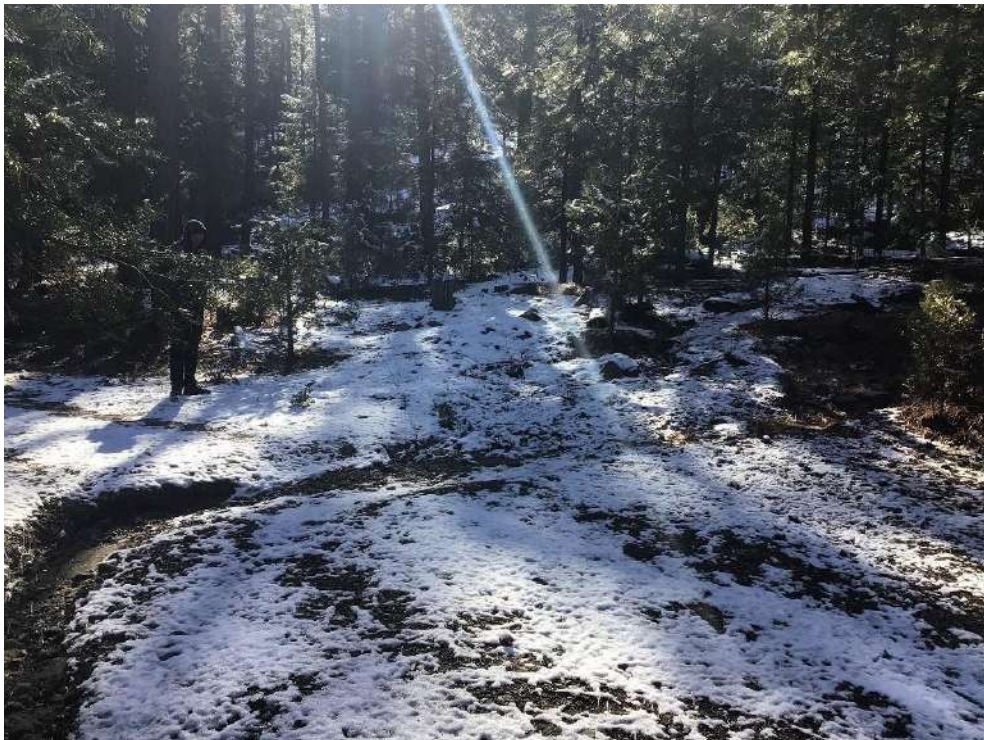
Gully 2.1 (photos below) is a smaller gully that leaves and returns to Gully 2

Photos 2.17 & 2.18: Gully Complex 2 crossing lower road. EFR13. January 20, 2023.

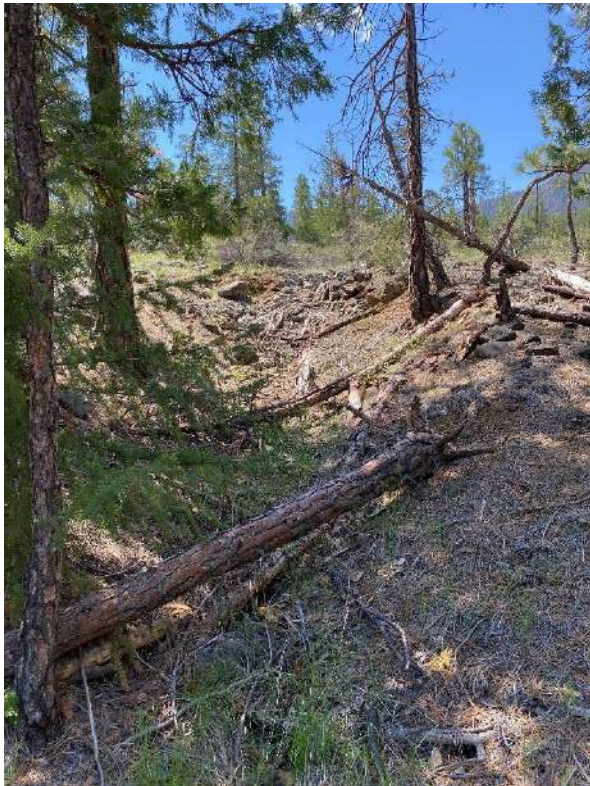
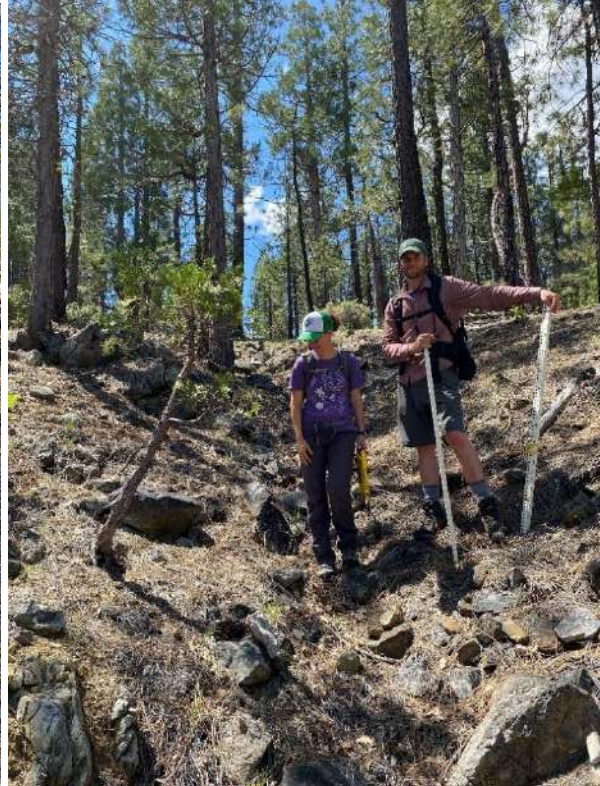
Photos 2.19, 2.20 & 2.21: Gully 8 above Highway 3. EFG8c, EFG8d and EFG8.; May 29, 2023.

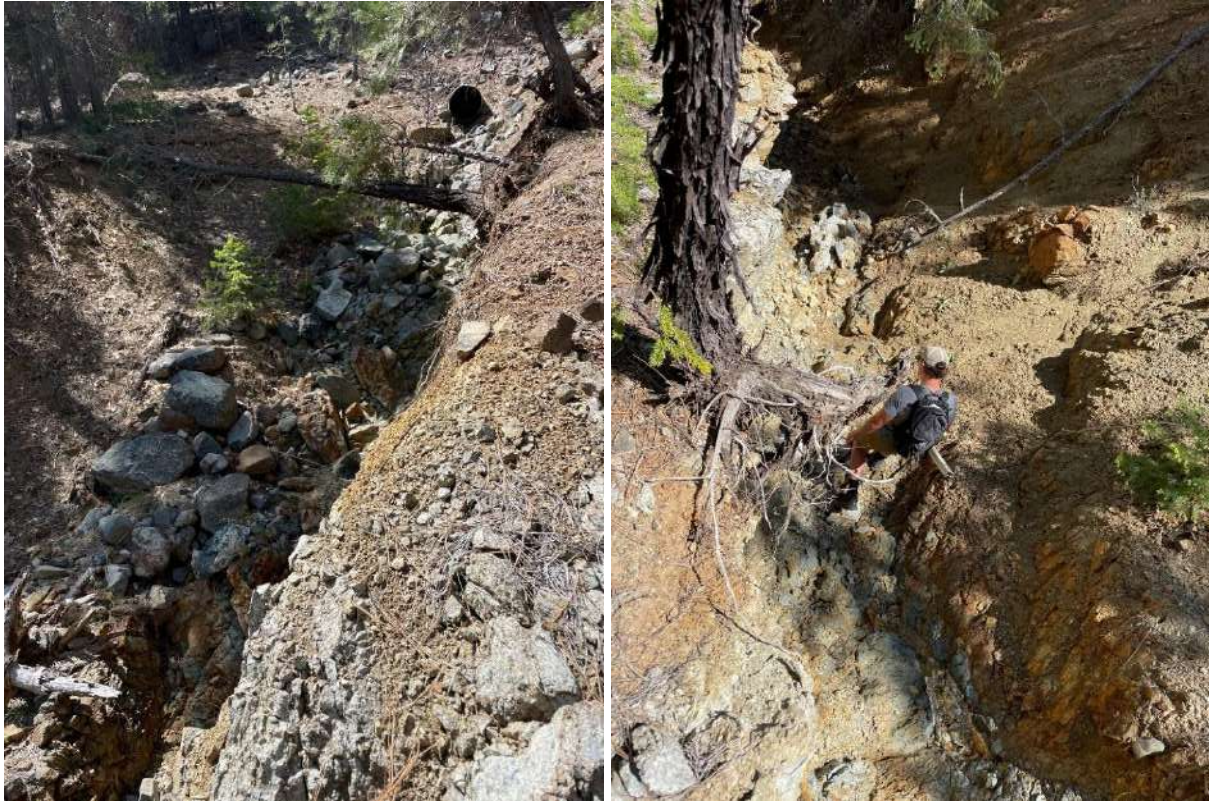
Photos 2.22 and 2.23: Left, culvert discharging in Gully 8. EFG8f. Right, Beginning of deep incision. EFG8f. May 29, 2023.

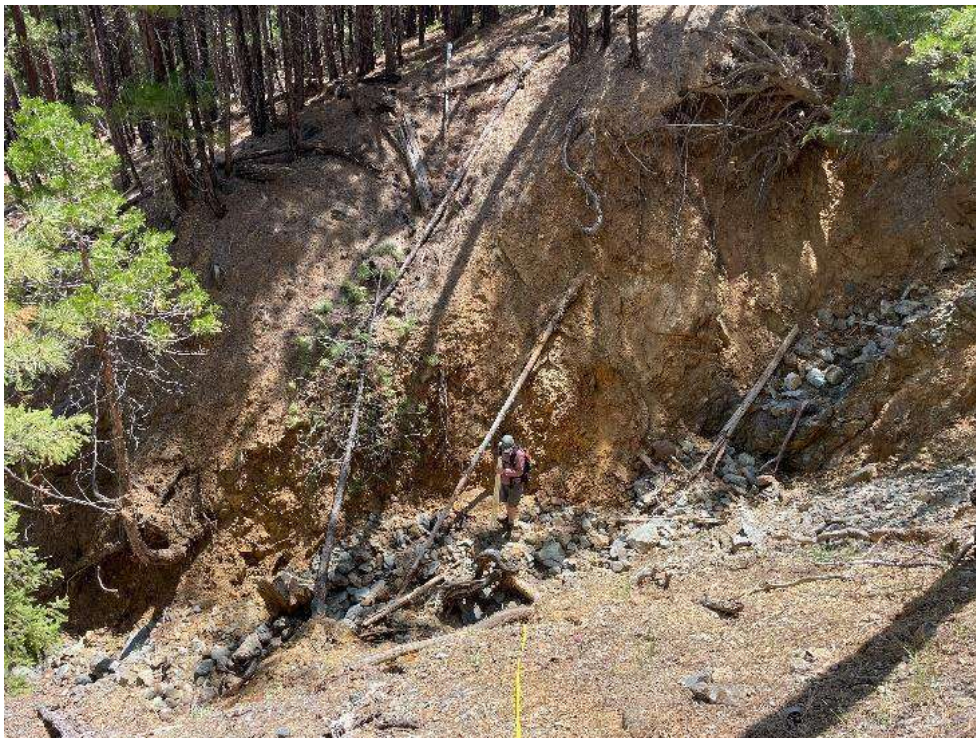
Photo 2.24: Maximum cross-section in Gully Complex 8 is 800 ft². EFG8f. May 29, 2023.

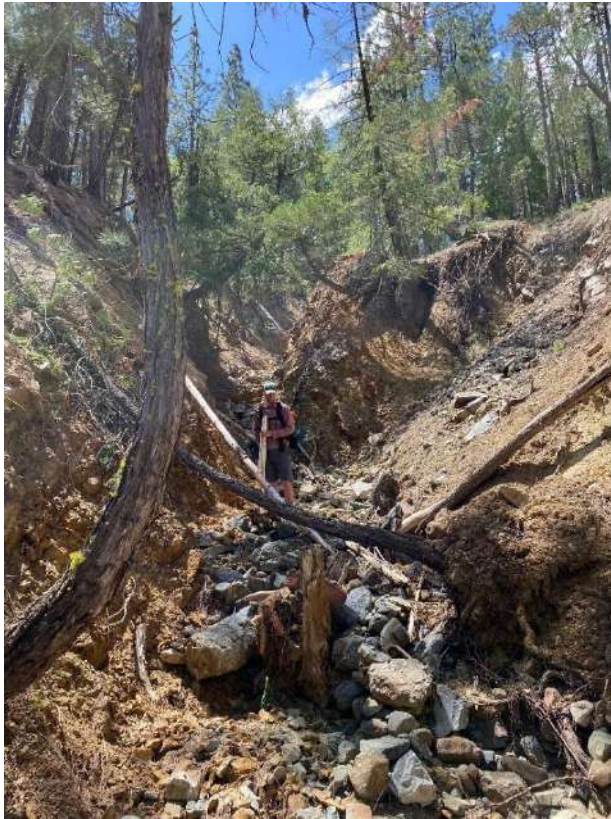
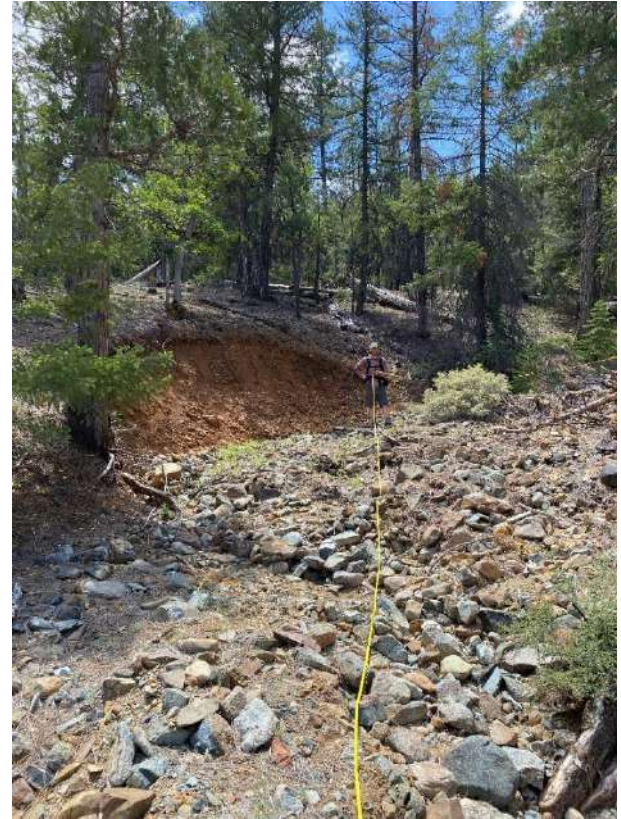
Photos 2.25 and 2.26: Left, maximum cross-section. EFG8f. Right, below bifurcation. EFG8h. May 29, 2023.

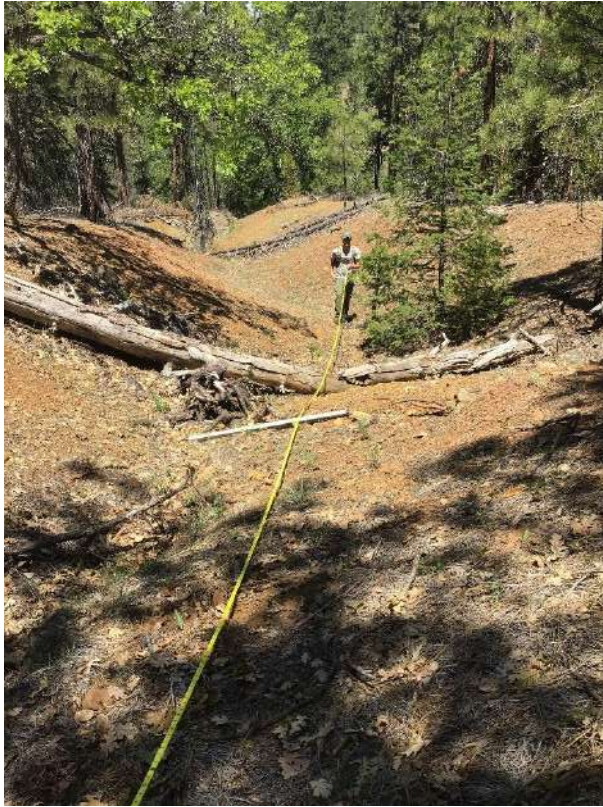
Photos 2.27 and 2.28: Segments below bifurcation. EFG9b and EFG8g. May 29, 2023.

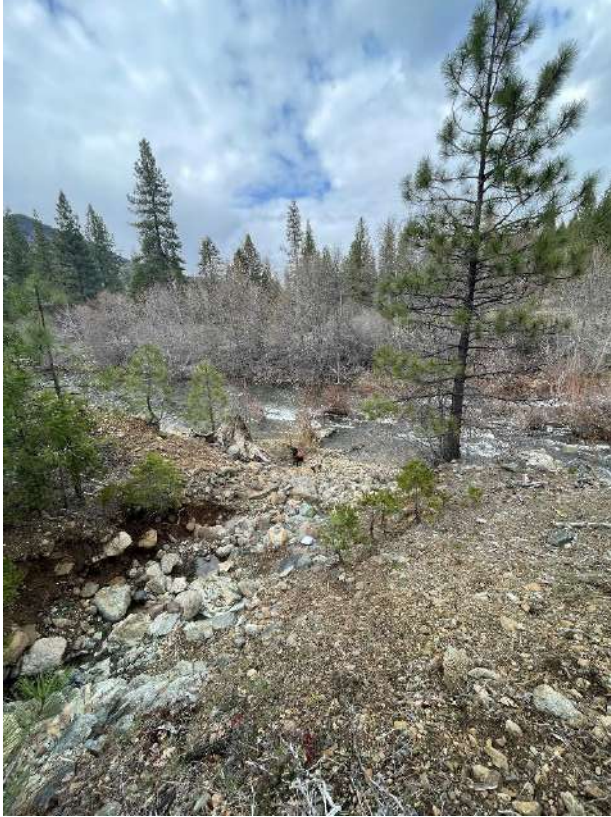
Photo 2.29: EFG 8.2 discharges into the East Fork Scott River. EFG8j. May 29, 2023.

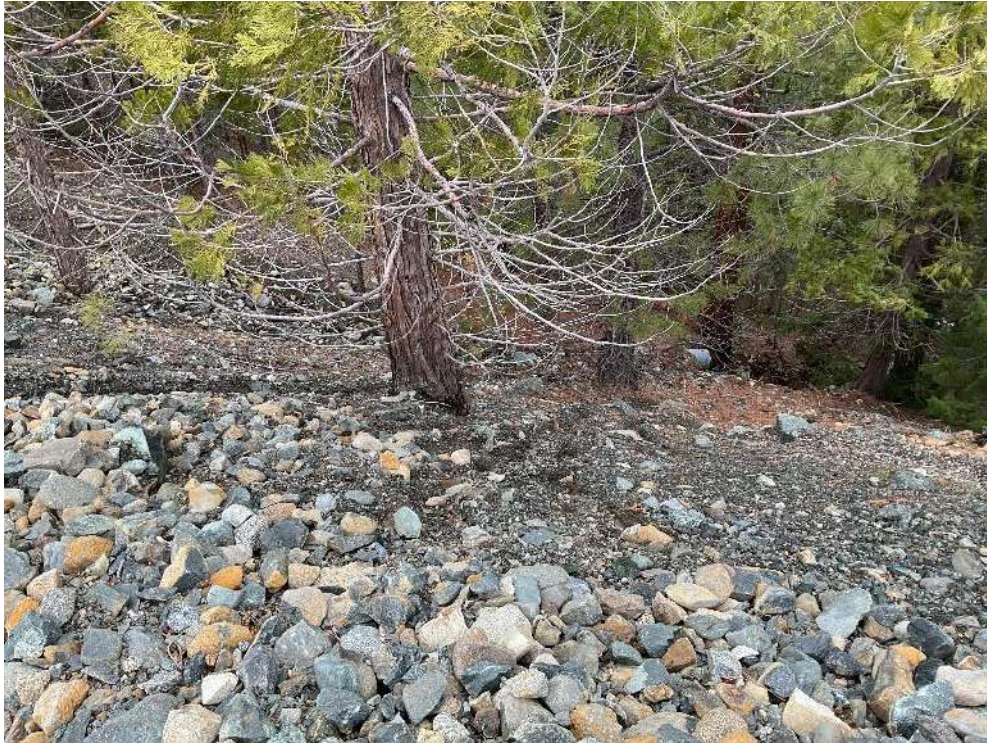
Photo 2.35: Culvert discharges at the top of Gully Complex 12. January 18, 2024.
