Beaver Valley Headwaters Preserve: SRWC Final Report

A Compendium of Natural Resource Information
Collected to Inform Management Decisions
Related to Riparian Habitat, Stream Channel
Restoration and Enhancement & Forest Health
Resiliency

*Prepared by Scott River Watershed Council
May 1, 2024*

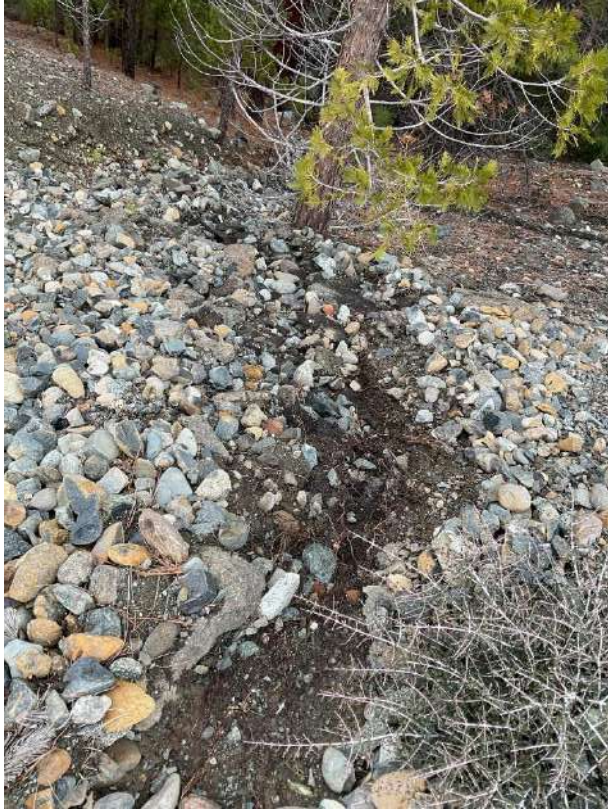
Photo 2.36: Discharge from outboard ditch erodes fill at the top of Gully Complex 12. January 18, 2024.

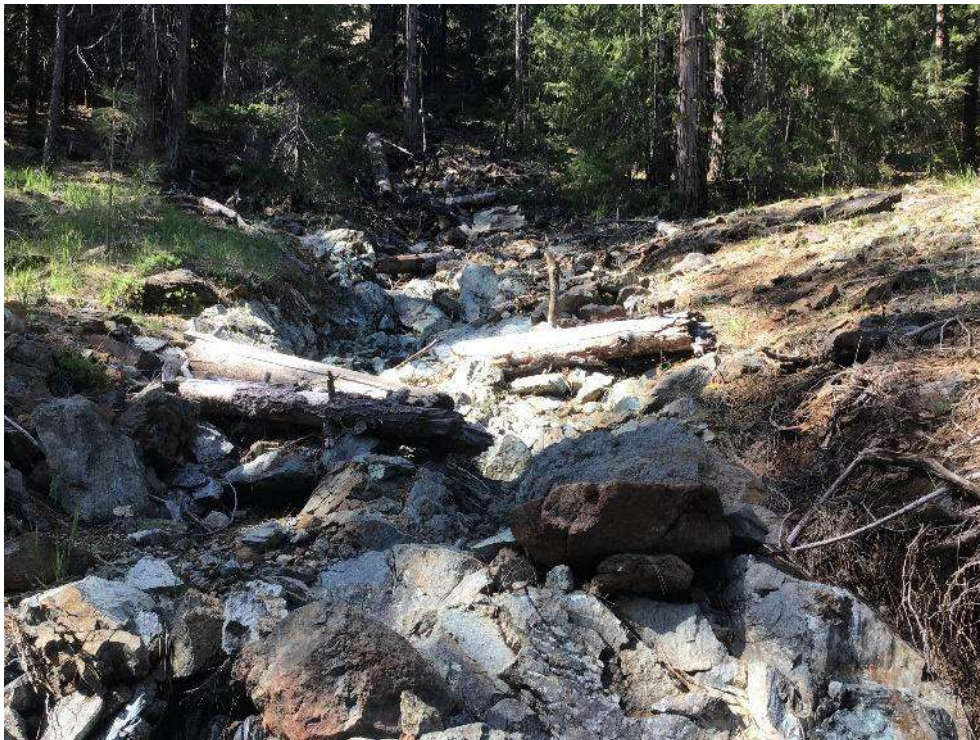
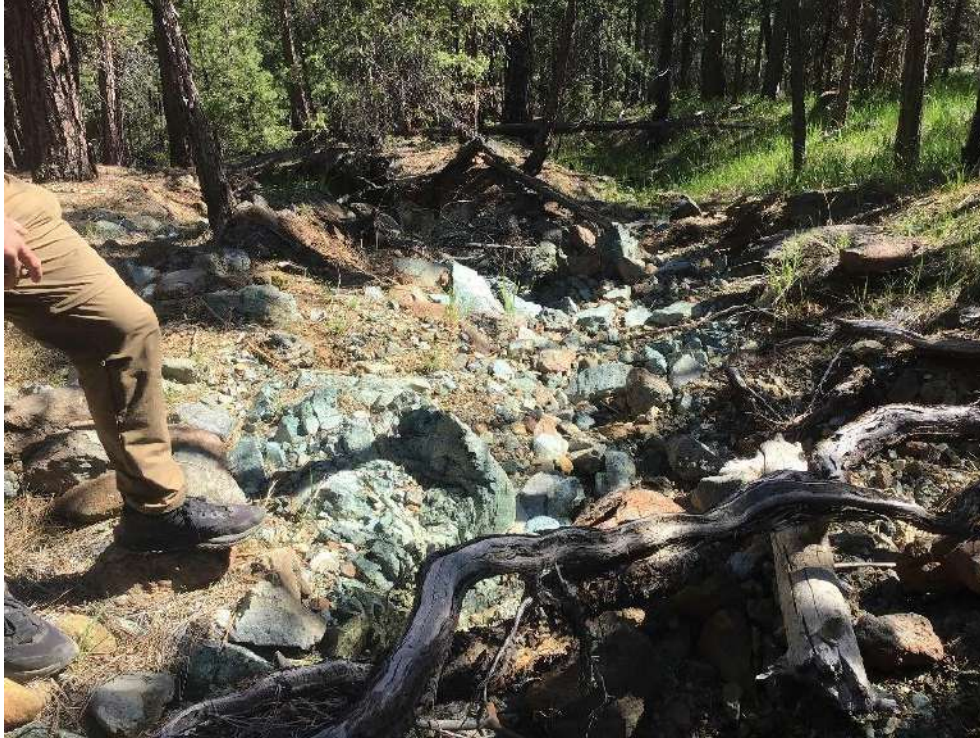
Photos 2.37 & 2.38: Typical features in Gully Complex 12. EFG12

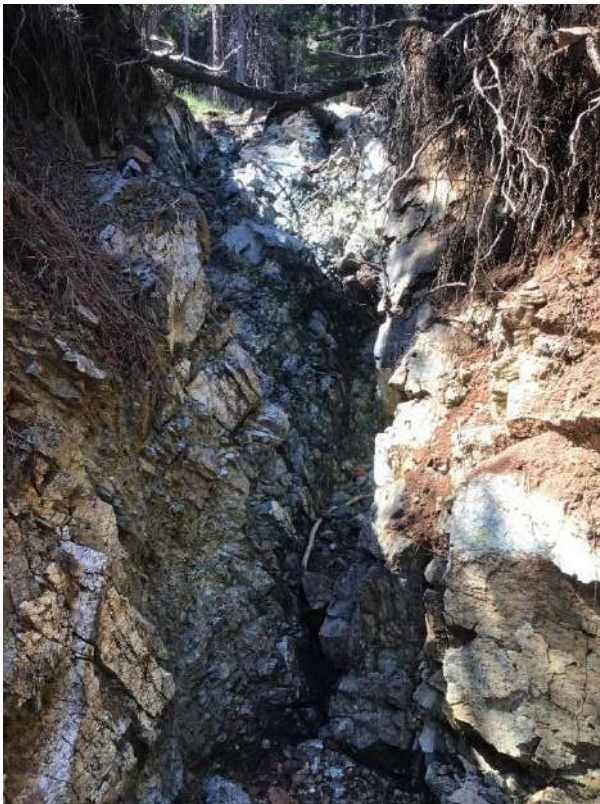
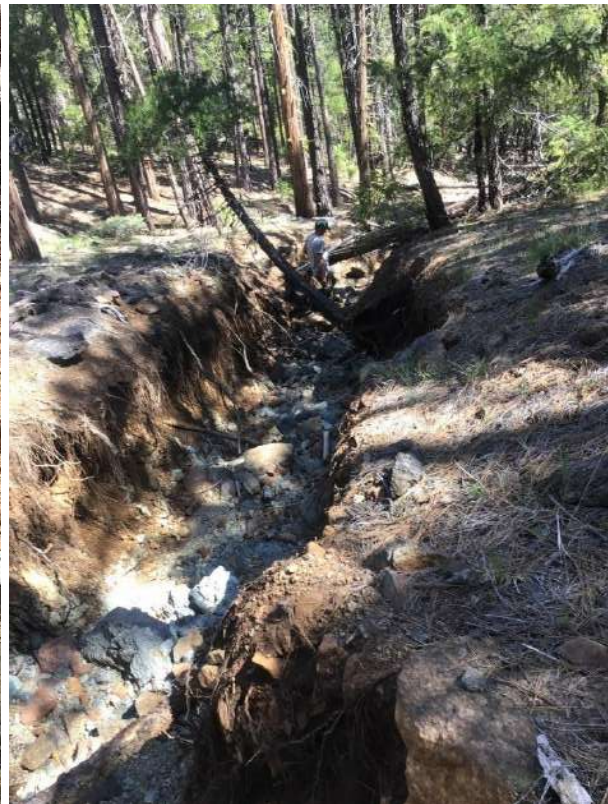
Photos 2.39 & 2.40: Greatest cross-section of Gully Complex 12 is 32 ft²; looking up and down the gully at that point.

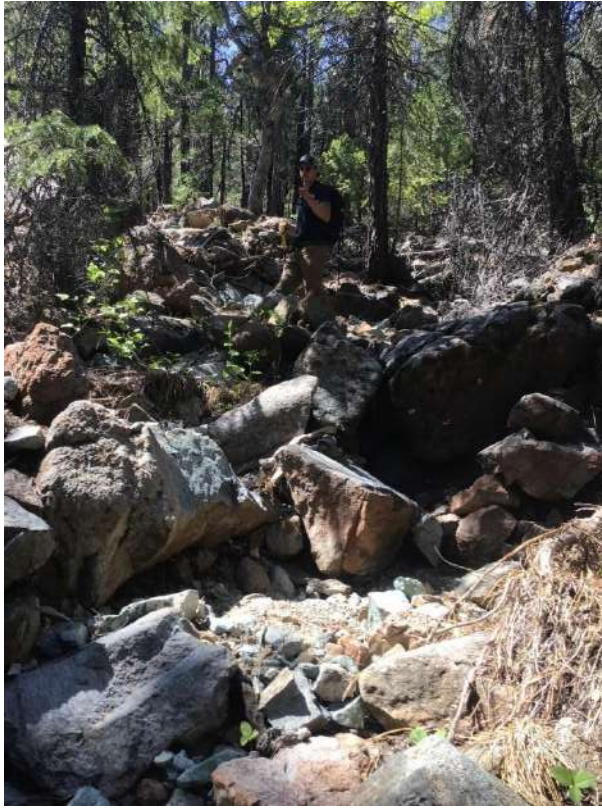
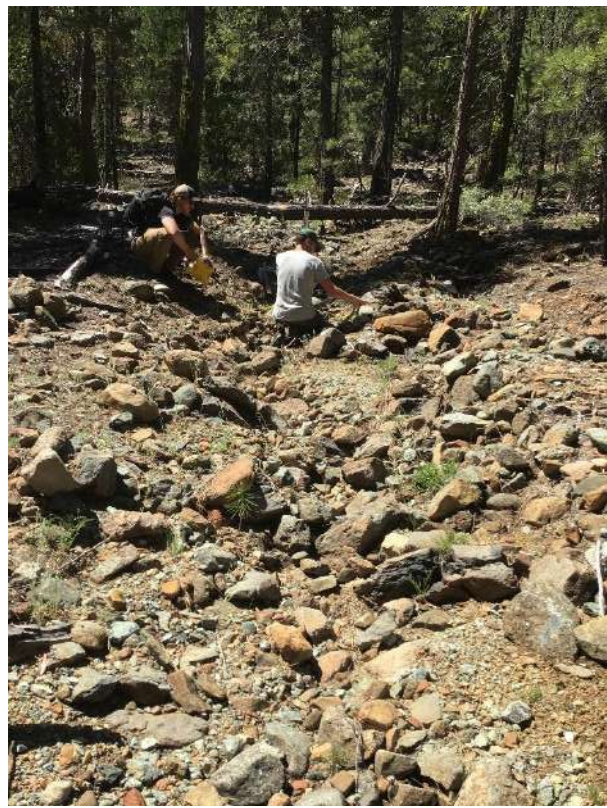
Photos 2.41 and 2.42: Typical features in Gully Complex 12. EFG 12d and EFG12g. May 23, 2023.

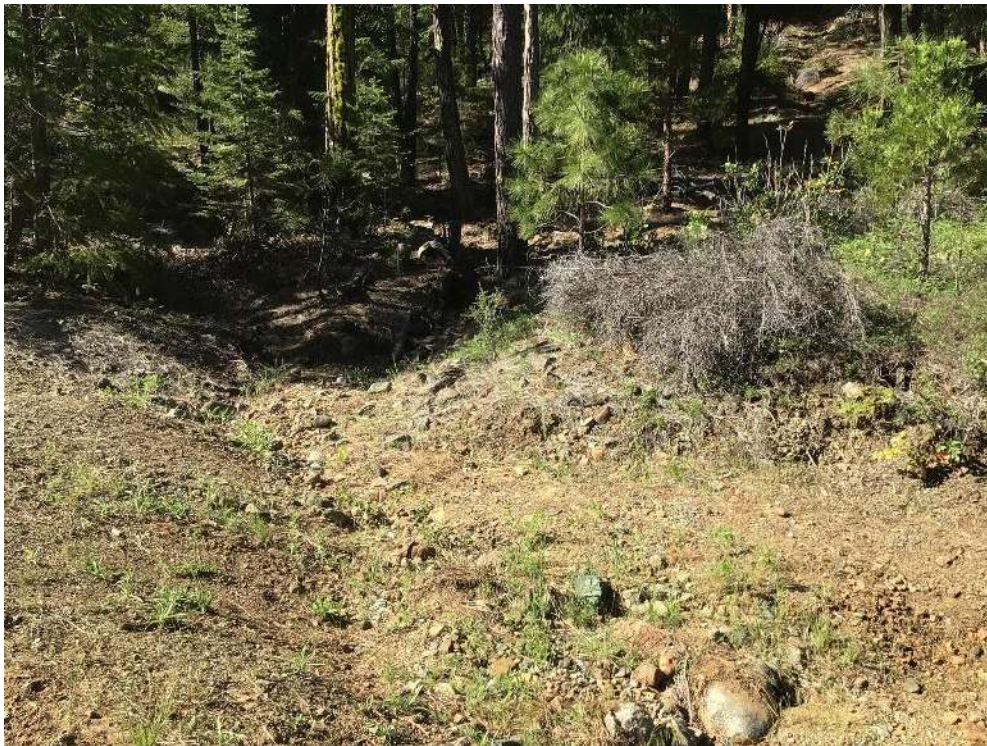
Photo 2.46: Immediately above road crossing. EFR6. May 23, 2023.

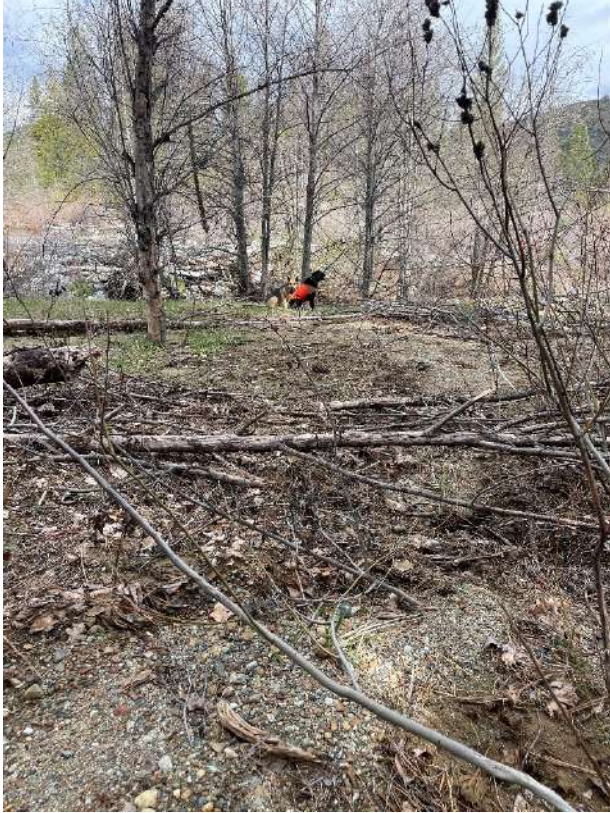
Photo 2.49: EFGC 5 discharges into the East Fork Scott River. April 5, 2023

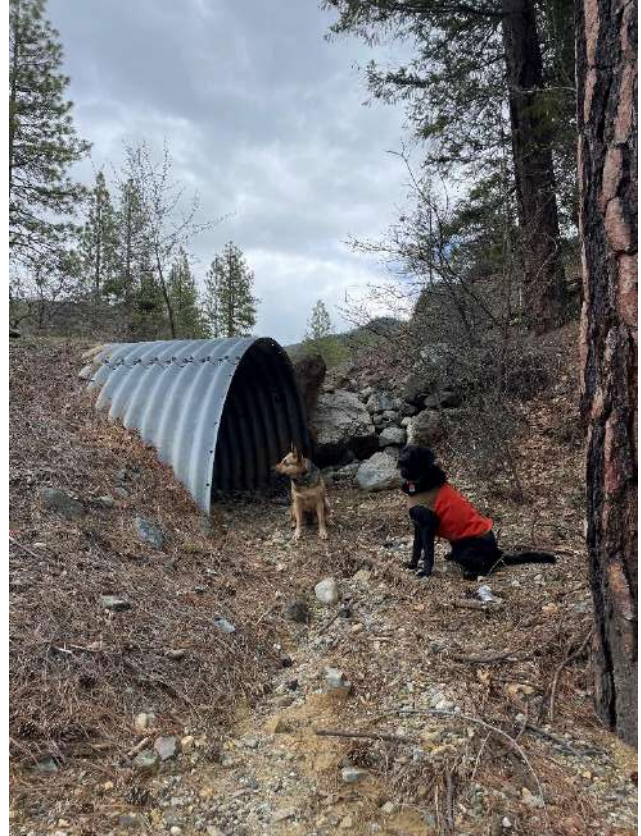
Photo 2.51: Beginning of EFG 24. Inboard ditch flows past culvert. EFG24a. April 5, 2024.

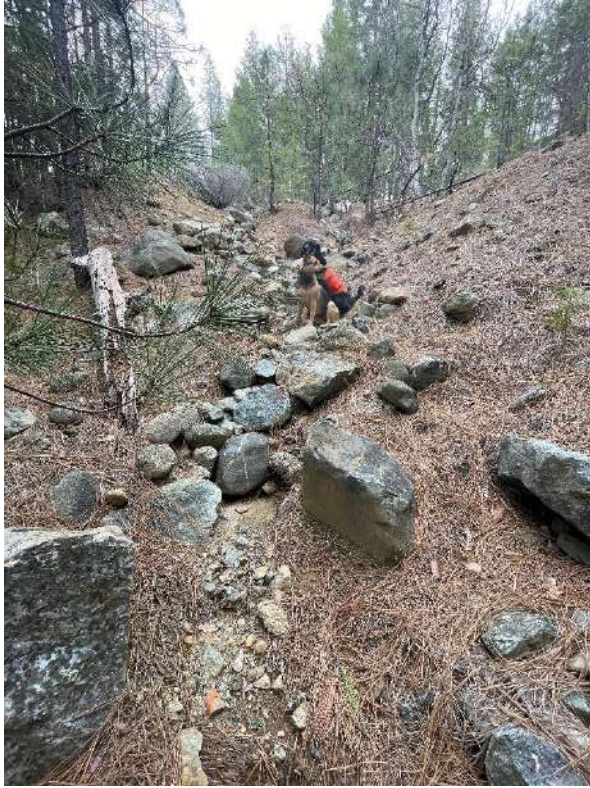
Photo 2.54: EFG 24 below road. EFG24b. April 5, 2024. EFG24e. April 5, 2024.

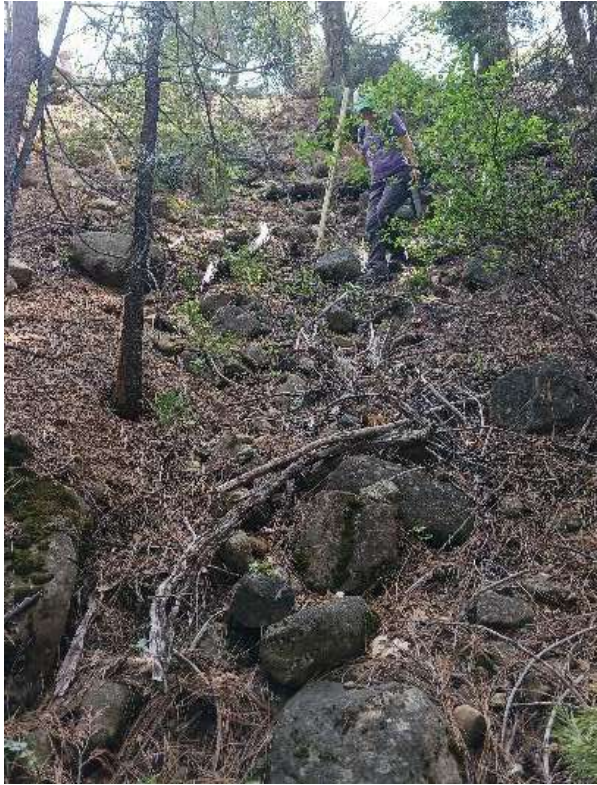
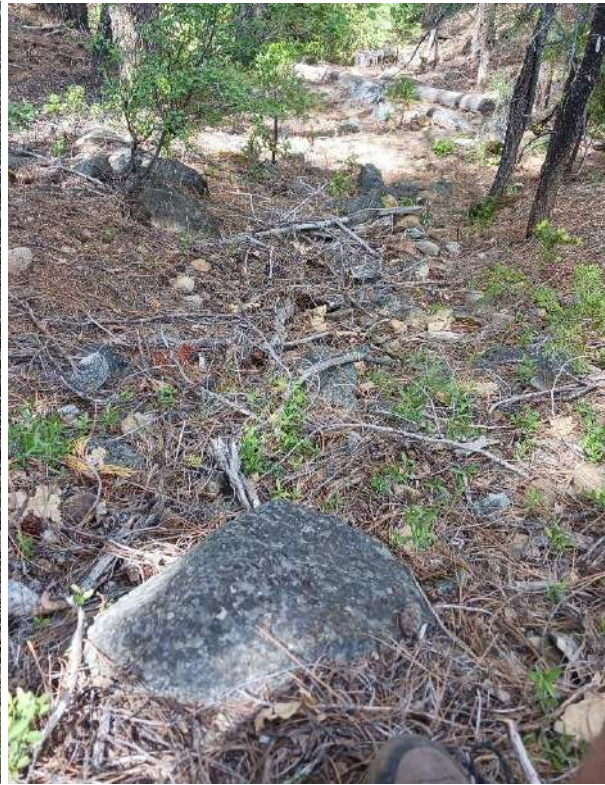
Gully Complex 6 (Table 2.10) begins slightly downslope of a berm on the downhill side of Highway 3 and bifurcates into two branches. Highway 3 does not appear to contribute to this gully system (Photo 2.21); there is no culvert or ditch. The thalweg of the gully is covered with a thick layer of duff (Photo 2.22), comparable to the forest floor around it, suggesting that it has not experienced recent erosion (Photo 2.23). It does not cause notable erosion when it crosses the dirt road. Perhaps this was a creek or swale that was cut off from its source by the construction of the highway.

Photo 2.56: Beginning of Gully 6. EFG6.1a. May 29, 2023.

Figure 2.57: Looking downslope from beginning of gully. EFG6.1a. May 29, 2023.

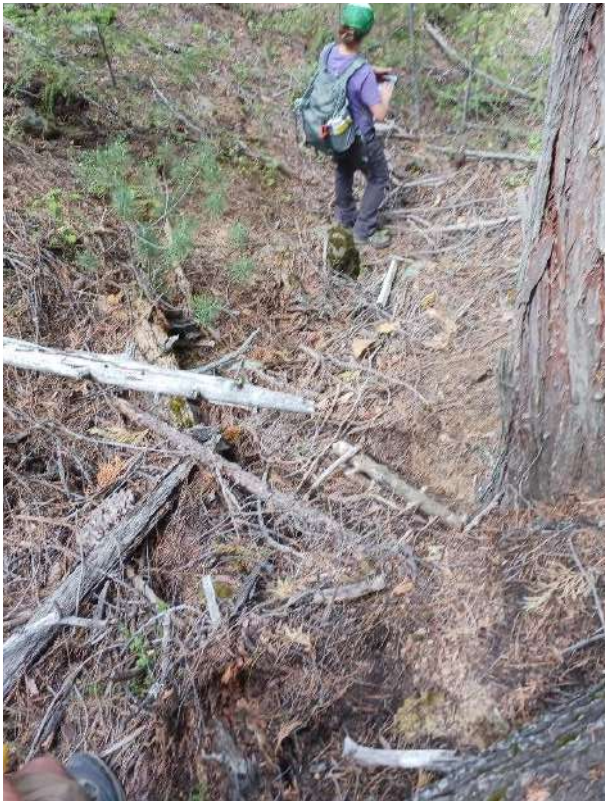
Photo 2.58: Significant layer of duff. EFG6g. May 29, 2023.
